**SUBJECT: Brownsville Dam Removal Report- Brownsville, Oregon**

# Brownsville Dam Removal Report

October 2007

**Project Number:** 2724012

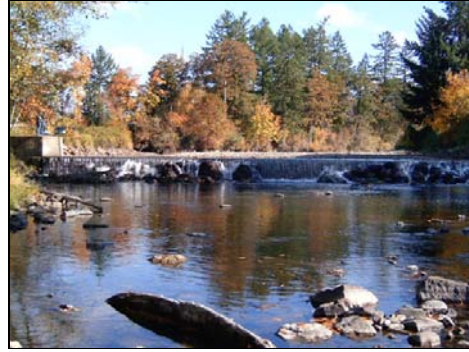
The Brownsville Dam was constructed as a hollow-core concrete dam.

The Brownsville Dam was constructed as a hollow-core concrete dam with downstream and upstream faces joined to a top or cover section. The concrete sections of which the faces and top were fabricated were approximately 12-inch-thick concrete with a 3/4-inch rebar mat. The interior of the dam was filled with sand and gravel. The dam was located between two concrete abutments located on either side of the Calapooia River, north to south. The dam structure was approximately 110 feet long, north to south and approximately 14 feet wide, east to west. Height of the dam faces were approximately 6 feet tall for the downstream (west) face and 8 feet tall for the upstream (east) face.

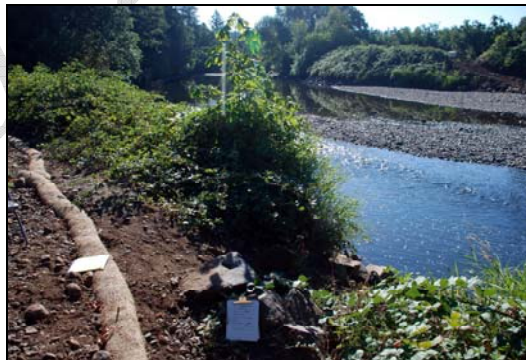
Sediment and erosion control best management practices used are included in the NPDES permit (Appendix A). Mr. Scott English, Erosion Control Inspector, completed installation and inspection for the project. Erosion controls included straw waddles, silt fences, isolation dams, and a turbidity curtain (Photographs 1 and 2).

Erosion controls included straw waddles (above), silt fences, isolation dams, and a turbidity curtain.

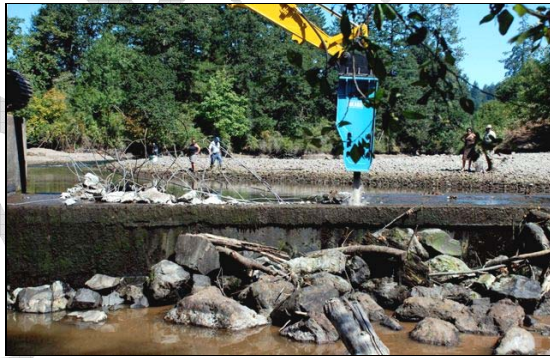
Removal of the notch on the north side began mid-day on August 27, 2007. Personnel used an excavator equipped with a jackhammer and mounted on top of the north side abutment to break open the concrete (Photograph 5). Another excavator with a bucket and thumb was used to remove the broken pieces, rebar, and gravel fill. By the end of the first day, the notch was completed and water was flowing freely past the dam. Construction was completed on the north side around mid-day on August 28, 2007.

An excavator equipped with a jackhammer broke open the concrete.

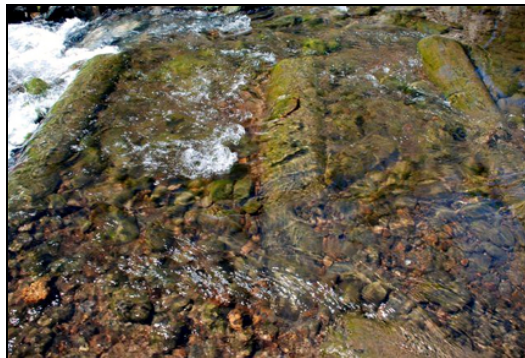
During completion of the north-side notch in the dam and placement of the cement blocks, large timbers with rebar and other wood remnants were encountered in the streambed and gravel bar (Photograph 8). The CWC notified the SHPO of the remnants and requested information on their disposition. At the request of SHPO and CWC, CES photographed and mapped the remnants prior to continued work. As directed, remnants were left in place except where they directly hindered the completion of the dam removal. It was not determined whether the remnants were related to the original wood crib dam or to a later construction. A copy of the remnant location map is included in Appendix C.

**Large timbers with rebar and other wood remnants were encountered in the streambed and gravel bar.**

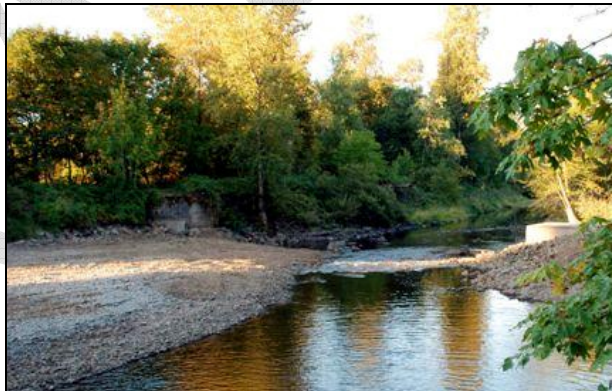
**The Calapooia River channel was graded to match the existing contour of the gravel bar and the presumed center of flow of the river.**

Site restoration began during the cleanup phase and was completed on September 8, 2007. Site restoration consisted of minor grading of the channel to approximate the presumed natural flow path of the river, placement of the large riprap, formerly in front of the dam, minor grading of the gravel bar, and restoration of the equipment access routes (Photographs 9-12). Specifically, the channel was graded to match the existing contour of the gravel bar and the presumed center of flow (thalweg) of the river upstream and downstream of the former dam.

The large riprap formerly lined up in front of the dam was placed in approximate natural patterns below the dam, but not in the center of the thalweg. Riprap and gravel were also placed in front of the abutments (i.e., on the sides adjacent to the river) to cover the areas exposed after removal of the dam.

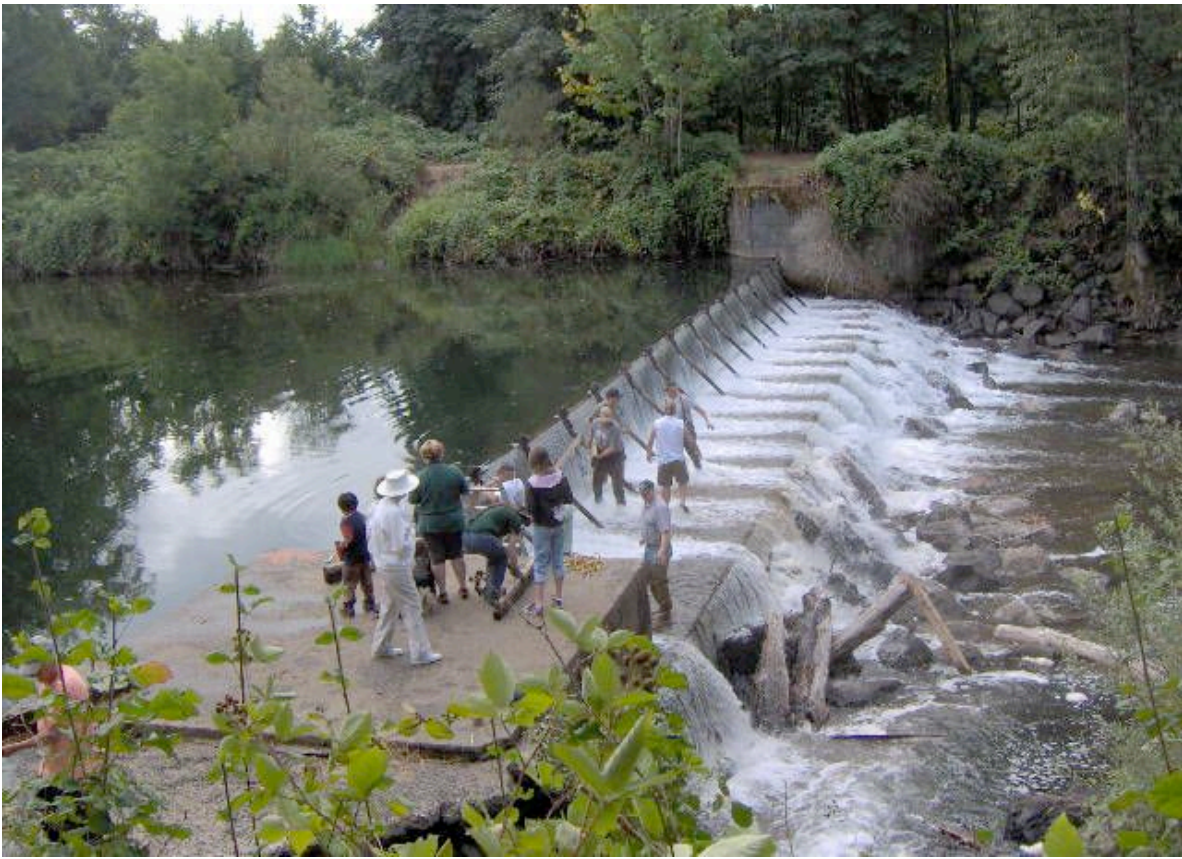
**Brownsville Dam – August 18, 2007**

Community members remove the flashboards for the final time.  
The flashboards raised the height of the dam by 5 feet to divert flow into the Brownsville Canal.

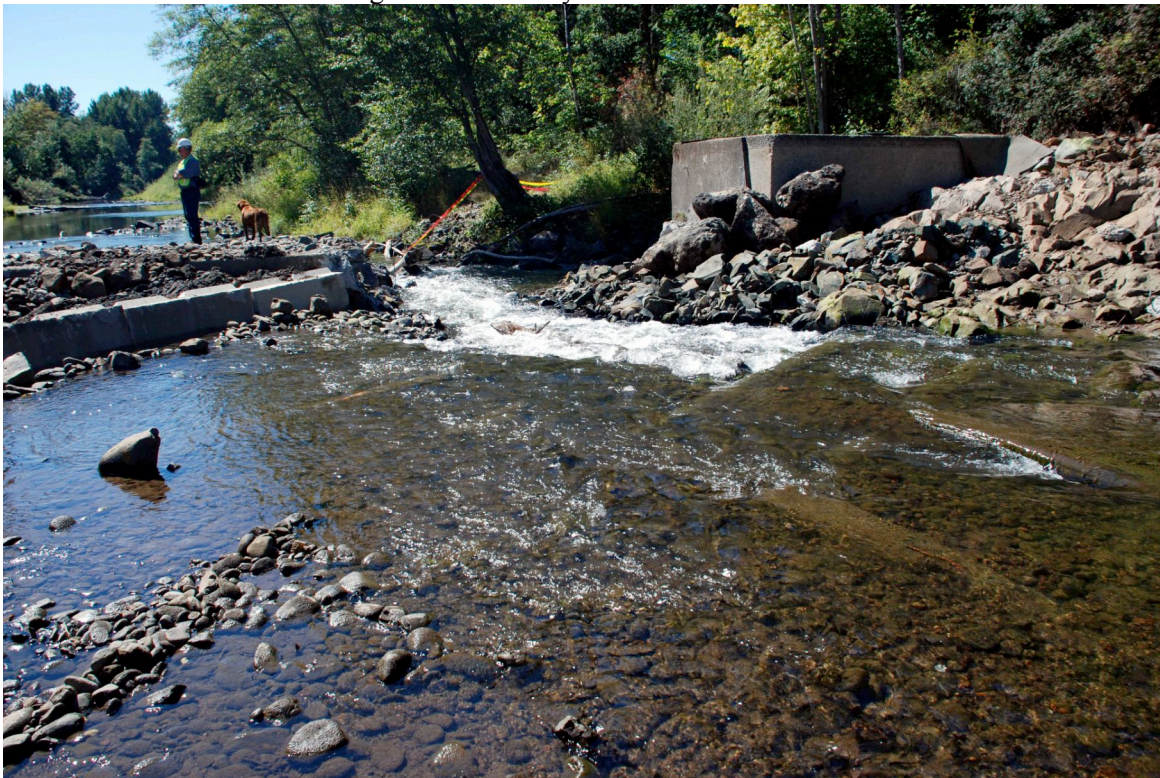
**Brownsville Dam August 28, 2007 Day 2 of construction (Looking downstream)**

Wooden crib dam visible after notch on North side removed and sediment washes out from on top of these old logs.  
Structure has rebar bolting it down, so likely it is remnants from the 1940s cribdam.

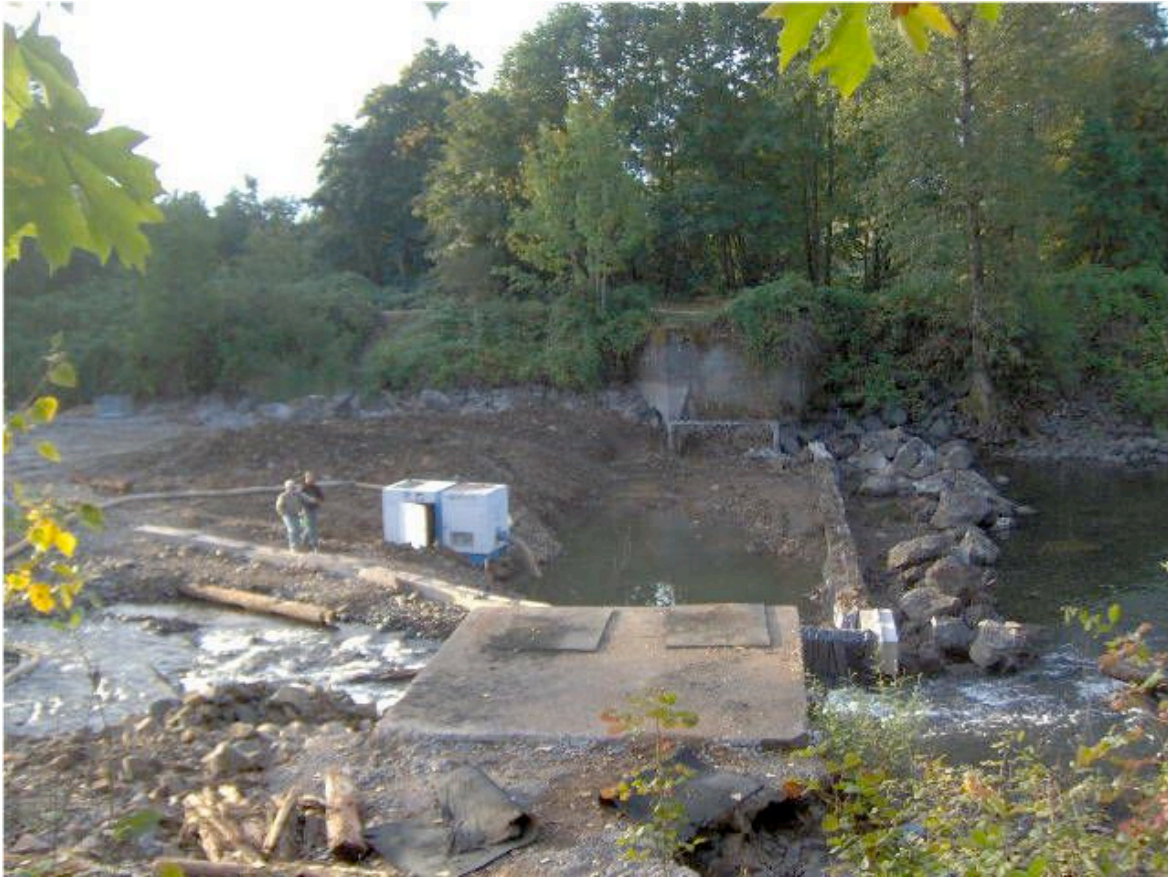
**Brownsville Dam September 5, 2007 – Day 7 of construction**

Entire upstream and downstream walls of dam removed. Ecoblocks in place dewatering site.  
Pump in place to dewater work area.
