East Fork Williams Creek
Sediment Analysis

East Fork Private Road Inventory
and Sediment Analysis

Prepared by
Charles Rogers
Williams Creek Watershed Council

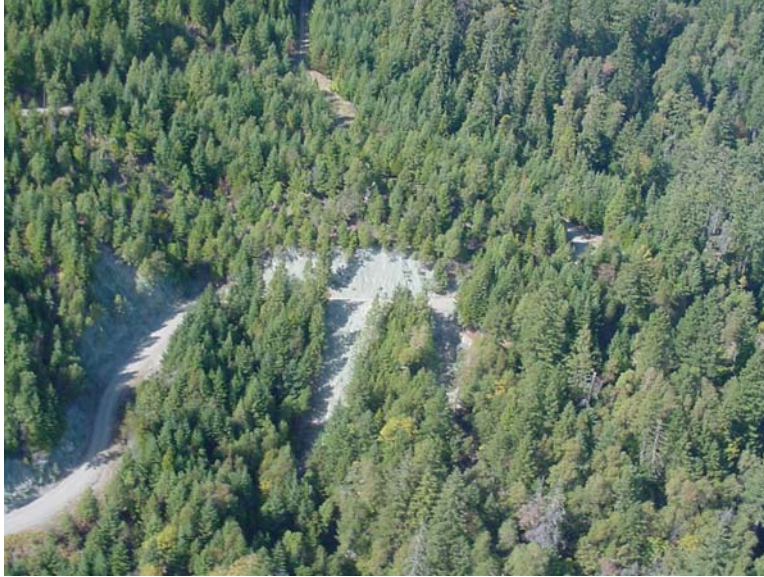
Fig 2. Aerial photo of landslide area on upper Rock Creek taken after BLM used hydroseeding techniques on the landslide to slow the erosion process. Photo by C.Rogers

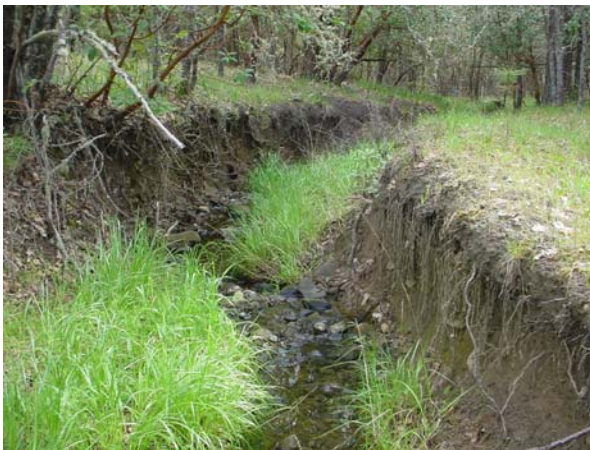
Gullies formed along Lower East Fork Road by cross-drained culvert outflow

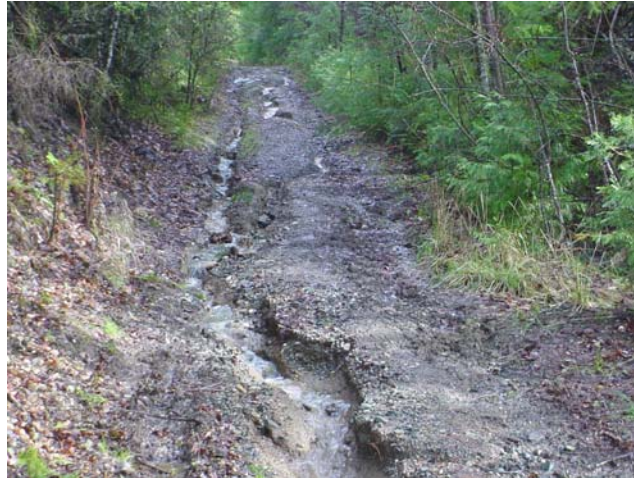
Fig. 8. Upper East Fork Road erosion damage from one year

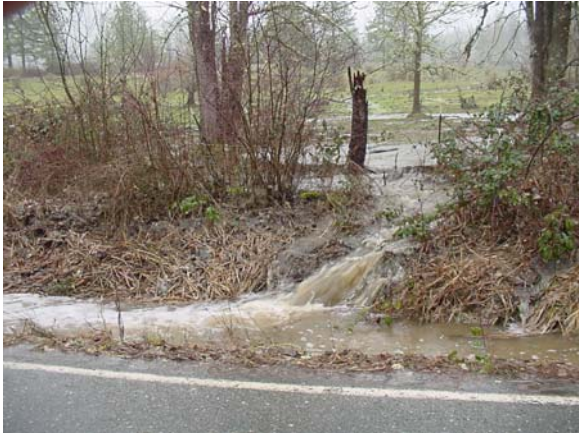
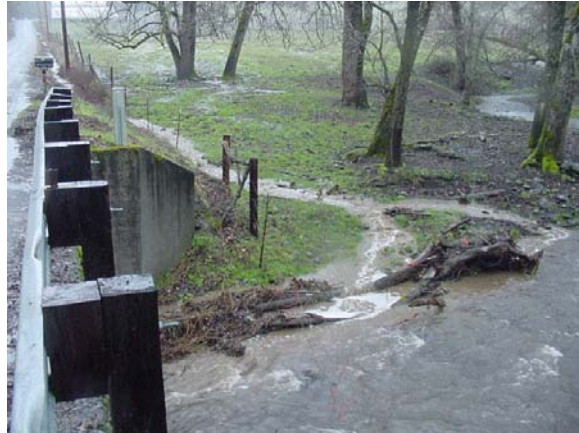
Fig 10. Fine sediment runoff during rainstorms is common from grazing land where cattle have disturbed and loosened the soil. Some of the runoff reaches the stream system along the East Fork Creek

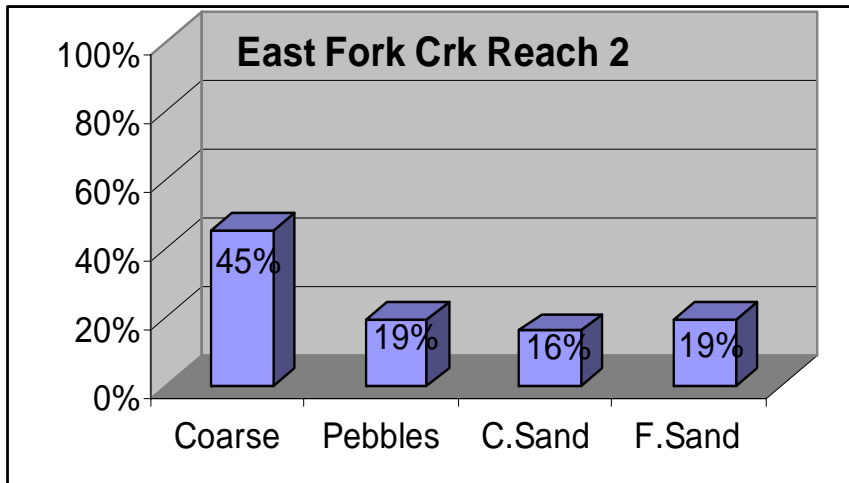
Fig 20. East Fork Williams Creek at the upper end of Reach 2

This sampling site is in Reach 2 at River Mile 1 and contains excellent spawning habitat. Sand content is in the 30% level with moderate amounts of wood debris. Large trees shade the reach and provide organic material for quality spawning habitat. Channel complexity is low with straight channel development, although restoration design could be very effective in this reach. Landowners have a pump station established at this site and want to incorporate restoration designs with their irrigation needs.

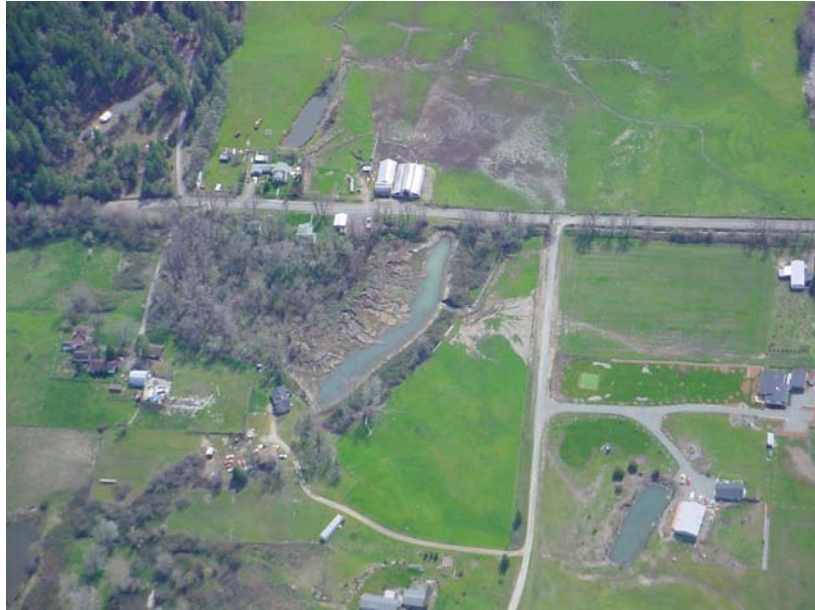
Panther Gulch Creek is captured by many ponds on its way to the East Fork Williams Creek with the final pond on lower Panther Gulch Road. This large instream pond fills from runoff and flows out through an overflow gate and into the roadside ditch along Panther Gulch Road and into the East Fork Williams Creek. This pond was the site of enormous erosion during December of 2002 when a large rain event brought 8 inches of rain to the area. The overflow of the water breached the dam, eroded the dam wall, and caused massive failure. This brought enormous amounts of sediment down the valley across Homestead Road and flooding and eroding soil in neighboring property. The overflow eventually entered the East Fork Williams Creek, raising the sediment levels and causing flood damage to nearby property (See photos on following page).

Fig: 58 Aerial photo showing pond on Panther Gulch where dam failure resulted in mudflows and flooding of lower Williams Valley

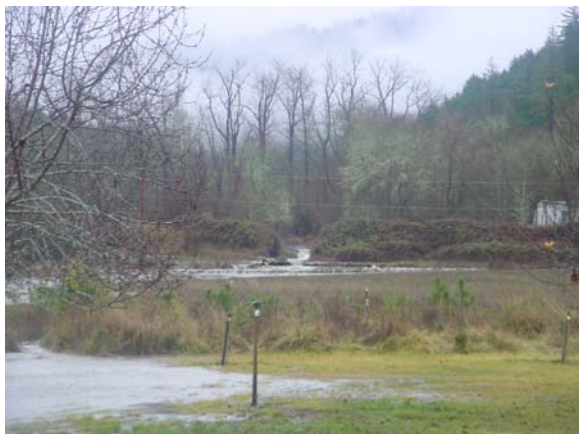
Flooding and overflow of pond resulting in collapse of dam and extensive mudflow on the Panther Gulch Creek

Fig 59. Dam failure with overflow of pond

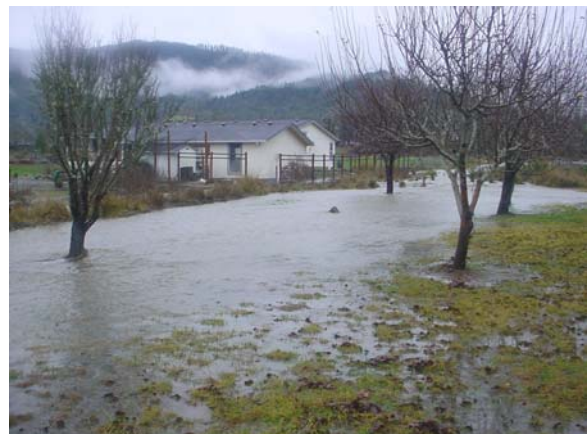
Fig 60 Flooding of neighboring lands

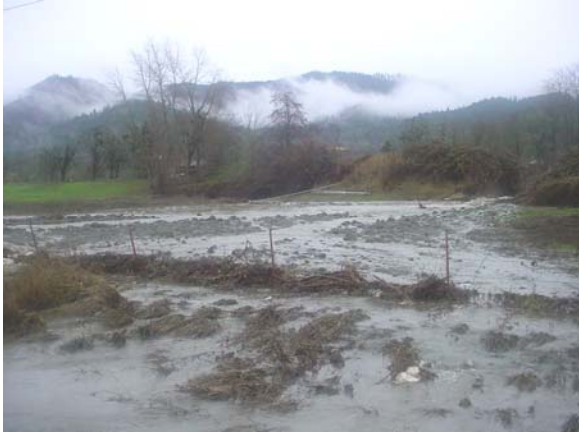
Fig 61. Sediment flowing out of failed pond

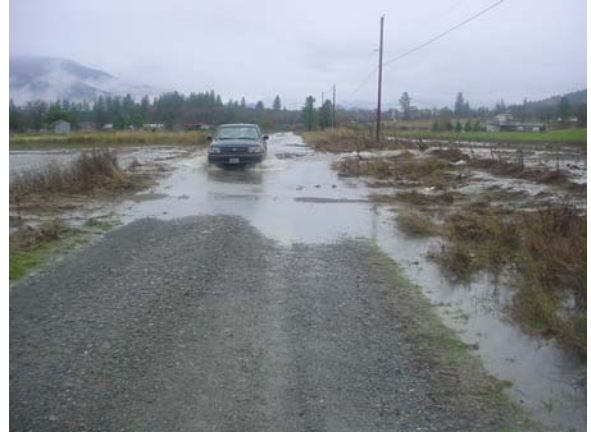
Fig 63. Overflow onto Homestead Road

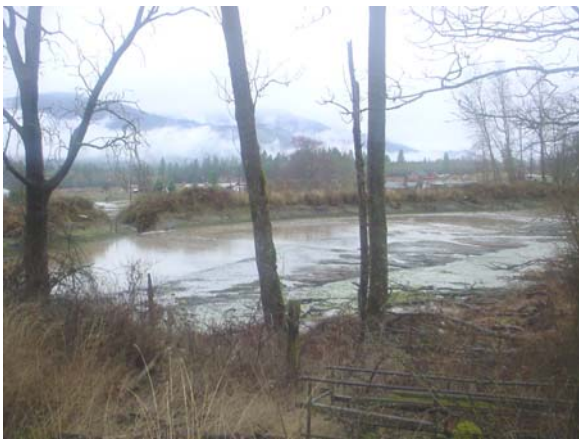
Fig 62 Pond emptied of water showing sediment deposited in bottom and failure point

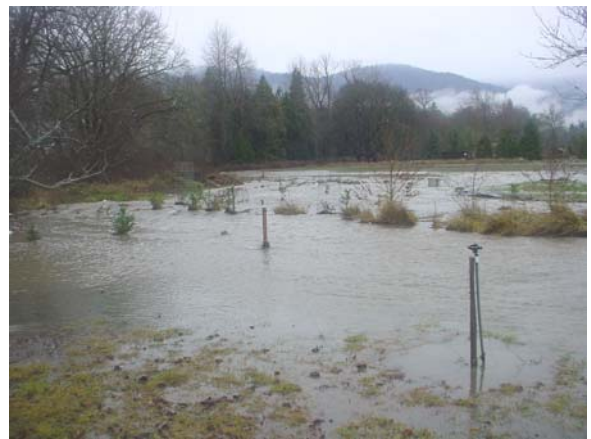
Fig 64. Flooding of neighboring land
