Evaluation of Fish Passage Improvement Projects in the South Coast and Rogue River Basins 2009

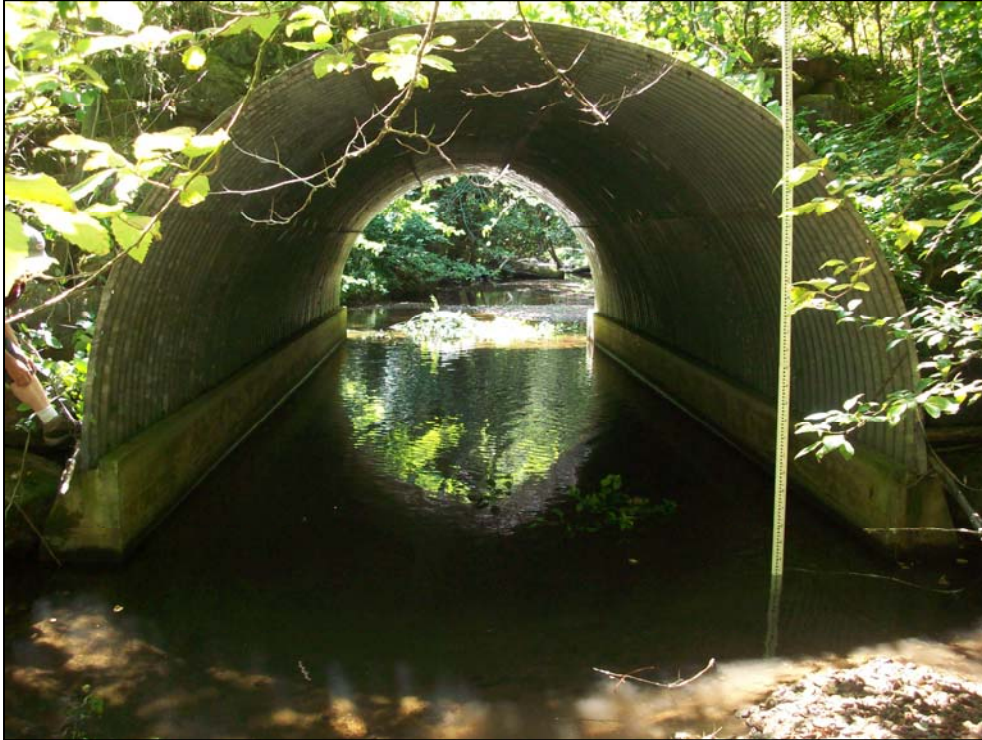
Photo 1. Site 11 bottomless arch rated as allowing juvenile to pass through only 1.8% of the modeled flows.

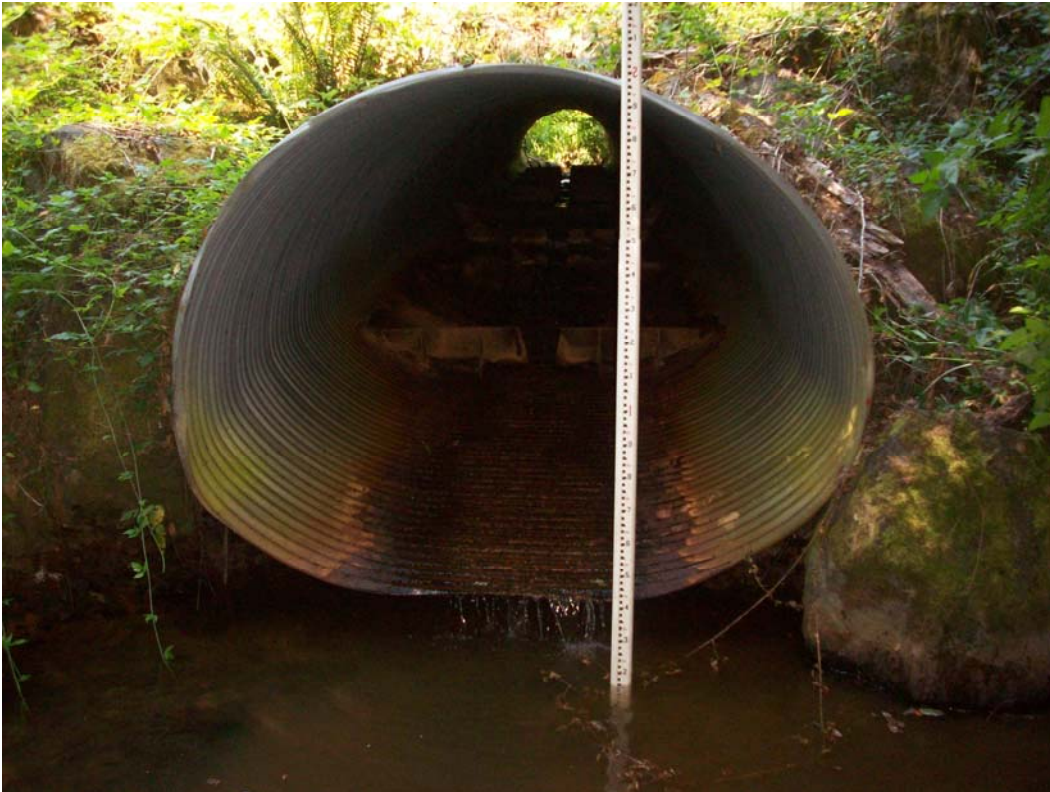
Photo 2 . Site 10 predicted to be a 100% barrier to juveniles. The culvert has a > 0.1 meter outfall drop.

- Revisit the 8 sites highlighted above and in Table 7 that appear to be juvenile barriers and evaluate if repairing the culverts is possible. If not, consider the cost benefit of replacing the culverts.
- Expand this study to look at the time of year that the expected passable flow range predicted by FishXings would occur at each site. This could be carried out using the regional regression equations in conjunction with ArcHydro. Then link those results to when juvenile species are expected to be migrating. This would help determine if the percentage of passable flows coincides with juvenile migration patterns.
- Consider further monitoring of juvenile passage using a sophisticated study design similar to the study ODFW conducted at Crowfoot Falls (Appendix A).

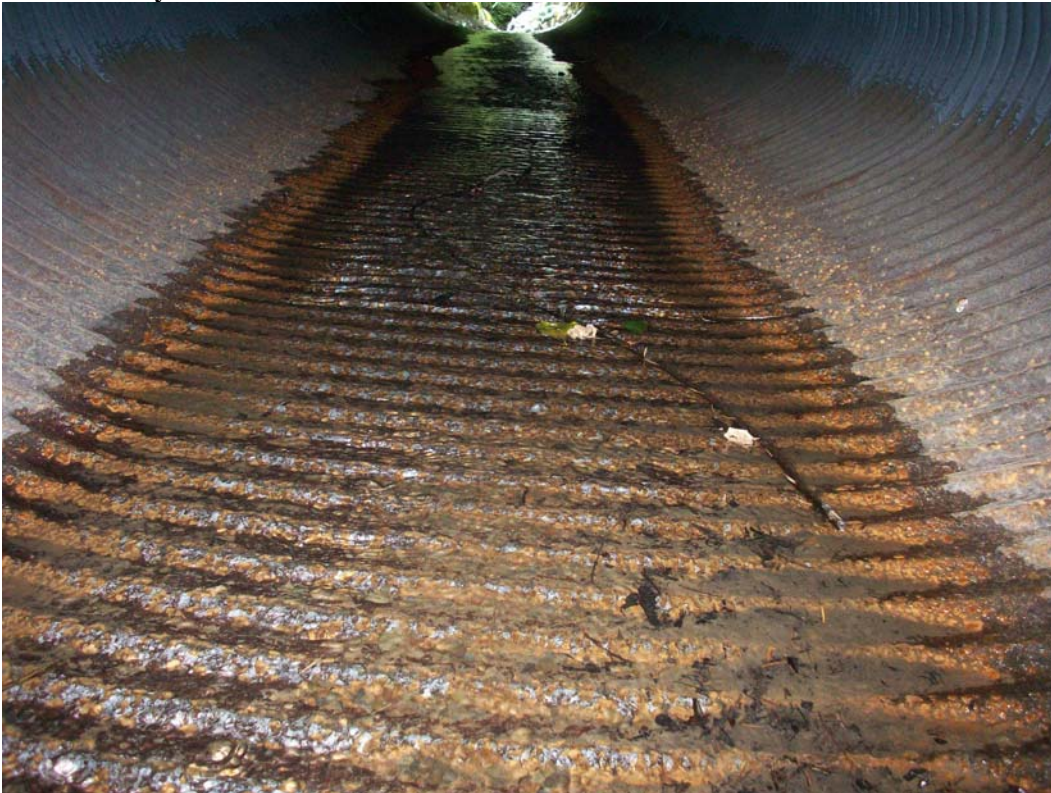
Photo 6. Site 82, velocity barrier, clear with no obstructions.

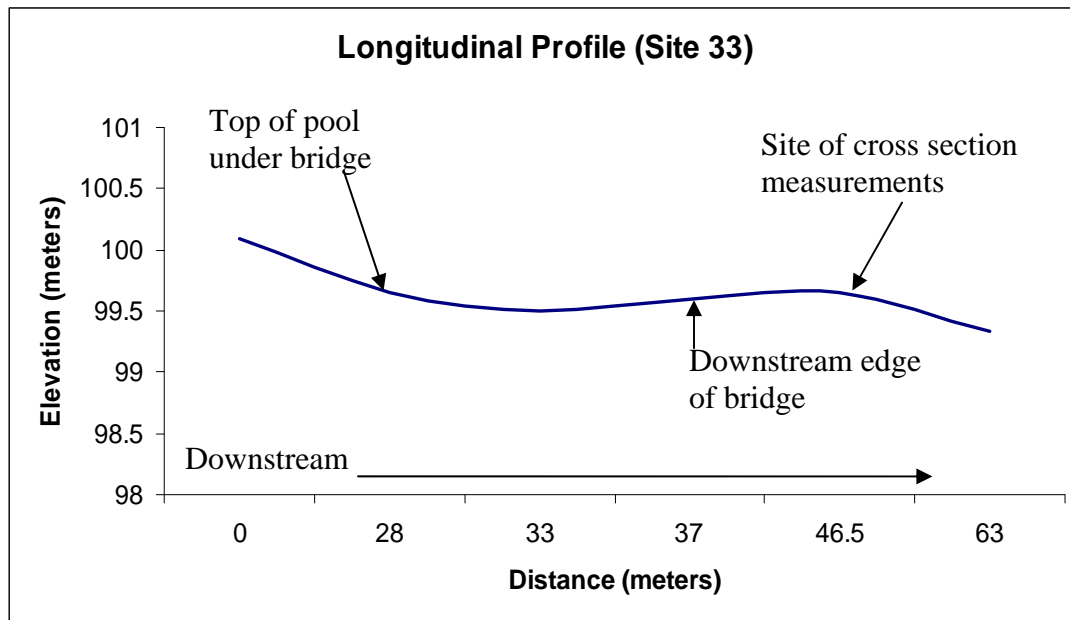
Figure 2928. Logitudinal Profile for Site 33, Coquille sub-basin.

The longitudinal profile was 68 meters long and captured the area of channel affected by the stream crossing upgrade from a culvert to a bridge. Overall the channel slope was 2.7%, while the slope immediately under the bridge was a -2.5%. As the profile illustrates, a pool was formed just under the bridge. The pool is a scour pool and is formed by large boulders forcing scour. The cross section illustrates a region at the pool tail crest (Figure 30Figure 29). Bedload evidence was found at the cross section in the form of stacked cobbles.

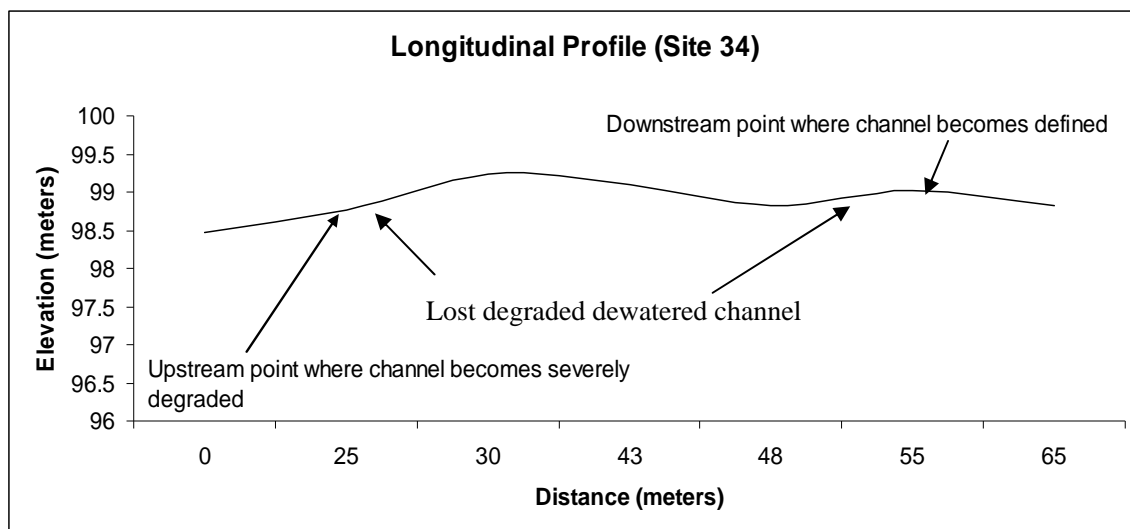
The longitudinal profile illustrates the longitudinal profile of Site 34. This is a highly degraded site. There is no defined channel for nearly 30 meters as the channel is consistently grazed by livestock. The banks have been denuded of all riparian vegetation here and the banks are non-existent. This section of the channel now acts as a wetland.

Figure 3130. Longitudinal profile of the channel at Site 34, Wimer Creek, Coquille sub-basin.

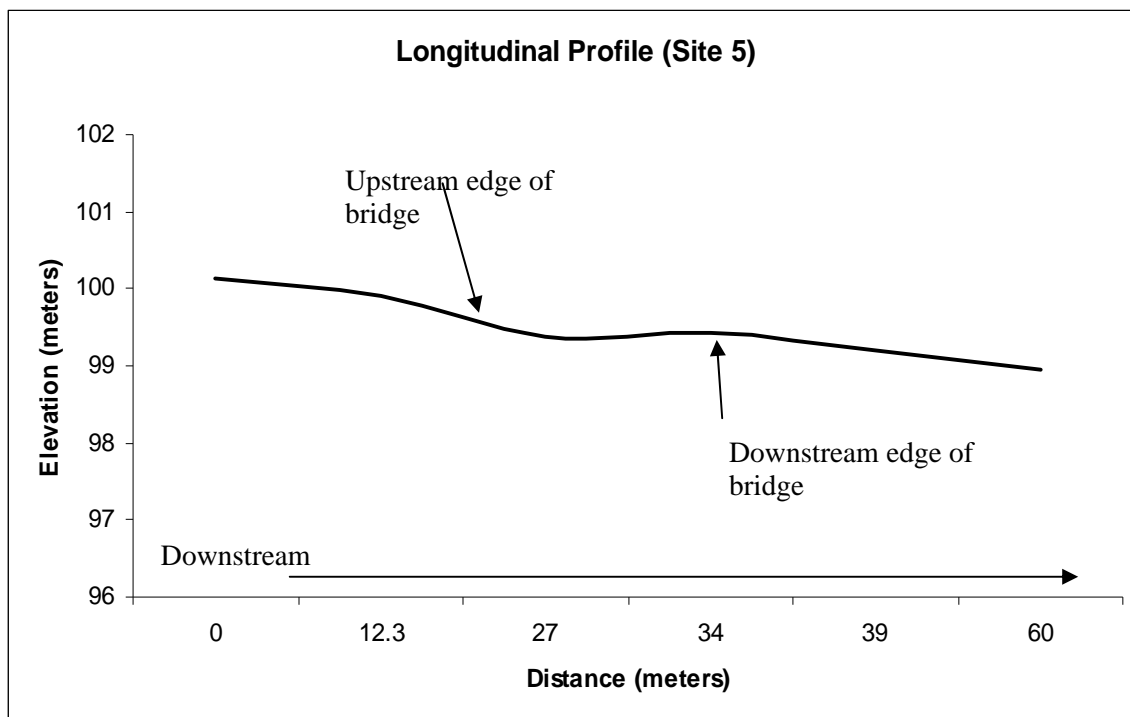
Figure 47 illustrates the shape of the longitudinal profile at Site 5. The channel gradient upstream of the project area was 2.8%, while the gradient downstream of the project area was 1.8%. We calculated the gradient within the project at 0.9%. When the previous structure was removed, the gradient was lessened and boulders were placed in the channel. This has caused some minor scouring within the channel, but most importantly the project area's slope is less than that of the channel. This ensures that fish including juveniles can pass through the area of restoration.

Figure 4746. Longitudinal profile for Site 5 on a tributary of Arrow Creek.
