Klamath Falls earthquakes, September 20, 1993—including the strongest quake ever measured in Oregon

by Thomas J. Wiley¹, David R. Sherrod², David K. Keefer³, Anthony Qamar⁴, Robert L. Schuster⁵, James W. Dewey⁵, Matthew A. Mabey⁶, Gerald L. Black⁶, and Ray E. Wells³

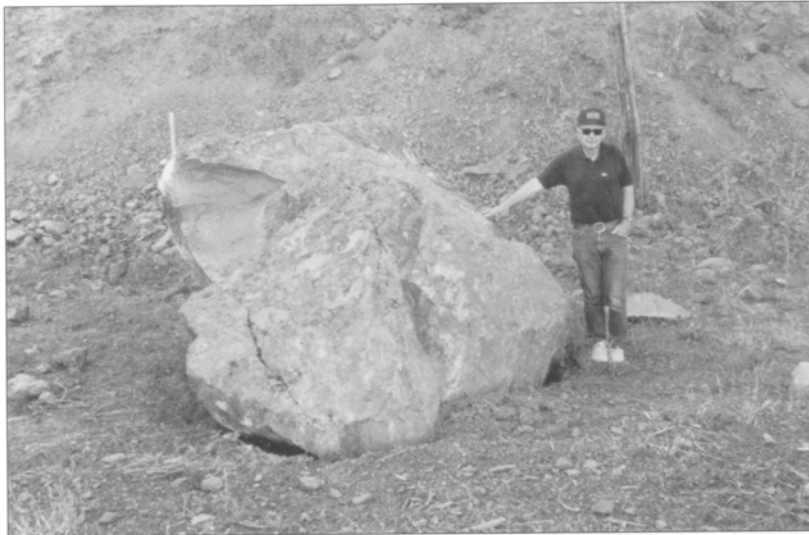
Figure 5. Rock-fall boulder from steep ridge bordering Oregon Highway 140 west of Howard Bay (Locality 1, Figure 2). Boulder fell from near-vertical slope partly visible in background and came to rest on highway shoulder.

The most numerous earthquake-induced rock falls were found along the east- to southeast-facing flank of a ridge immediately south and west of Howard Bay, 17 km (11 mi) east-southeast of the 10:45 p.m. epicenter (Locality 1, Figure 2). This ridge, which is 250 m (820 ft) high, has slopes exceeding 45° in some places. Basalt lava flows crop out in the upper part, and the lower slopes are mantled by boulder-rich colluvium and talus. Several dozen boulders, some as large as 4 m (13 ft) across, broke loose and fell or rolled down the slope during the earthquake. A few boulders came to rest on the shoulder and roadway of Oregon Highway 140 (Locality 1, Figure 2; Figure 5). One of these boulders was struck by an 18-wheeled truck, which then veered off the highway and into more boulders at the base of the cliff. Many more boulders came to rest on the unpaved road that climbs the southeastern side of the ridge.

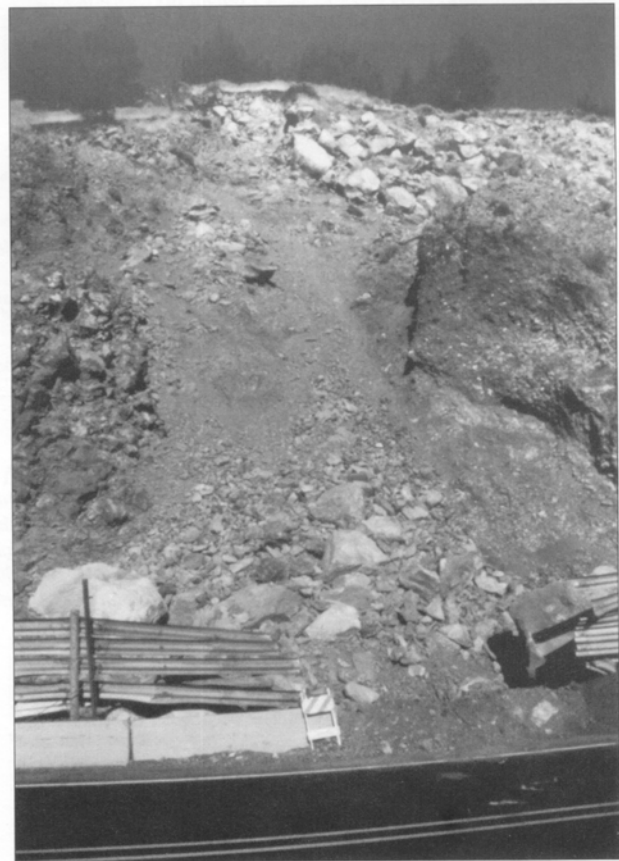
The largest observed rock slide originated on a steep road cut on the east side of U.S. Highway 97, at a point 3 km (1.8 mi) south of the town of Modoc Point and 23 km (14 mi) from the 10:45 p.m. epicenter (Locality 3, Figure 2; Figures 6 and 7). This rock slide, which contained an estimated 300 m³ (10,600 ft³) of material, broke loose from a 60° slope composed of heterogeneous volcanic rock that is locally weakly cemented, intensely fractured, or both. The rock slide moved downslope about 100 m (330 ft); most of the material was contained behind a roadside barrier consisting of concrete sections surmounted by a steel fence, but one large boulder, 3.5 m (11.5 ft) in maximum dimension, crashed through the barrier onto the highway. The boulder hit a southbound vehicle, killing the driver.

Figure 6. Rock slide from Modoc Rim, 2.9 km (1.8 mi) south of the town of Modoc Point and adjacent to U.S. Highway 97 (Locality 3, Figure 2). Note breach in roadside barrier and impact marks in highway pavement caused by large boulder that hit southbound vehicle and came to rest on road. The boulder was pushed off the road before the photograph was taken and is visible just behind the right side of the breach.

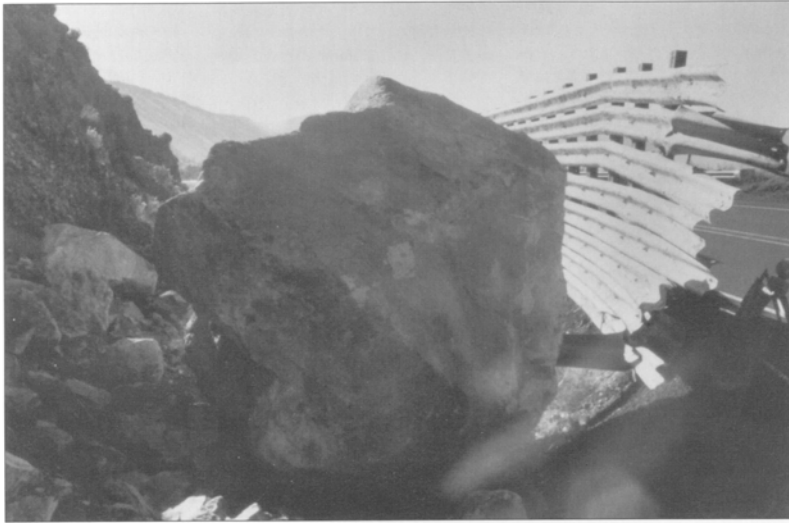
Figure 7. Close-up of large boulder from the Modoc Rim rock slide (Figure 6) that breached barrier along U.S. Highway 97.

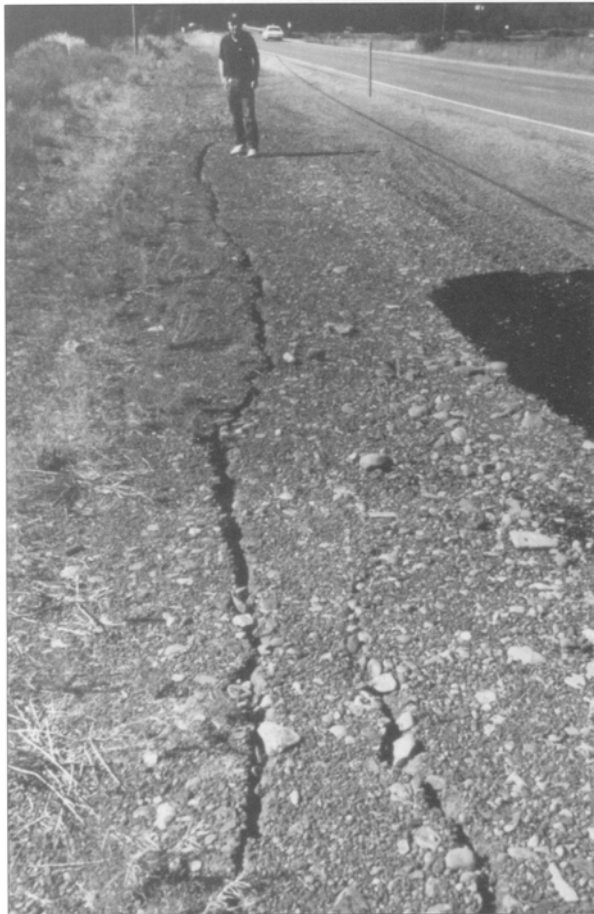
The Oregon Highway 140 bridge across Howard Bay, 17 km (11 mi) east-southeast of the 10:45 p.m. epicenter (Locality 1, Figure 2), was damaged by slumping and settlement at the north abutment and settlement of the south abutment. At the south abutment, the approach fill settled approximately 10 cm (4 in.). Left-lateral displacements totaling approximately 17 cm (7 in.) occurred across joints in the bridge deck, probably due to slumping and settling that caused the bridge deck to rotate counterclockwise. South of the bridge, the highway is built on a fill causeway at the edge of the marsh. For a distance of several hundred meters, the fill along the west shoulder of this causeway slumped into the marsh, opening cracks 5–10 cm (2–4 in.) wide (Figure 8).

Figure 8. Linear cracks in the causeway fill south of Howard Bay bridge on Oregon Highway 140. These cracks were caused by slumping of fill in a westward direction, toward the right edge of the photograph.

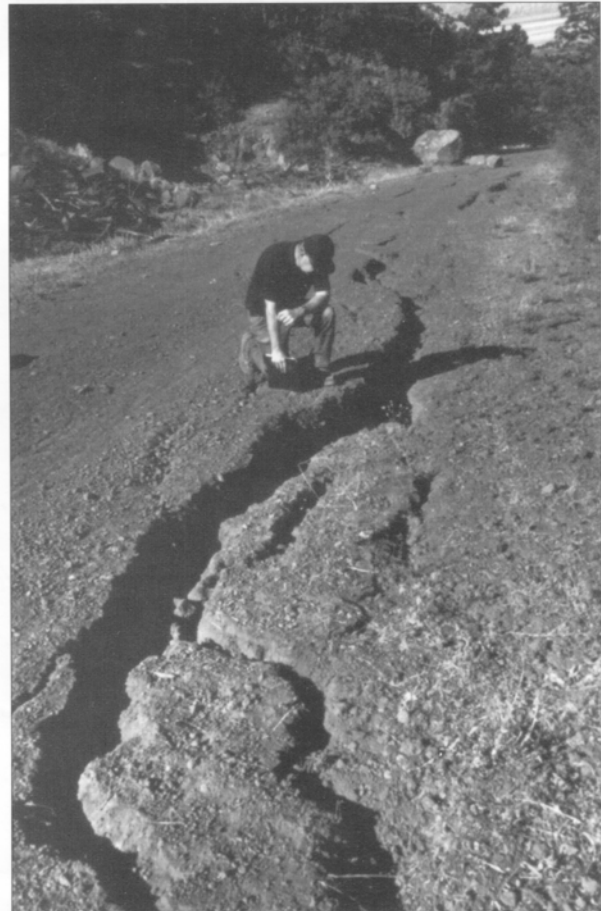
Several slumps in fill also occurred along the gravel road below the ridge immediately west of the bridge (Figure 9). These slumps were characterized by crescent-shaped open cracks that were concave downslope in plan view. The largest cracks were more than 100 m (330 ft) long and 30 cm (12 in.) wide. Several such slumps occurred in the quarry and the quarry road on the southeast-facing slope of the ridge, and at least two slumps occurred lower on the road, adjacent to a canal.

Figure 9. Crescent-shaped cracks associated with rotational slump in fill. Slumps involved unpaved road in quarry at Locality 1 on Figure 2. Boulders on road from earthquake-induced rock falls are visible in background.
