US 20 Pioneer Mountain to Eddyville

**GEOTECHNICAL DATA REPORT – PHASE 2A
SUPPLEMENTAL GEOTECHNICAL INVESTIGATION**

**PIONEER MOUNTAIN TO EDDYVILLE SECTION
US ROUTE 20 RELOCATION DESIGN AND CONSTRUCTION**

April 24, 2008

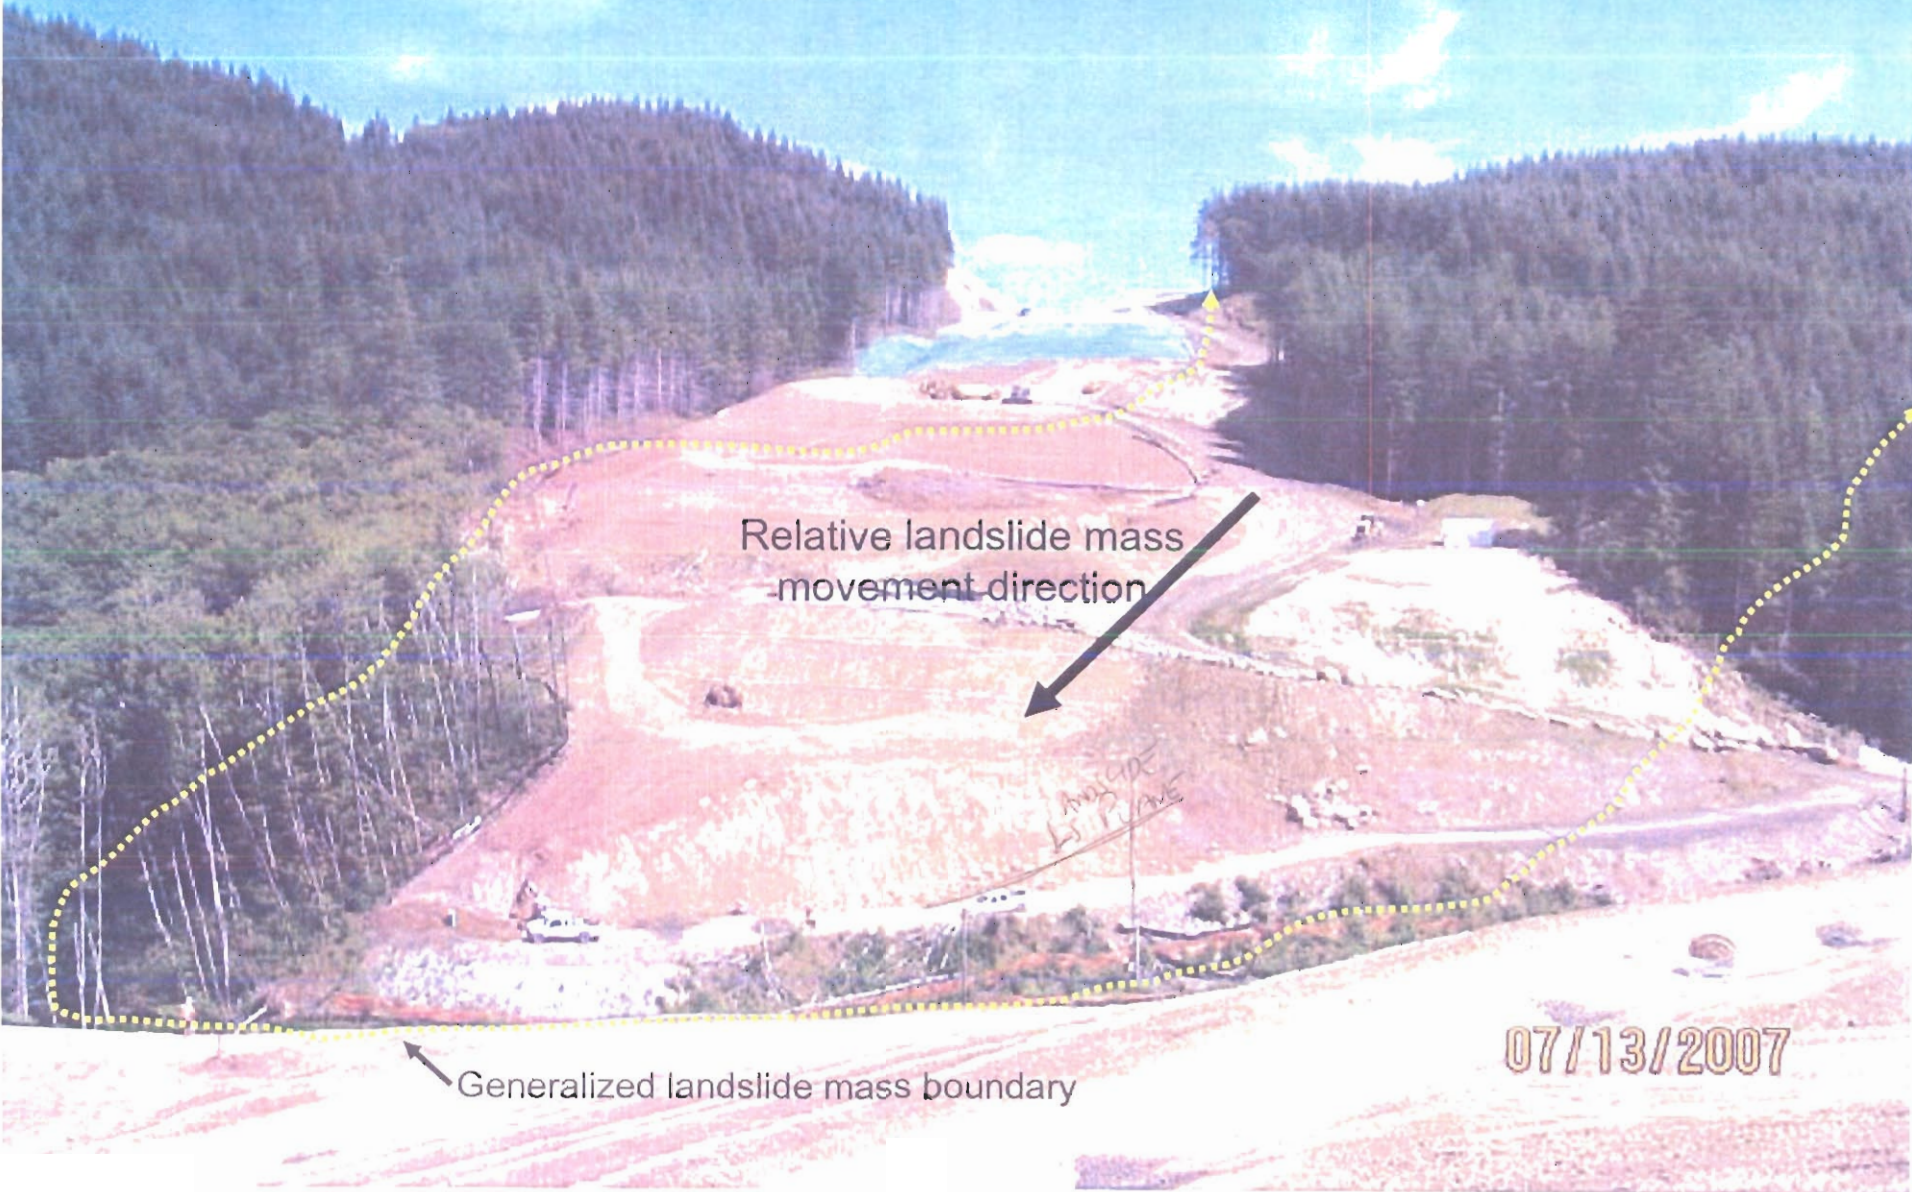
Landslide issue and possible solution

View east in Crystal Creek Drainage

Relative landslide mass movement direction

Generalized landslide mass boundary

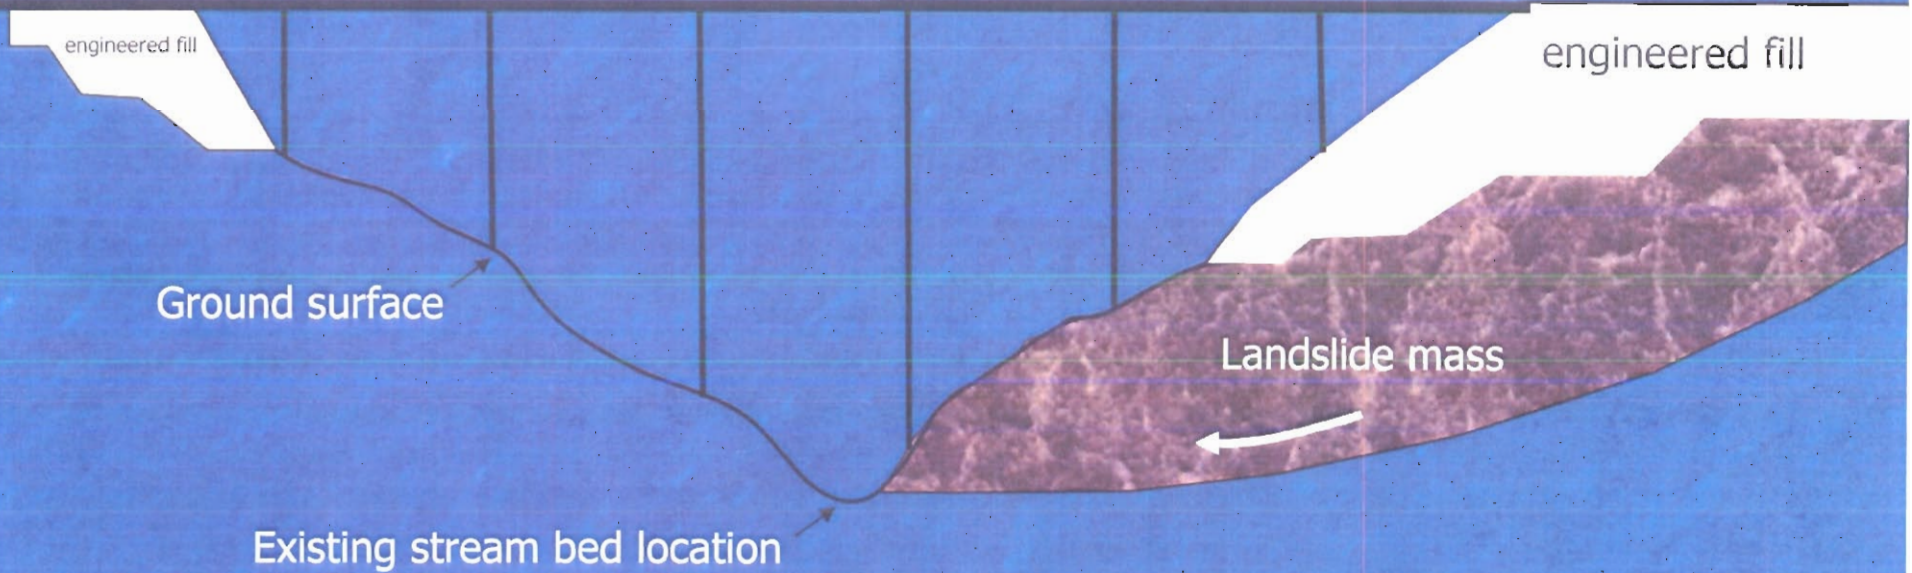
Conceptual landslide mitigation by
buttressing

The current geotechnical issue
before ODOT and YRC

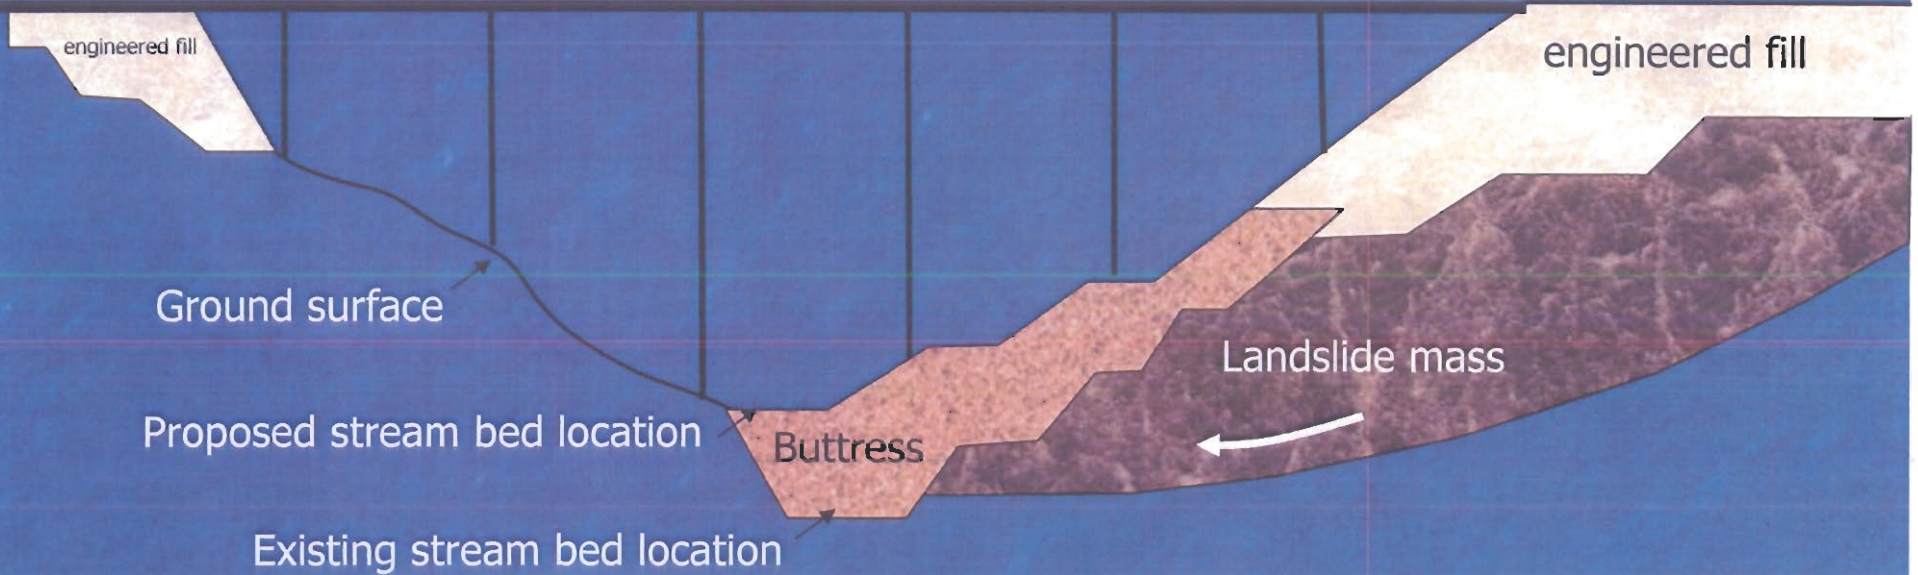
Conceptual landslide mitigation by
buttnessing

A potential solution

Stand-alone shear keys or drilled
shafts eliminated due to
constructability and cost
