MONITORING REVIEW
FOR
DEVINE CANYON UPLAND
RESTORATION PROJECT
(2008)

Project Description

**OWEB Effectiveness Monitoring Report – Fence,
Water Development, Grazing Management**

OWEB Grant #: 204428

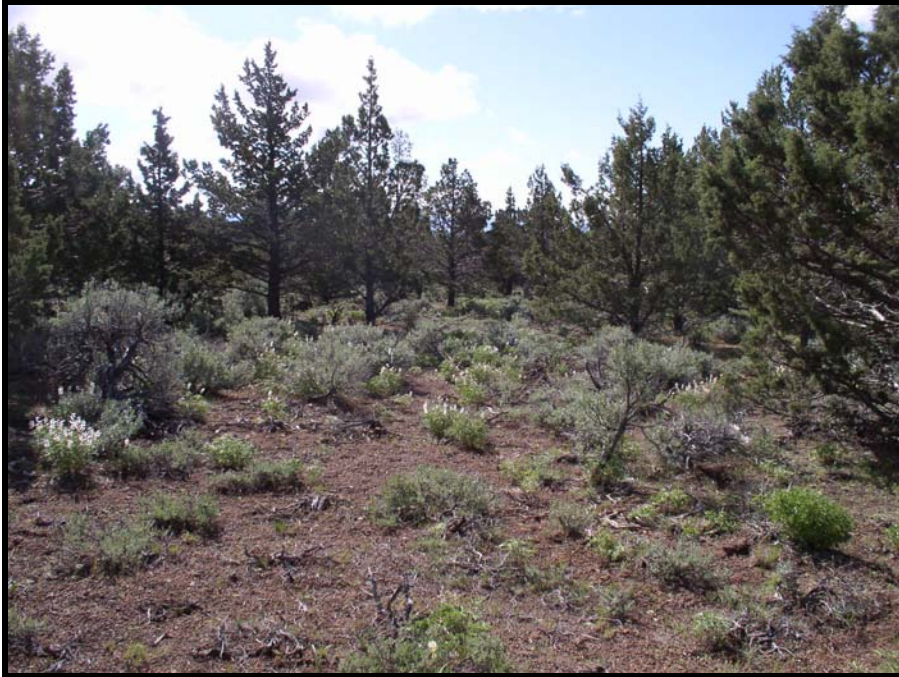
2005 NORTH

Site #1: Soil Site Stability is a 2.2, Hydrologic Function is 2.2 and Biotic Integrity is 2.0. The range site is therefore determined to be in good condition with an upward trend.

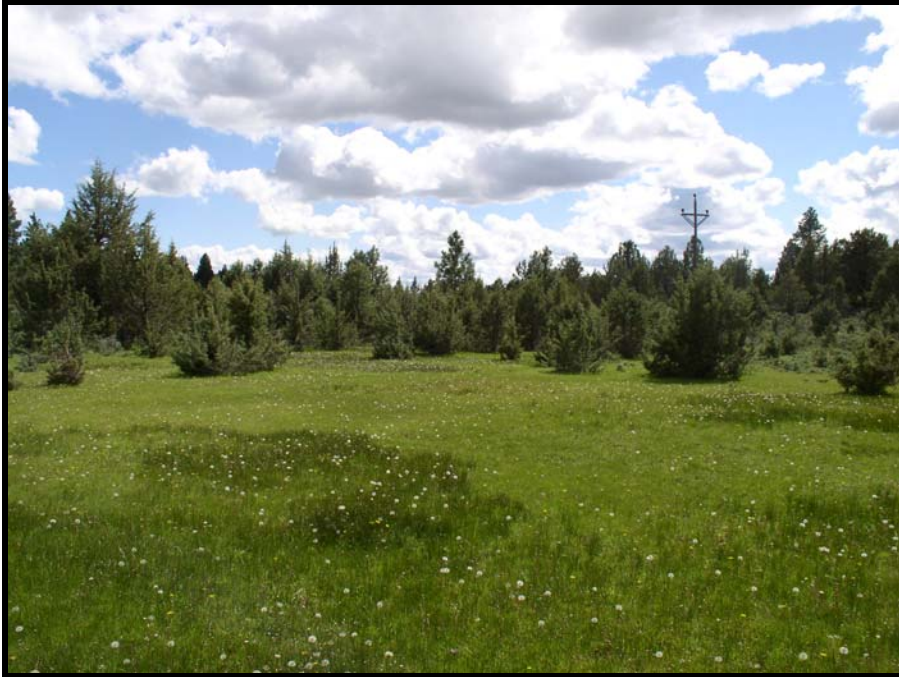
2005 West

Site #2: Soil Stability is a 1.8, Hydrologic Function is 1.9 and Biotic Integrity is 2.1. The range site is therefore in good condition with a slight upward trend.

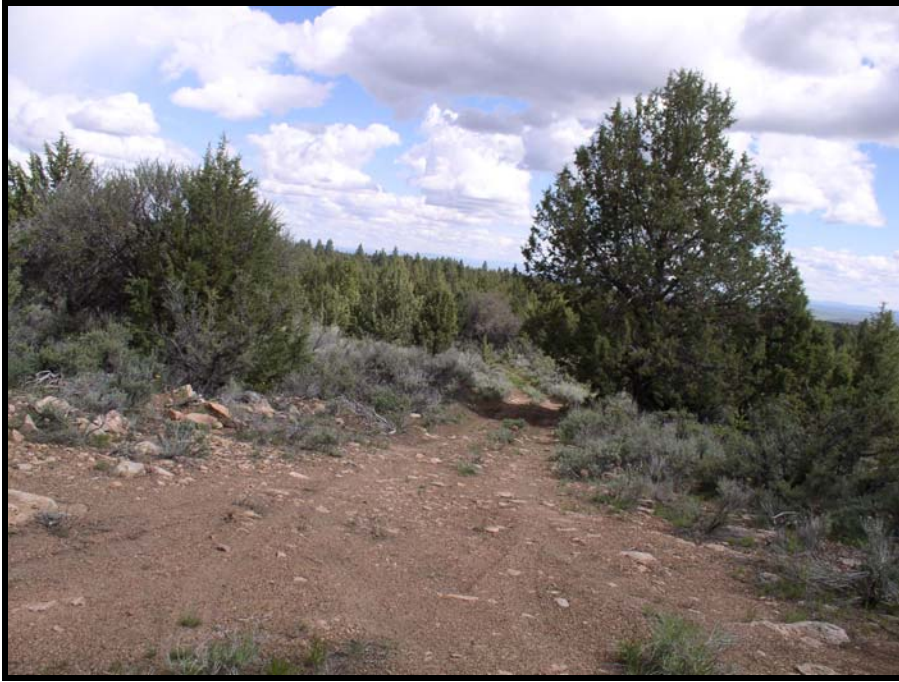
2005 EAST

Site #3: Soil Stability is a 2.1, Hydrologic Function is 2.1 and Biotic Integrity is 2.1. This range site is in good condition also with an upward trend.
