Tumalo Creek Restoration Project
 Monitoring Report 2008
 Prepared by Tom Walker, Deschutes National Forest

Introduction: This report summarizes monitoring conducted on the Tumalo Creek Bridge to Bridge Restoration Project, implemented on the Deschutes National Forest, Bend/Ft. Rock Ranger District between 2004-2007. This report contains monitoring information on fish populations, planted vegetation, and physical stream attributes.

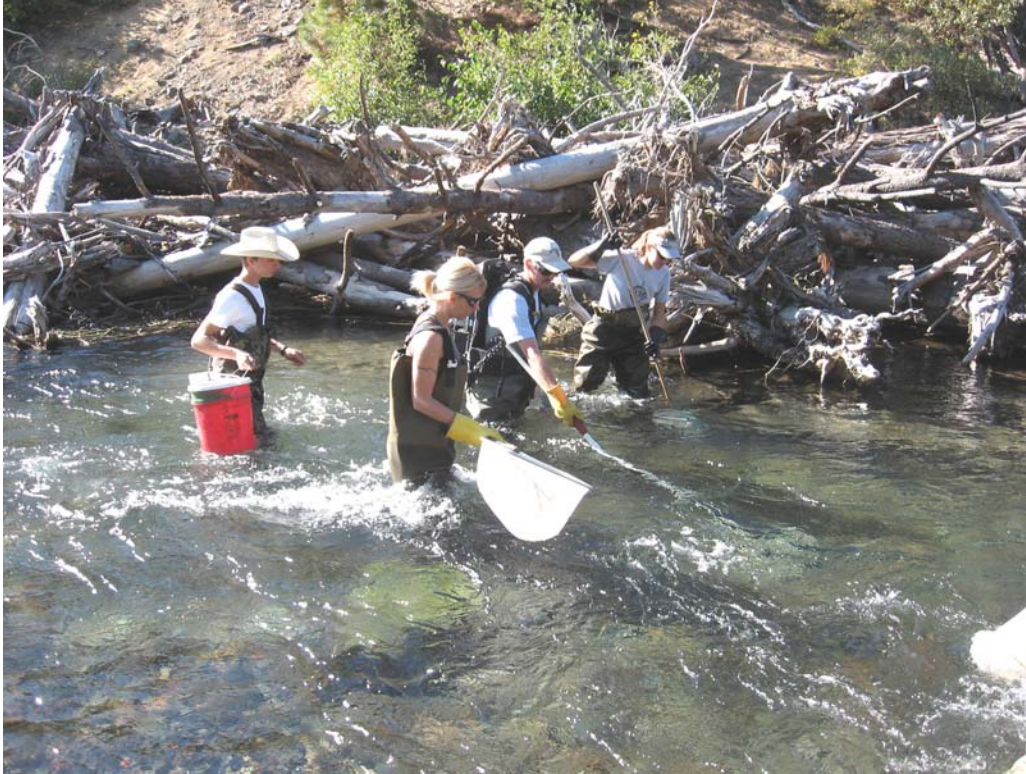
Photograph 1. Electrofishing Survey

Methodology: Multi-pass depletion surveys with block nets and battery-powered Smith-Root backpack electrofishers was the method employed for all pre-project surveys. Post project fish surveys were accomplished with mark-recapture, with the exception of the main channel of Phase I where a depletion survey was used. Caudal fin clips were used to mark fish in the mark-recapture surveys. In all surveys, all fish captured were measured for fork length and released. Some individuals were weighed to develop a Condition Factor.

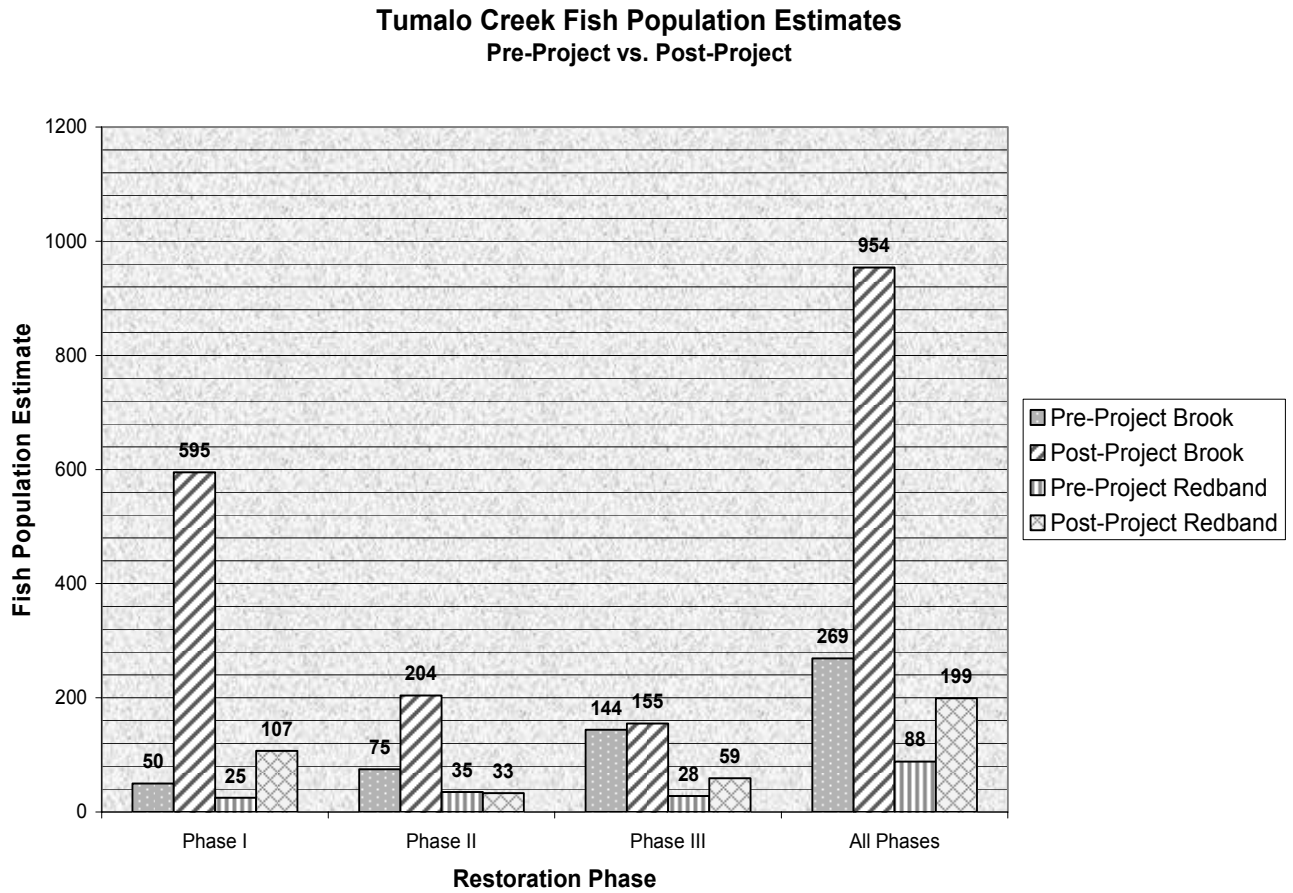
Figure 1.

The graph below demonstrates the fish population estimates for both species in all three restoration phases.

Within the Phase I study area, the creation of the side channel and available habitat achieved during restoration increased the numbers of fish post-project. Fish population estimates increased from 75 per 100 meters channel length pre-project to 702 per 100 meters post-project, primarily due to the large numbers of fish inhabiting the newly created side channel. This survey was conducted within a reach that received more extensive restoration than the rest of the Phase I project area, and would be considered atypical of the entire phase. Project work throughout the remainder of this phase was primarily main channel restoration, with a minor component of side channel creation. The increase in fish populations observed within this study area is likely not as pronounced in other areas within Phase I.

Within the Phase II study area, the fish population estimate increased from 110 fish per 100 meters to 237 fish per 100 meters due to an increase in the brook trout population. This study area did not include side channel creation.

The Phase III study area fish population estimate increased from 172 to 214 fish per 100 meters. The pre-project fish population was higher than the other study areas likely due to accumulations of large wood that had drifted down from above. These accumulations were temporary and unstable, likely to move out at the next high flow event. This area had also been assessed for fish populations prior to some prior restoration work in 2001 that had relocated a portion of the channel and placed boulder structures (8/31/2001 and 10/02/2002 data in table above). The fish population estimates were only 60 and 61 fish per 100 meters at that time. While both fish species exhibited significant increases, the brook trout population had the greatest increase, primarily due to large numbers found within the side channel habitat of the Phase I study area.

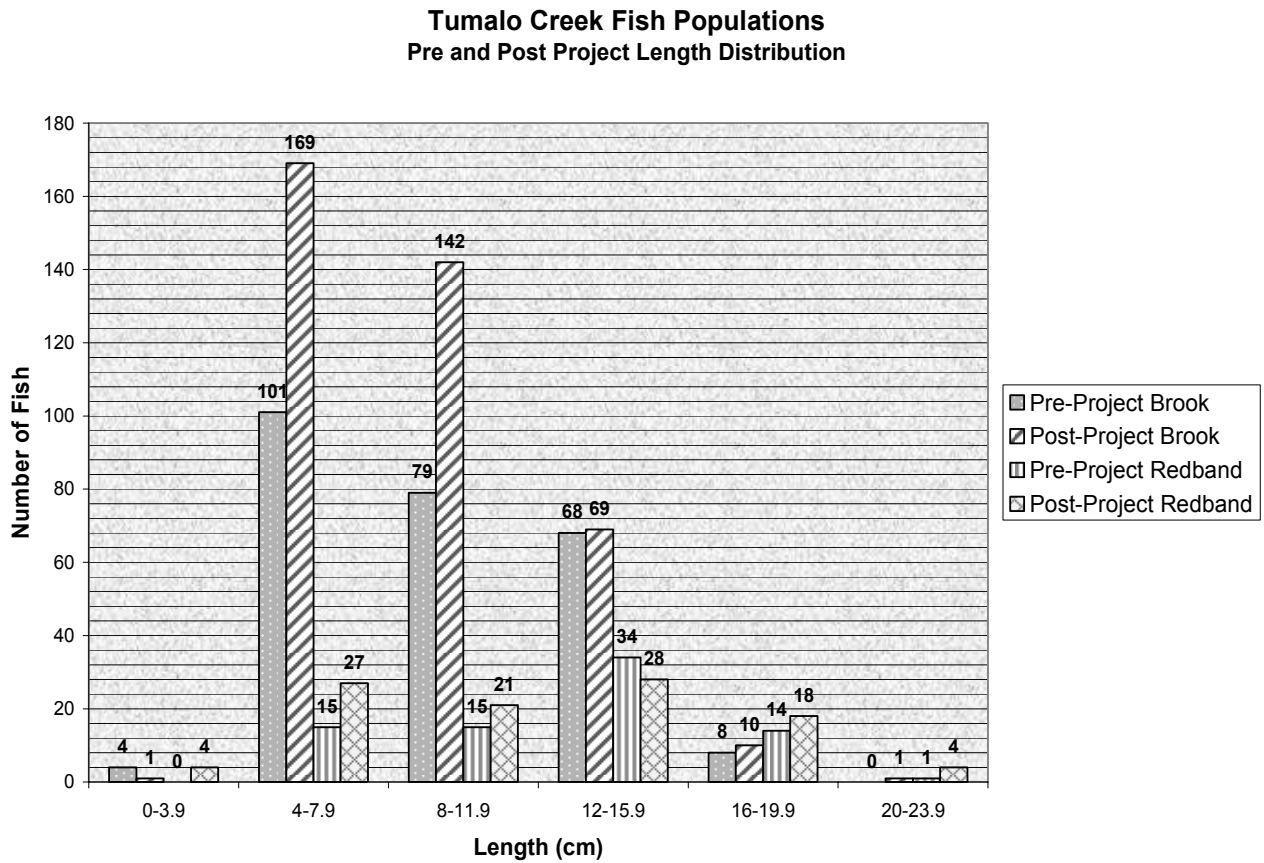
Figure 2.

The graph below demonstrates the length frequencies of both fish species pre and post restoration for all phases. Demonstrated is the increase in brook trout, primarily smaller fish associated with side channels which serve as rearing habitat. There was also a slight increase in larger redband trout (>16 cm). The numbers represent what was actually captured and measured rather than the population estimates.

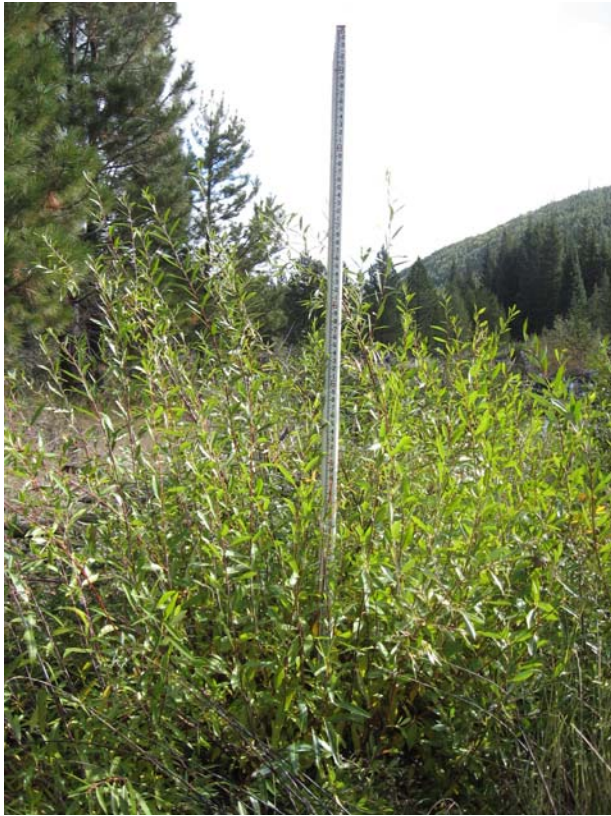
Photograph 2. Phase I Plants

The photographs below, taken in October 2008, depict the plants in all three restoration phases. Plants were not measured for height in 2008, but individuals were near 7, 8, and 3 feet height for Phases I, II, and III, respectively. The rod in the photographs is 9.5 feet tall.
