**Statewide Survey of Oregon Watershed Enhancement Board Riparian and Stream
Enhancement Projects**

8-30-02

By
Matthew Anderson
And
Gino Graziano

Sponsored by the Oregon Watershed Enhancement Board and Northwest Service Academy.

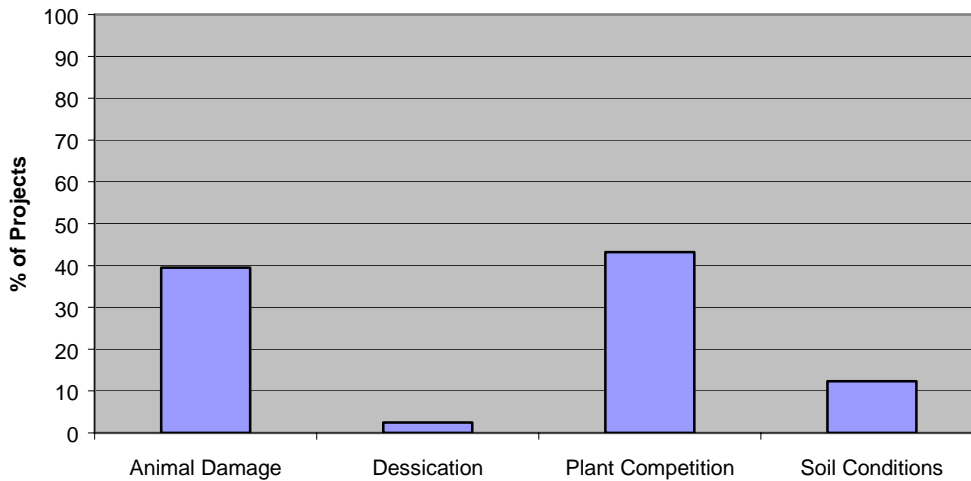
Figure 1: Observed causes of plant mortality on 81 riparian planting projects in the Willamette, North Coast, South Coast, and Lower Columbia basins

Figures 1-4 show the observed causes of mortality to riparian plantings in four regions of Oregon. The regions were delineated based upon similarities in climate, vegetation, and geography. The graphs depict the percent of projects that had evidence of mortality caused by animal damage, desiccation, plant competition, or soil conditions. Although there were other causes of mortality, these were the most common. The graphs do not show the severity of the damage, only that there was one or more mortality of that type recorded at the project site.

The data indicates that the frequency of causes of mortality varies significantly from region to region. Plant competition and animal damage are the most common causes of mortality for tree planting projects in wet, west-side basins. Mortality from desiccation and soil conditions are considerably less common in this region (figure 1). In arid basins, desiccation is the most important factor affecting riparian plantings, but animal damage is also common (figure 3). In Southern Oregon, over 50% of projects have some mortality related to desiccation and soil conditions, over 30% have suffered from plant competition, and 50% from animal predation (figure 2). In the Grande Ronde and Powder basins, desiccation is by far the most common cause of mortality, impacting 70% of the projects surveyed. Each of the other mortality factors is observed on less than 25%

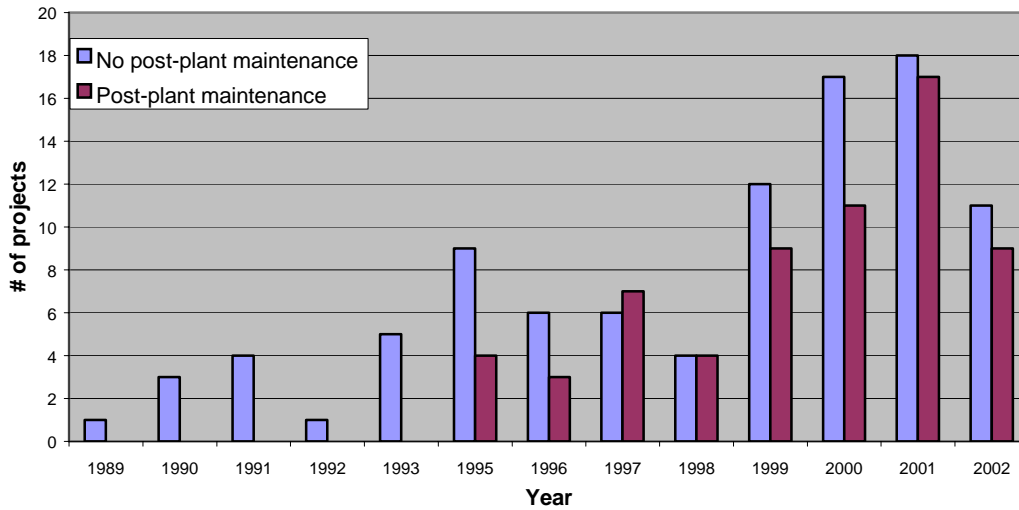
Figure 6: Post-planting maintenance use on riparian planting projects over time

Figure 6 shows the number of projects per year that have received irrigation, physical clearing, or herbicidal clearing. Of the projects, 97 have had no post-planting maintenance and 64 have had some post-planting maintenance.

that time (figure 6). The use of tree protection has also increased (figure 7). Use of tree protection has fluctuated from less than 20% in 1997 to almost 60% in 1999. Overall since 1995, 39% of projects have had some form of protection from animal damage.

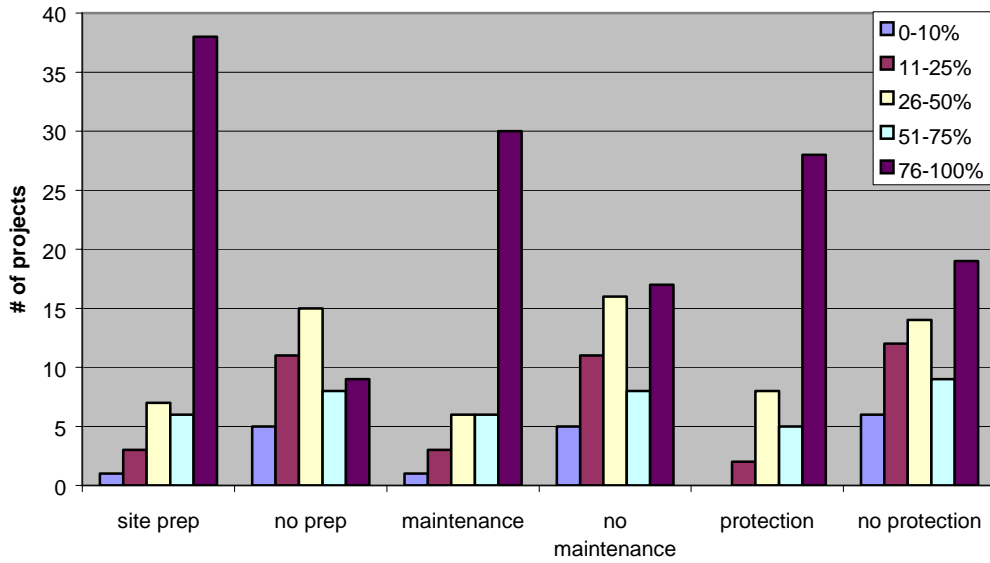
Figure 8: Tree survival based on site preparation, post-planting maintenance, and tree protection

Figure 8 depicts the tree survival on 104 riparian planting projects implemented since 1999. Tree survival of each project is considered based on the use of site preparation, post-planting maintenance and tree protection. For example, 47 projects had 76-100% survival, of those 38 had site prep and 9 did not.

The results from this study indicate that site preparation, post-planting establishment, and tree protection, when used appropriately, can significantly increase tree survival. Figure 8 compares the tree survival on 104 projects receiving or not receiving site preparation, maintenance, or tree protection. This figure indicates the value of using each of these methods. According to this information, there is a dramatic difference in the number of projects with very high survival based on whether or not site preparation is used. Likewise, projects with maintenance generally have much higher survival than those that do not. The fact that there are more projects with low survival that do not have site preparation or maintenance indicates more projects could benefit from these efforts. There is less discrepancy between the number of protected and unprotected plantings with high survival, but very few protected projects have extremely low survival. This indicates that tree protection is a valuable method and could be useful on more projects but is being employed judiciously most of the time. These results indicate that ensuring a site is in the proper condition prior to planting (i.e. cleared of invasive species, proper soil conditions, etc.) is essential to a successful planting project.

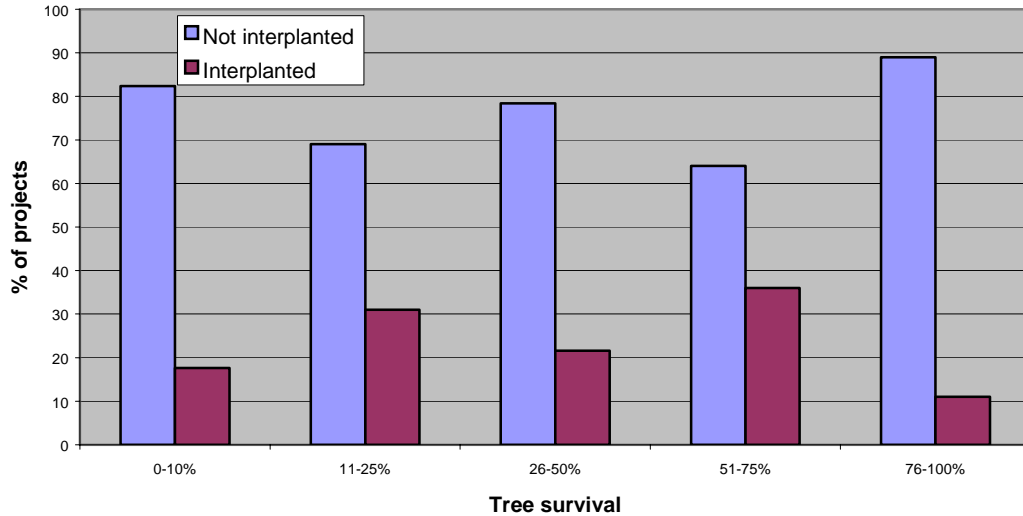
Figure 9: Percent of projects interplanted in each tree survival category

Figure 9 Compares percent of projects, based on tree survival, that were interplanted.

The frequency that projects are planted after the first planting (interplanted) in each survival category is an indicator of project follow-up. Projects that have low tree survival should have a higher frequency of interplanting than projects that have high tree survival. The frequency which projects in each tree survival category are interplanted (figure 9) shows 82% of projects in the 0-10% tree survival category are not interplanted. This data indicates that the vast majority of planting projects with low survival are being abandoned.

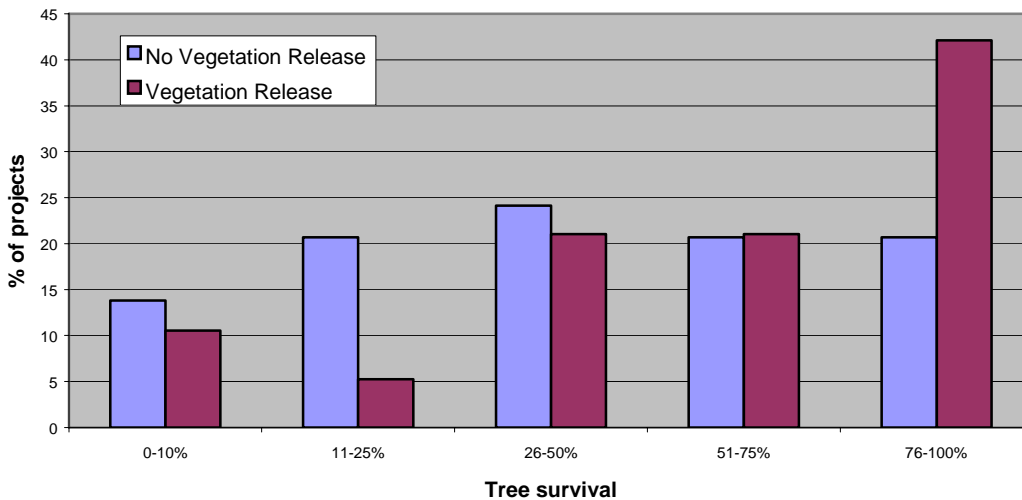
Figure 10: Tree survival on 48 Coast Range projects with and without vegetation release

Figure 10 shows tree survival on projects in the coastal basins of Oregon that received efforts to control competing vegetation after planting versus those that did not. Of this data set, 29 (60%) of the projects did not receive this post-planting vegetation release and 19 (40%) did.

Projects that received physical or herbicide clearing on coastal drainage projects have greater than 75% survival twice as frequently as those that did not (figure 9). Twice as many projects with less than 25% survival have not received vegetation release. The fact that only 40% of coastal projects had efforts to control plant competition, suggests that more maintenance can be done to improve efficient establishment of plantings in coastal drainages.

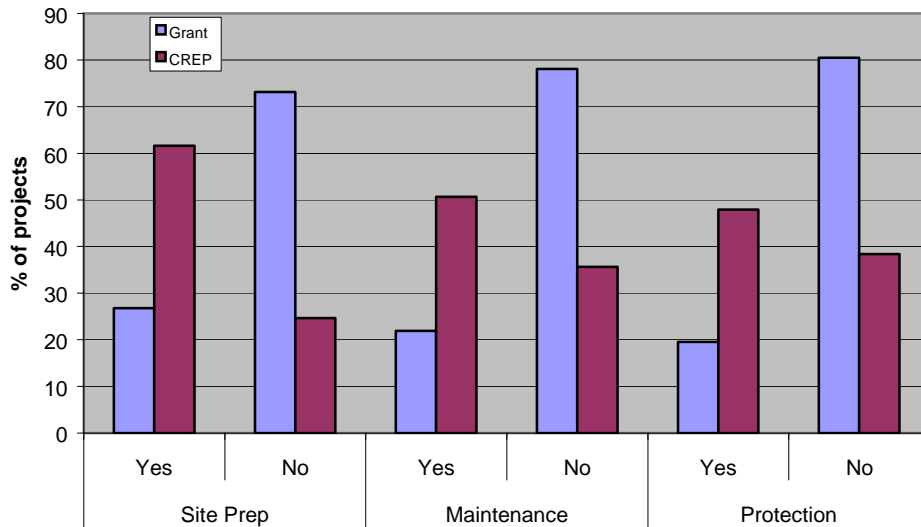
Figure 12: Comparison of site preparation, maintenance, and tree protection frequency between grant and CREP projects

Figure 12 depicts the use of site prep, post-planting maintenance, and tree protection since 1999 for grant and CREP projects separately. Of the 104 total projects since 1999 surveyed 41 are OWEB, and 63 projects are CREP.

CREP projects receive site preparation, post planting maintenance, and tree protection more often than grant planting projects. By comparing grant and CREP tree survival, figure 12 depicts the difference that a more frequent use of tree establishment techniques can have on a program's overall tree survival. Of CREP planting projects 52% fall into the 76-100% survival category, while the grant program has ~35% of tree planting projects in this category. The data shows that more frequent use of these methods increases tree survival.

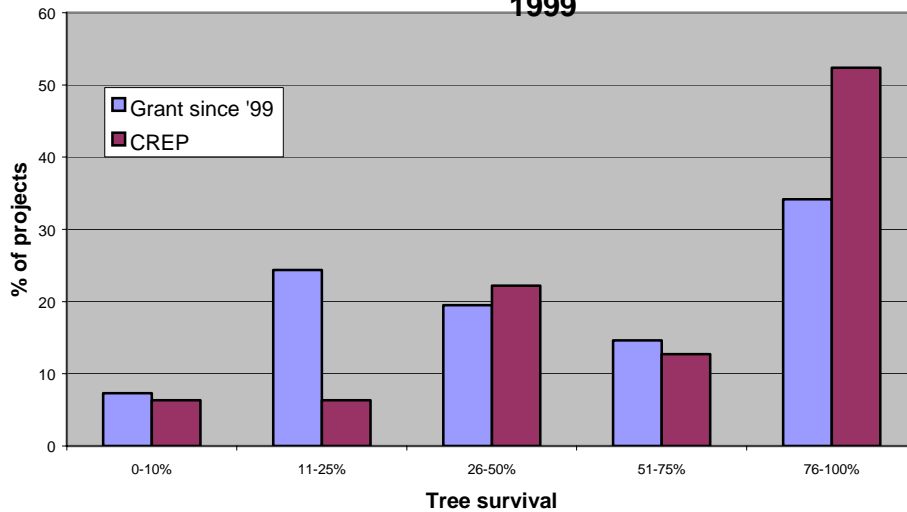
Figure 13: Tree survival on grant and CREP projects since 1999

Figure 13 shows the tree survival of 63 CREP projects and 41 grant projects since 1999. The use of this subset of grant projects is to compare only the years that CREP has been active.

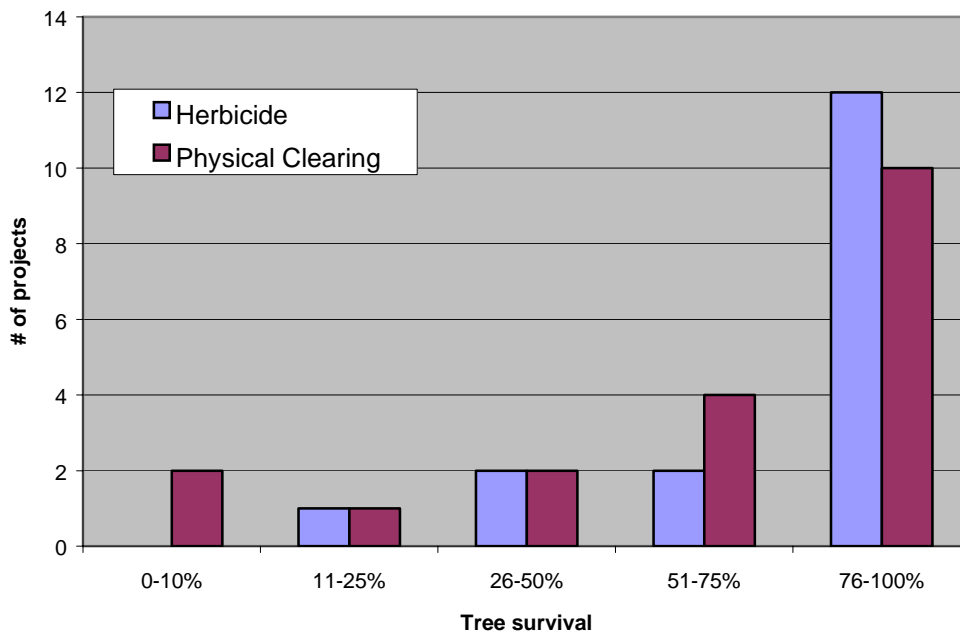
Figure 14: Herbicide versus physical clearing on tree survival

Figure 14 shows the relative survival on projects that used herbicide for release from plant competition and those that used physical clearing. There were a total of 17 projects that used only chemical methods and 19 projects that used only physical methods. Compared to 71% of CREP only 15% of grant projects use herbicidal clearing methods.

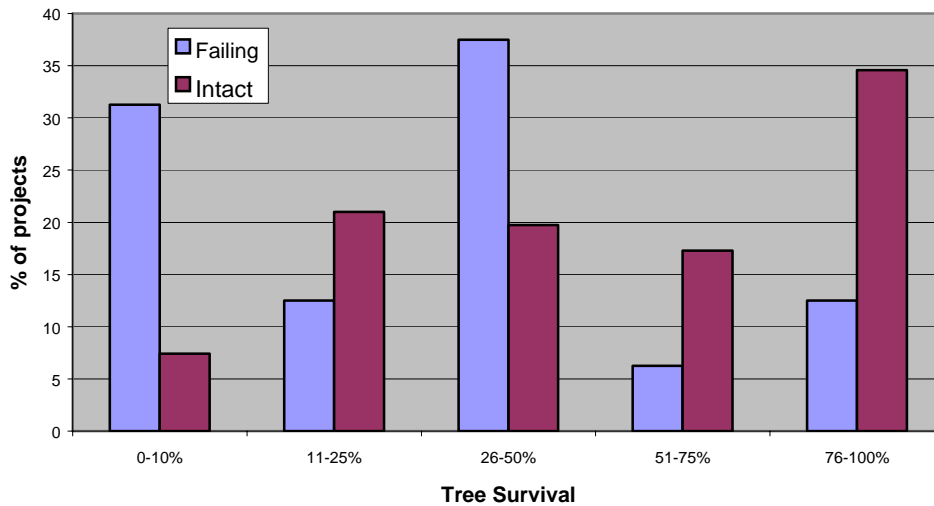
Figure 16: Comparison of tree survival on projects with intact versus failing or incomplete fences

Figure 16 shows the tree survival on CREP and grant projects with intact, versus failing or incomplete fences. Trees were planted on 16 projects that have failing or incomplete fences. 13 of those projects (81%) had less than 50% tree survival. 81 tree planting projects had intact fences, 42 of those (52%) had greater than 50% tree survival.

On projects that involve tree planting and have failing or incomplete fences, livestock can do a significant amount of damage to the planting. Of the projects that livestock have had access to, 30% are decimated (less than 10% survival) and less than 20% of those projects have greater than 50% survival (figure 15). This finding suggests the need for diligent fence maintenance and strong landowner involvement.

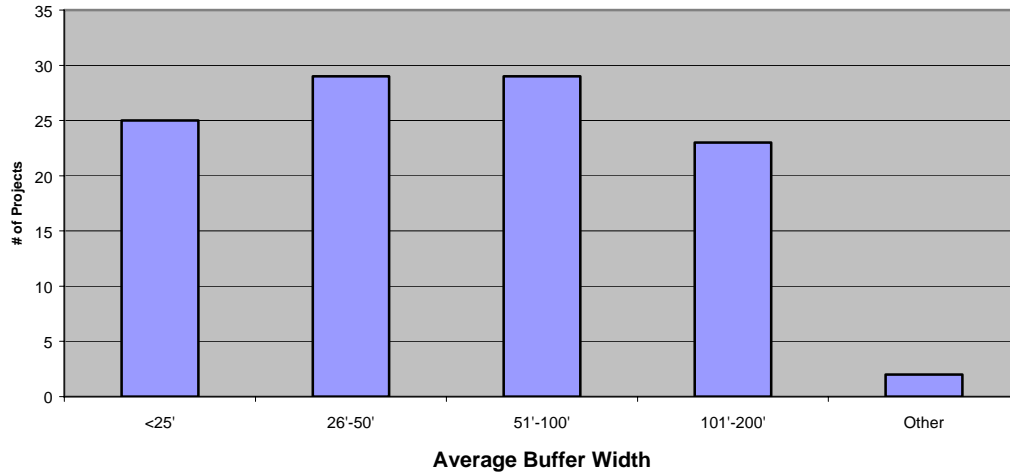
Figure 17: Number of projects in each livestock exclusion buffer width category

Figure 17 depicts the number of projects in five livestock exclusion buffer width categories. Of 106 active livestock exclusion projects, 25 had 25' or less average buffer

width, 29 had between 25' and 50' average, 29 had between 50' and 100' average, 23 had between 100' and 200' average, and 2 did not follow the creek.

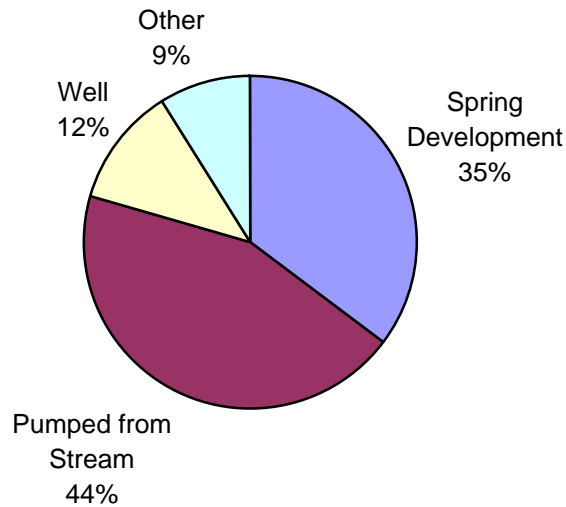
Figure 19: Water sources for 32 off-channel watering facilities

Figure 19 shows the ratio of water sources on the 32 off-channel watering facilities monitored.

Of the 32 off-channel watering facilities surveyed, a large majority (84%) is currently in use. Of the facilities monitored, almost half pump water from the stream, 35% flow from a spring, and 12% are pumped from a well. In many ways, the spring development is the best method for off-channel watering development in that it requires little to no maintenance and does not directly impact stream flows. Additionally, spring developments may allow for easier distribution of watering facilities. However, natural springs can provide excellent wetland habitat that may be impacted by such developments.

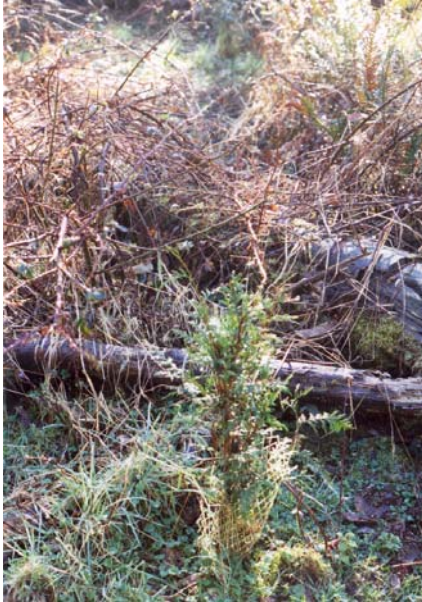
of the projects in this region (figure 4).

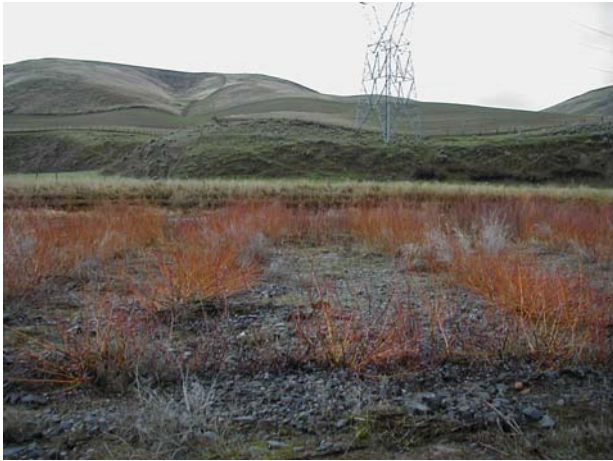
Photo 2 This four-year-old Central Oregon planting project, visited in November, has high survival in a site prepared by sub-soiling to plant willow sticks in rocky substrate.

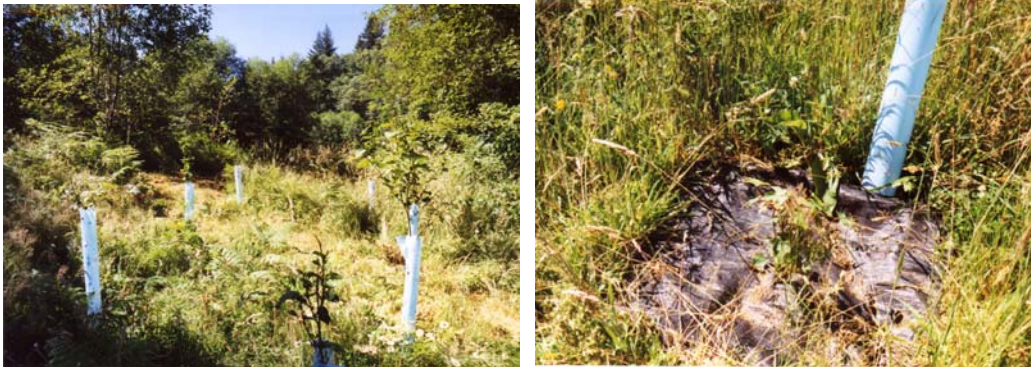
Photos 3 & 4 – This Lincoln County CREP project illustrates the benefits of tree tubes and mulch mats. On the left, red alder are growing out of tubes, and on the right, a fragile big leaf maple is adequately protected.

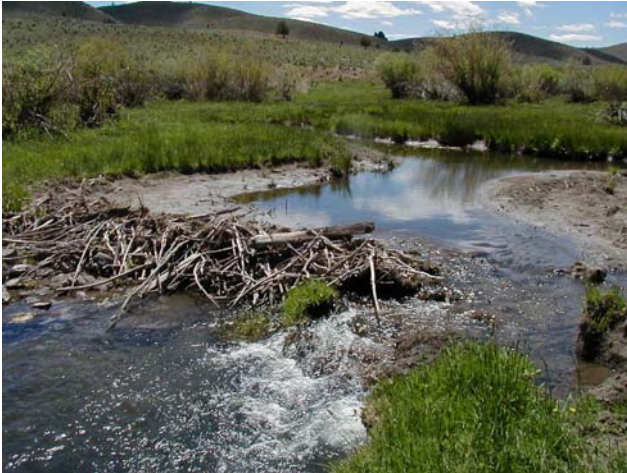
Photo 5 - This interplanted project in Grant County with unprotected willows is an example of establishing a site with persistent planting. Note the beaver dam, evidence of the main cause of mortality at this project site.

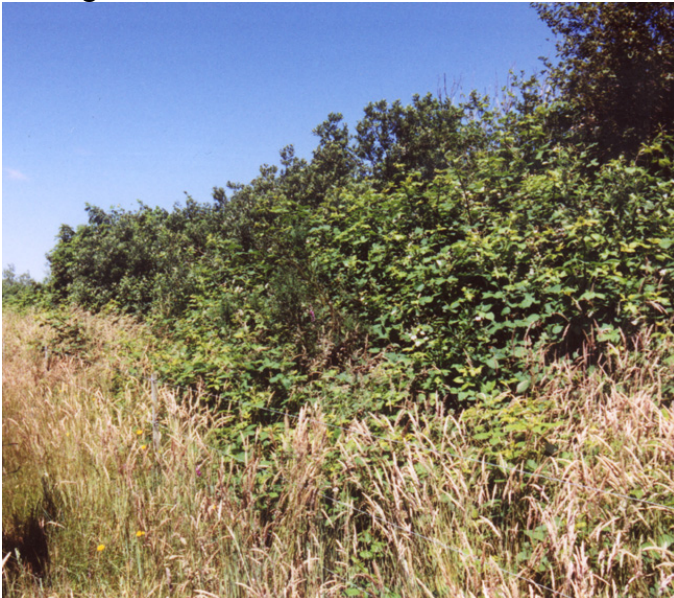
Photo 6 – Plant competition can be a formidable obstacle when planting in a riparian area like this one in the north coast region. Although the invasive species are the most notorious, native plants such as snowberry can also suppress plantings.

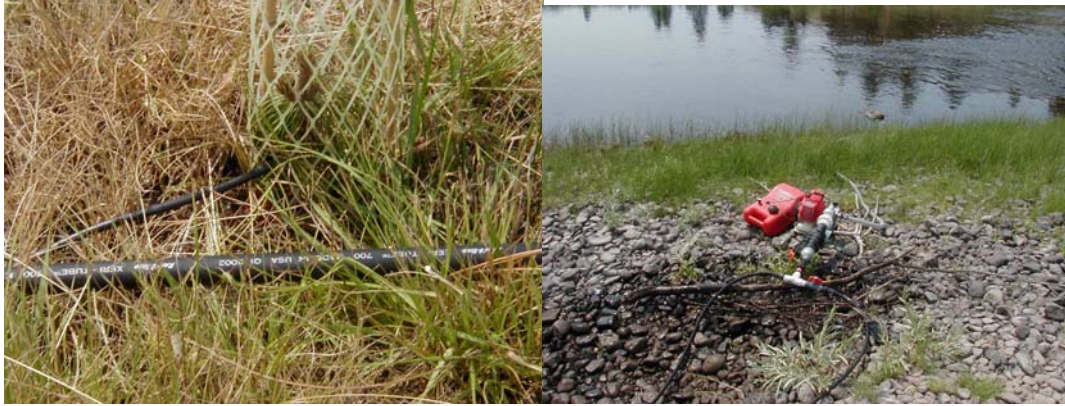
Photos 7 and 8 - Desiccation is a significant cause of mortality on plantings in arid and semi-arid regions such as this one in northeast Oregon. Utilizing irrigation with a gas powered pump (right) and drip line (left) is an excellent way to increase survival of these planted ponderosa pines in their most vulnerable years.

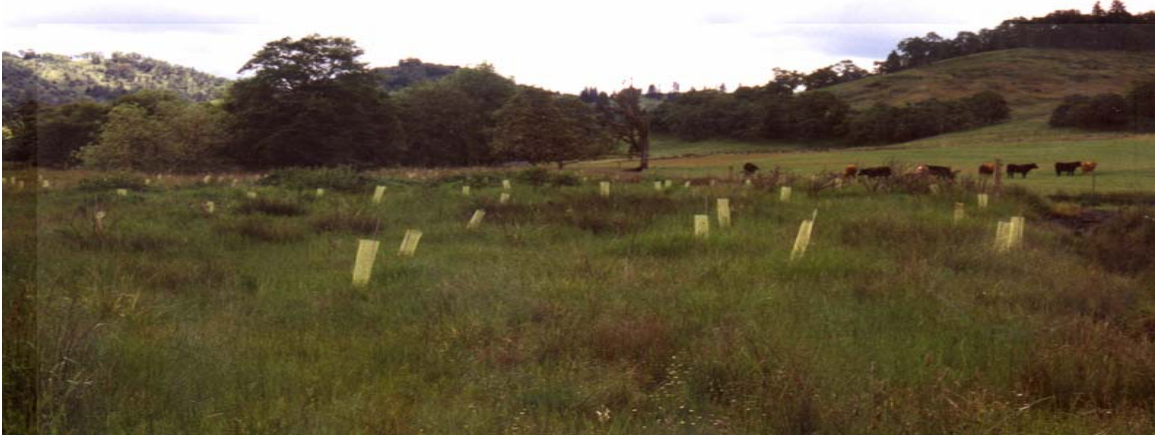
Photo 9 – Livestock exclusion and riparian planting project in the Umpqua valley.

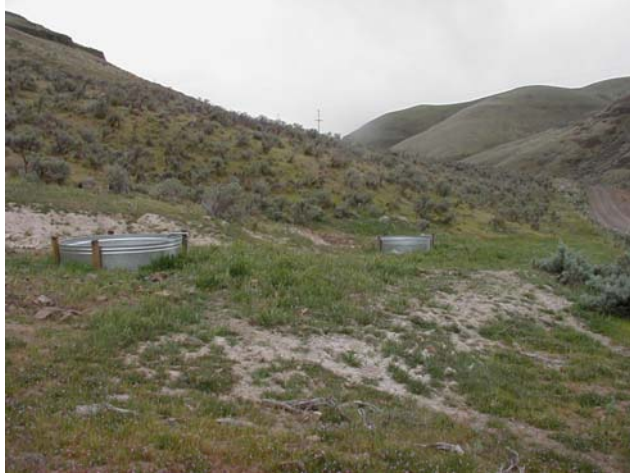
Photo 10 - These stock watering tanks in Gilliam County allow better livestock distribution and reduced pressure on the riparian area.

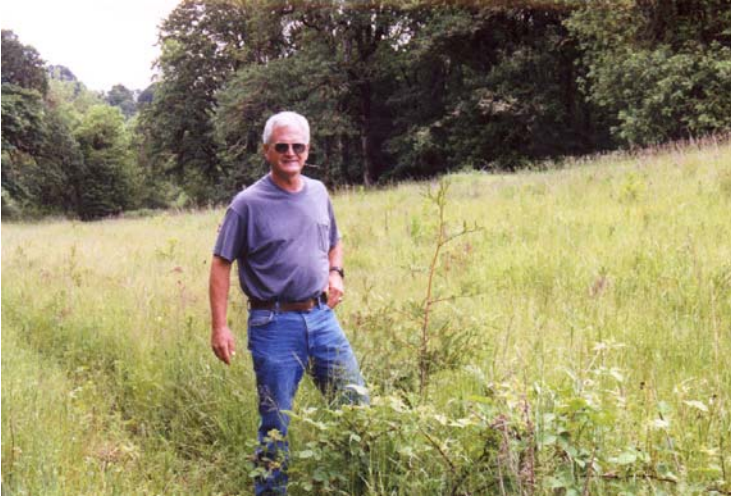
Photo 11 – Richard Girton proudly shows the impressive growth of a western red cedar planted one year earlier under the CREP program. Although his property is frequented by wildlife, the existing herbaceous and woody vegetation provide other foraging alternatives.
