EXERCISE 8

Landslides and Avalanches

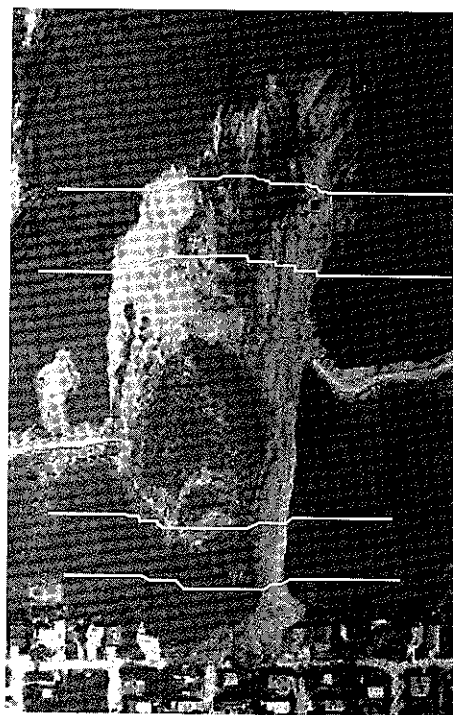
FIGURE 8.5 Contours that cross landslides, as shown on vertical photos, bend to follow concave part of slope in the upper scarp area of the slide. Contours in the lower part of a landslide will be convex and irregular over hummocky terrain. La Conchita, California, 1995; Same site as in Figure 8.4. Photograph courtesy of Pacific Aerial Surveys, http://www.geog.ucsb.edu/~jeff/projects/la_conchita/1995/95_slideshots.html

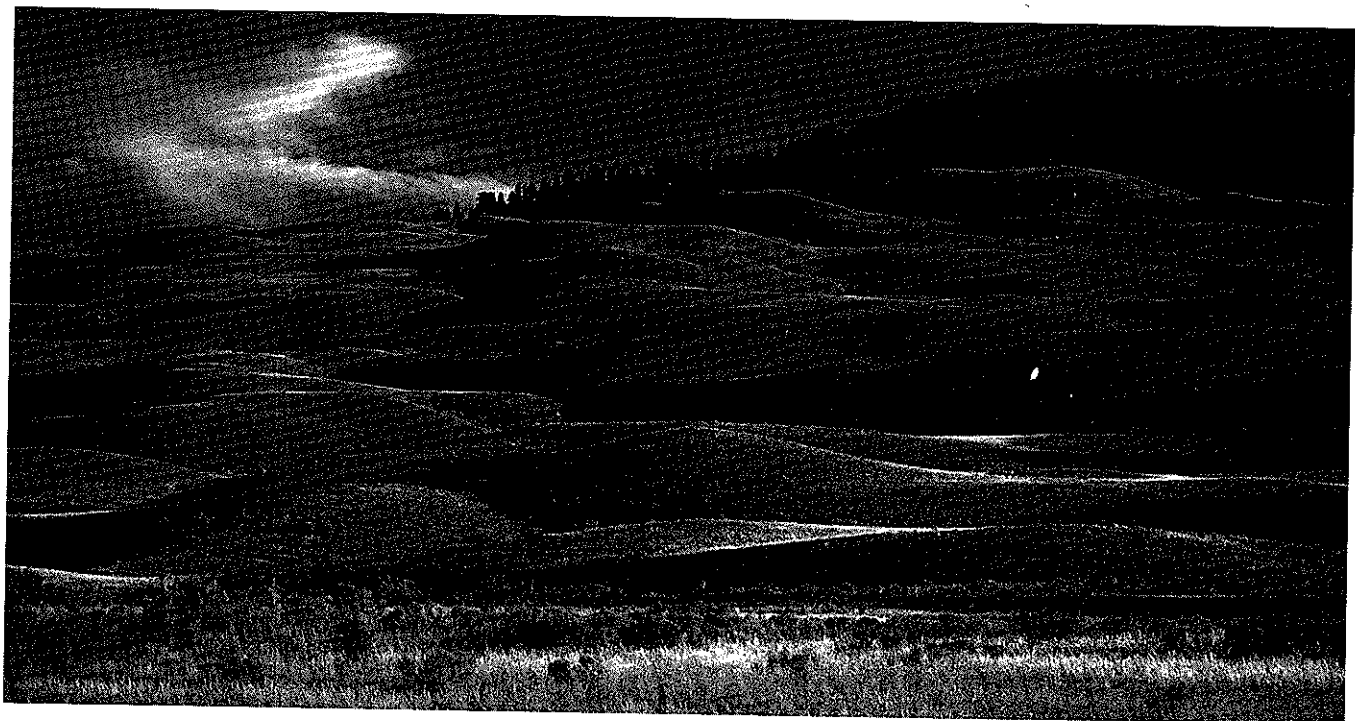
FIGURE 8.6 Gardiner, MT, landslide(s). View to SSW. (Photograph by © Duncan Foley)

Figure 8.6 is a photograph of the lower part of a landslide complex south of Gardiner, Montana. Direction of view in the photograph is to the south from the townsite. This is an old landslide, but it well illustrates hummocky terrain related to landslide deposition. Refer to Figure 8.7, the aerial photograph, and Figure 8.8, the topographic map.

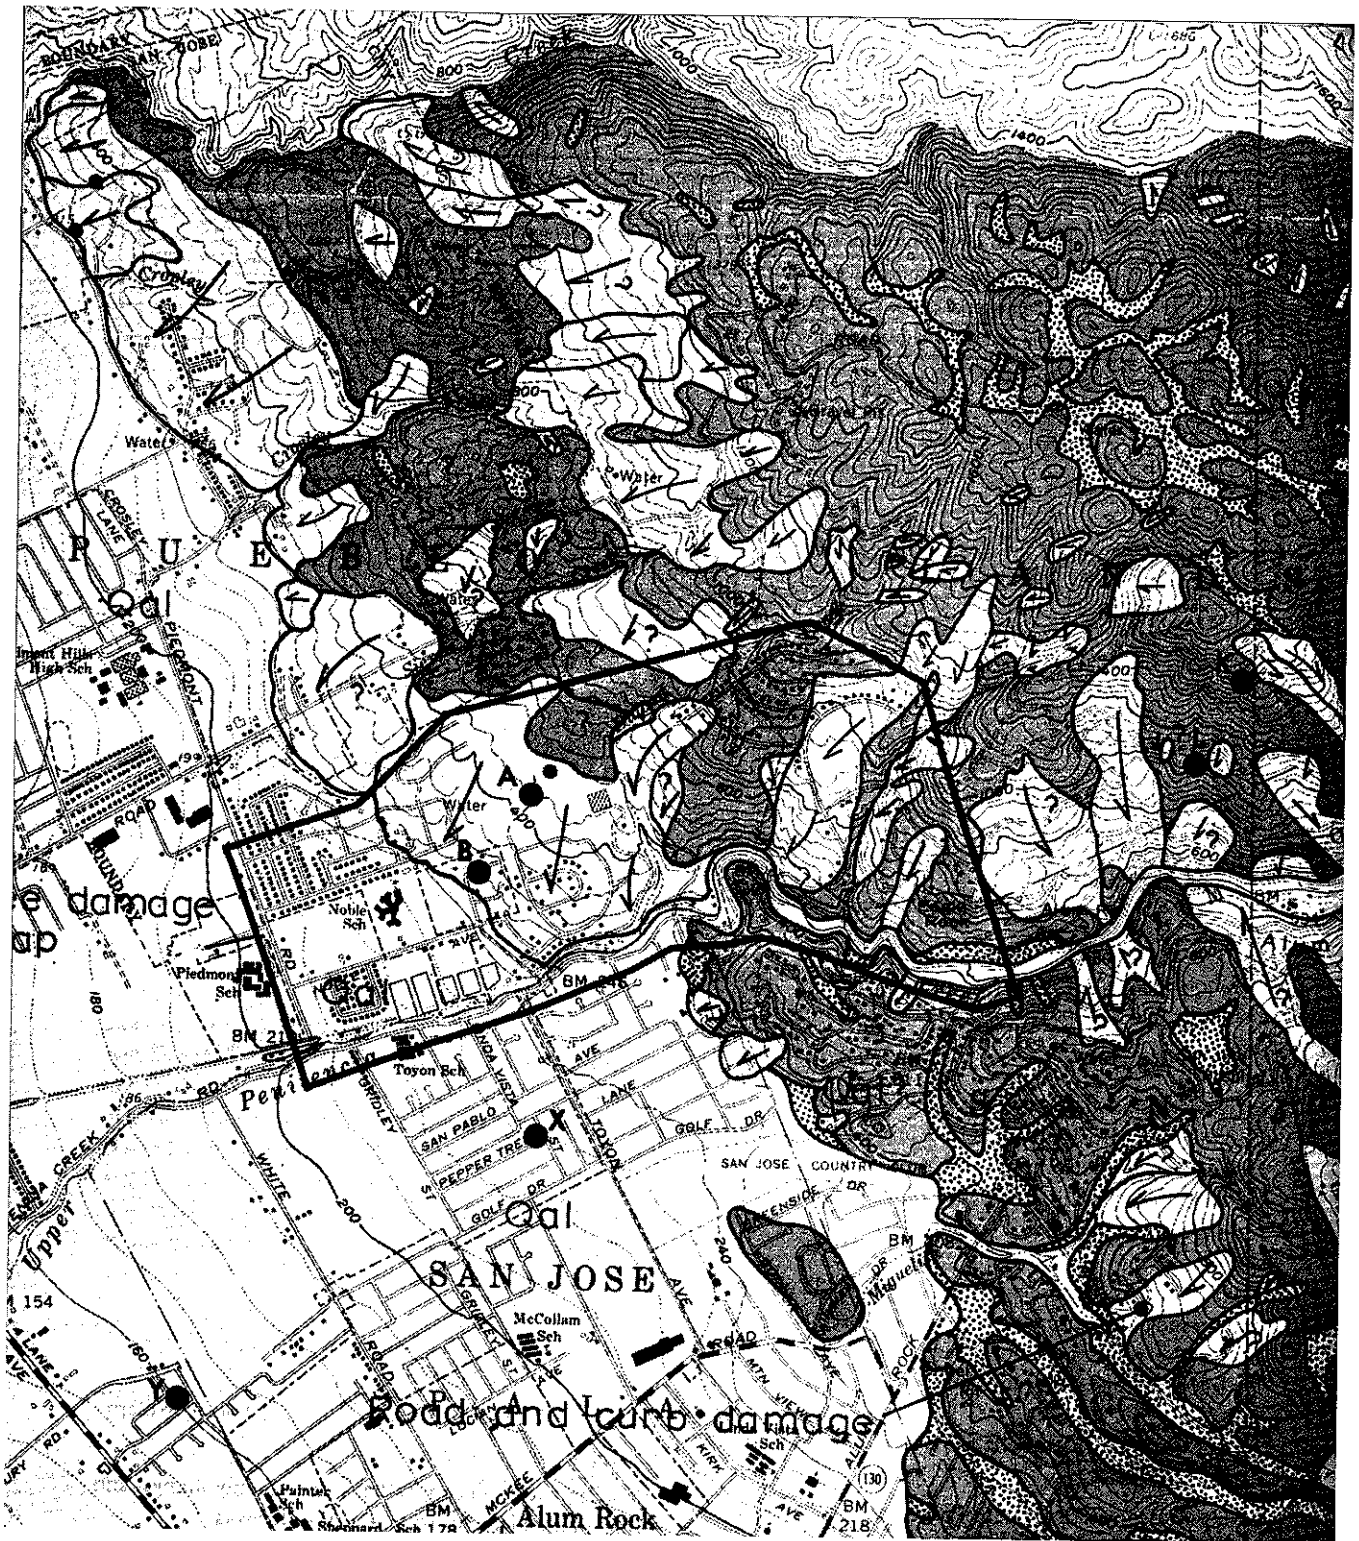
CONTOUR INTERVAL 40 FEET
 DOTTED LINES REPRESENT 10-FOOT CONTOURS
 DATUM IS MEAN SEA LEVEL

FIGURE 8.12 Landslide and other surficial deposits in northeastern San Jose, California. (Nilsen and Brabb, 1972).

1. Review Part A, carefully examine Figure 8.12, the explanation for this figure, and the topographic map for this area (Figure 8.13 in the map section at the back of the book). Note that two different contour intervals are used on each map.

2. Place an X in the area of the largest landslide deposit within the enclosed area in the center of Figure 8.12. What is the approximate area of this slide, in square miles?

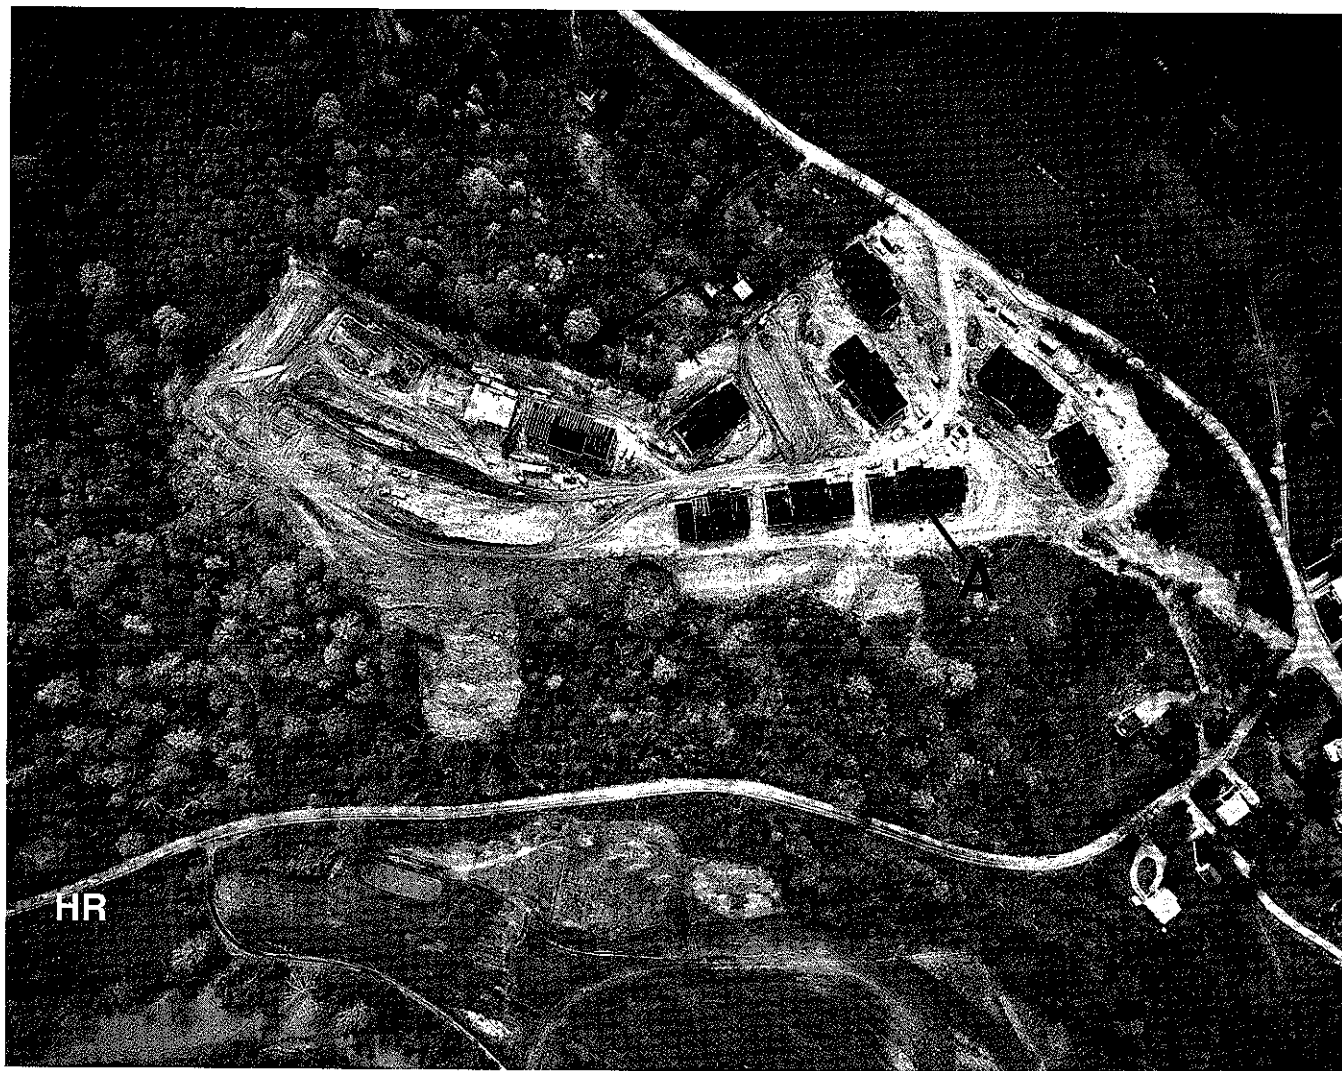
FIGURE 8.18 Aerial photo (1968) of apartment site overlooking the Hocking River, south of Ohio University. North arrow in the upper middle of the photo points to lower left of photo. Building "A" is marked on this photo and on Figure 8.23 (in color plate section at the back of the book). Hocking River "HR" in lower left side of bottom edge of photo.

7. a. Where would the landslides observed in the 1968 photo (Figure 8.18) be in your sketch (Figure 8.19)?

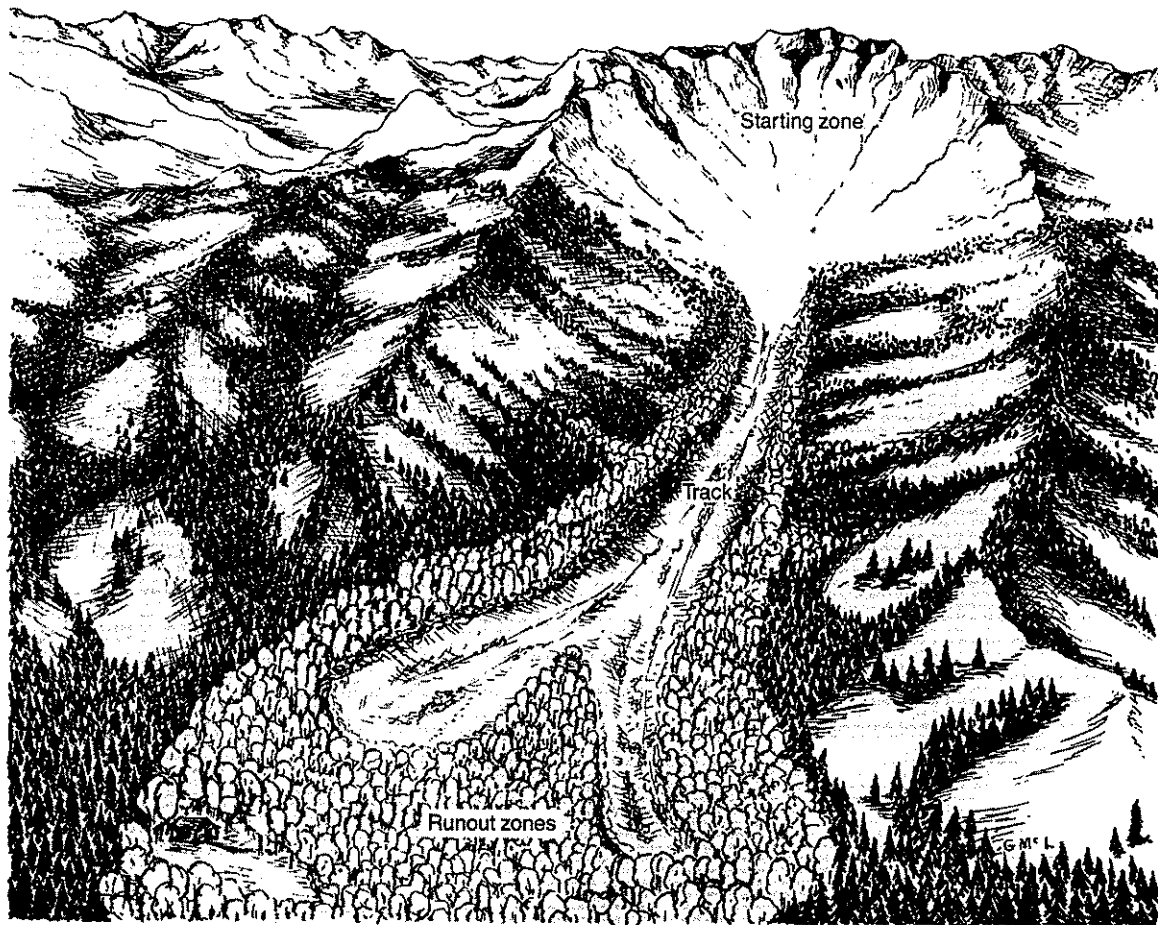
FIGURE 8.25 Large avalanche path showing various features. The smaller runout zone, reached more frequently, is cut through the aspen forest. The larger zone is reached much less frequently, is revegetated by aspen, and must be considered in planning any development (Mears, 1976; after Salm, 1975).

Avalanche paths are separated into three zones: the starting zone, the track, and the runout zone. Figures 8.25, 8.26, and 8.27 illustrate these and their captions discuss important aspects of avalanche travel and hazards. Use these figures as you investigate the maps discussed below.
