East Fork Williams Creek
Sediment Analysis

East Fork Private Road Inventory
and Sediment Analysis

Prepared by
Charles Rogers
Williams Creek Watershed Council

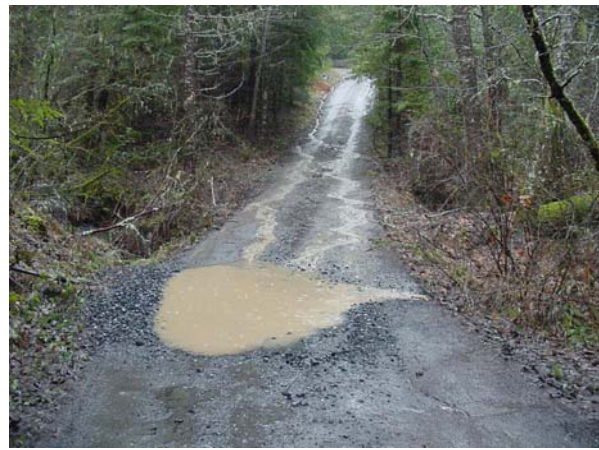
Drainage on roadbed that empties into creek system – Spring Creek driveway

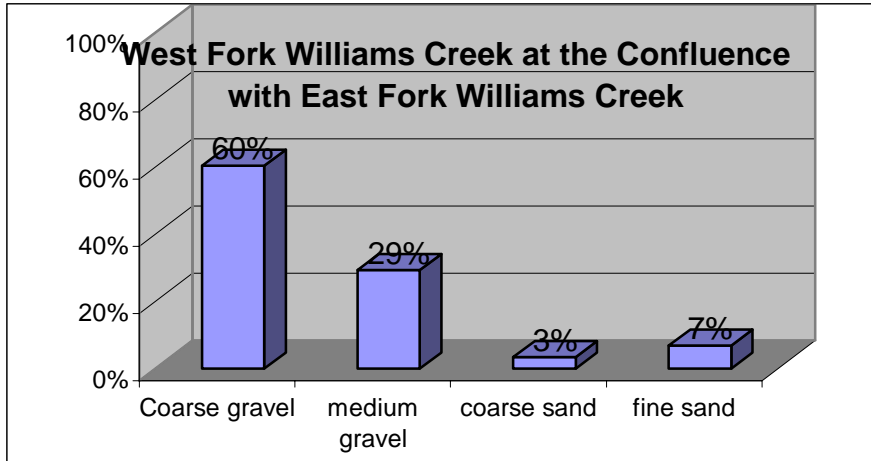
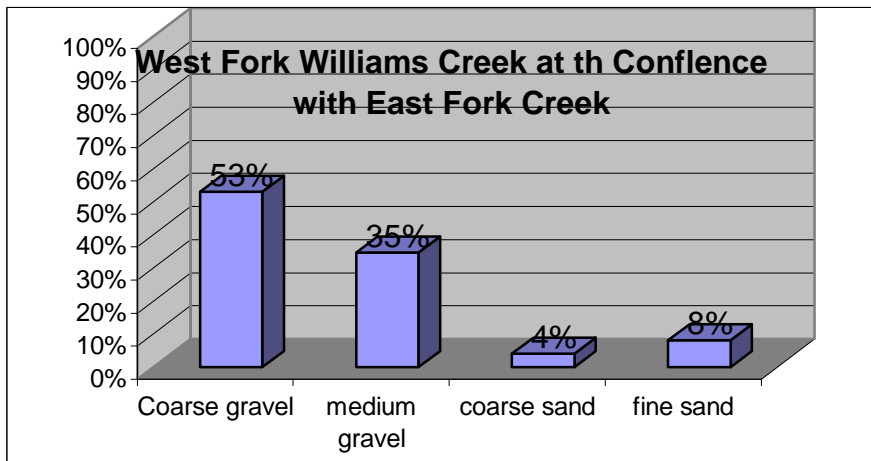
Fig 18: West Fork Williams Creek at the Confluence of East and West Fork Williams Creeks

The Confluence of the East Fork and West Fork Williams Creeks are just downstream of the Brown’s Road Bridge. This area has experienced considerable lateral erosion of pastureland and floodplain on the landowner’s property.

This area is subject to the constrictions developed by the East Fork Road and Brown’s Road bridges just upstream of the confluence. This constriction produces higher than normal velocities contributing to scour and removal of vegetation. A large pond is located between the two creeks that is in the pathway of the eroding banks and may be impacted by the flow of the creeks if erosion continues.

Sampling was done in this area as a comparison to the East Fork Williams Creek to see how the sediment deposition relates to the other major tributary of Williams Valley. This area is also subject to enormous amounts of erosion and will need a major restoration and erosion control project that can address the associated problems.

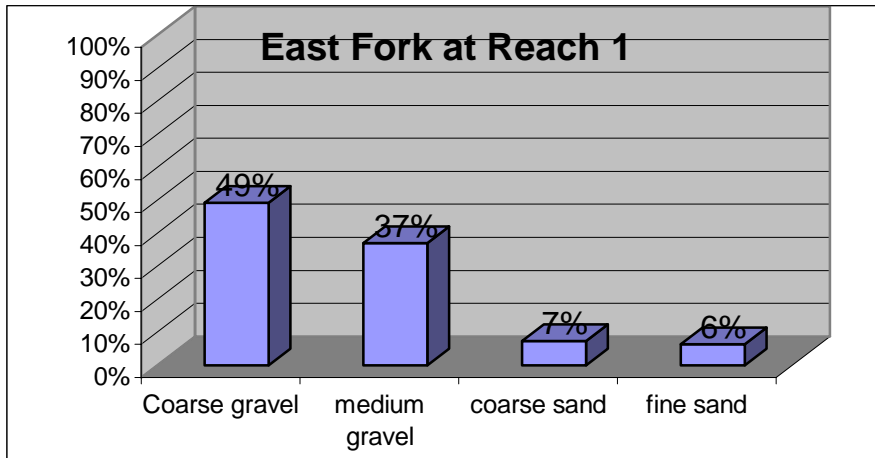
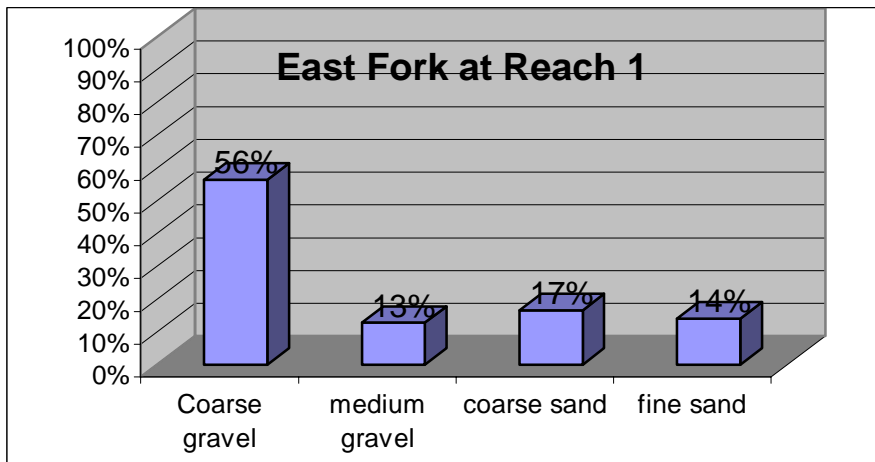
Fig 19: East Fork Williams Creek at Reach 1

This is the lowest stream reach on the East Fork and has excellent spawning habitat. Sand content is in the 13 – 30% range, varying by location. Several sitings of spawning salmon have been observed in this reach. Complexity of channel structure is good with some large woody debris present to check the rapid flow, although the past three years have experienced higher than normal peak flows that have removed wood and reduced complexity.

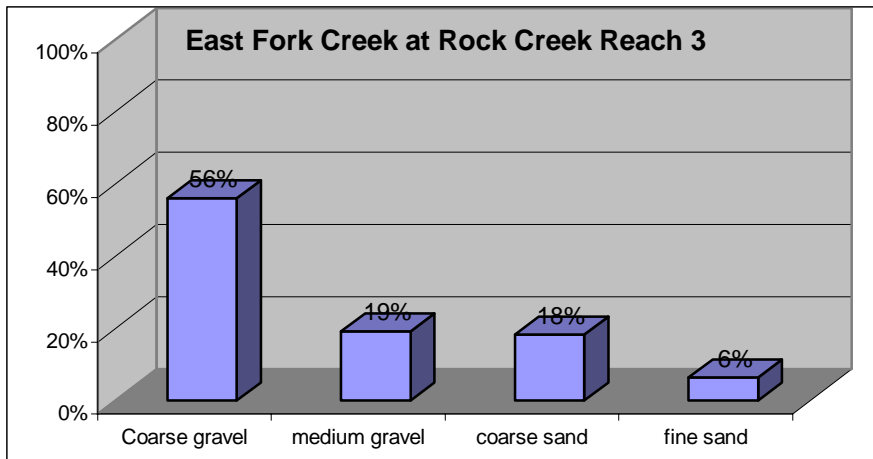
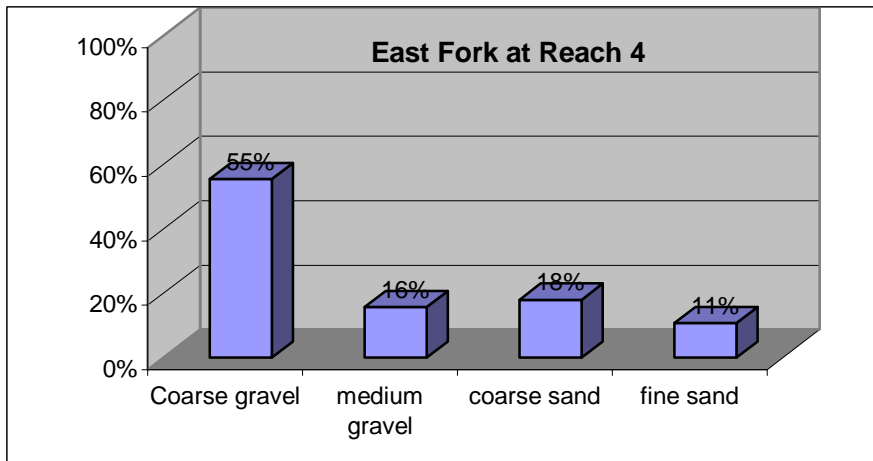
Fig 22. East Fork Williams Creek at Reach 3 near boundary of Linebaugh and Farver

Reach 3 of East Fork Williams Creek extends up to the confluence with Rock Creek, which supplies 40-50% of the water flow. Coarse gravel dominates this reach with sand content in the 24% range. Coarse sand outweighs the fine sand due to the proximity to the granitic source rock and the high energy system as these two creeks converge. Numerous boulders with little woody debris are found in this reach, but fish counts indicate juvenile survival is present but low.

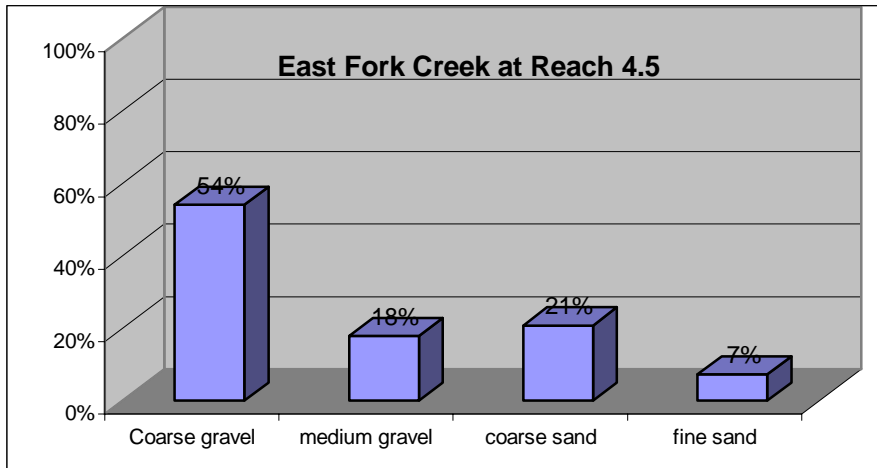
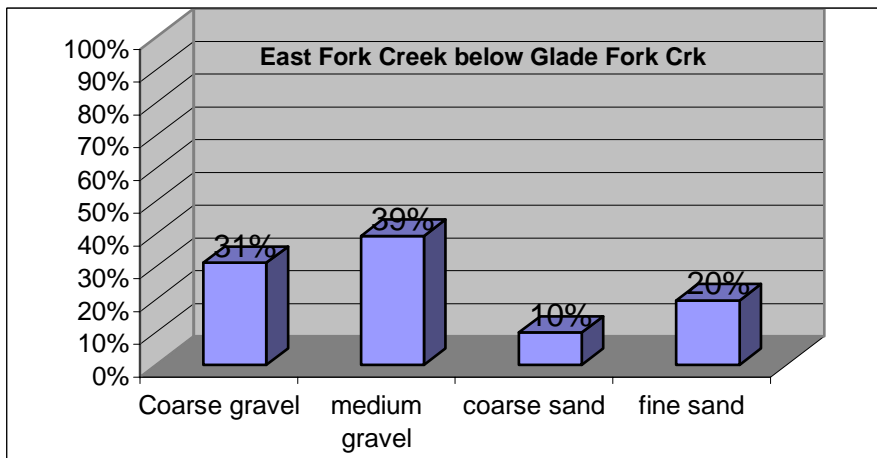
Fig 23. East Fork Creek at the confluence of Glade Fork Creek Reach 4

Reach 4.5 is ideal for coho, steelhead and macroinvertebrates with low gradient stream systems, abundant gravels, and good quality water clarity and low water temperatures. Temperatures are moderate during summer months but channel complexity is low. Large wood content is low due to removal of wood over time without replacement. This is a stream system that would do well with restoration including installation of wood structures, boulder clusters, and increased stream shade systems.

Spawning coho have been seen and photographed in this reach and the landowner has reported that he remembers seeing many more salmon spawning in this area 30- 40 years ago when he first moved here. This area could also benefit with tree planting and improvement of the riparian zone. Several houses are very near the creek with clearings and roads that impact the habitat. Blackberries have invaded much of the open areas and the addition of trees would go a long way in improving the native habitat. Erosion has been observed along the banks in the upper reaches and can be contributing to the high amounts of sand being transported throughout the system.

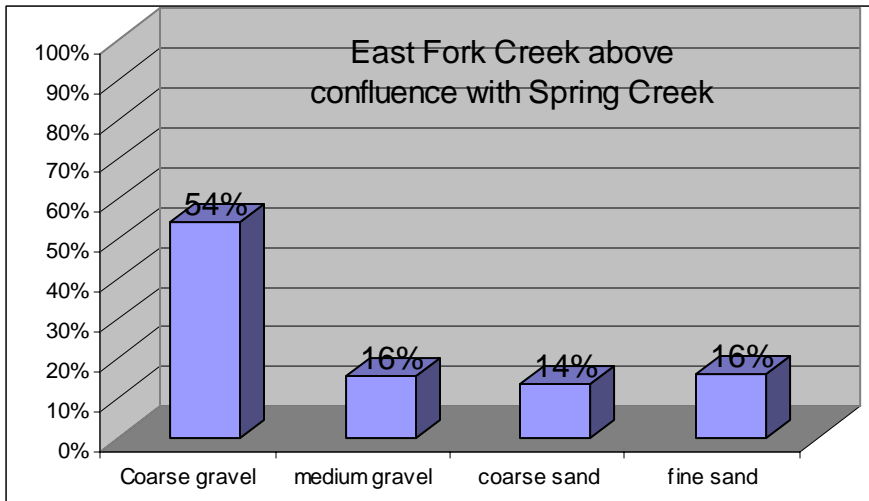
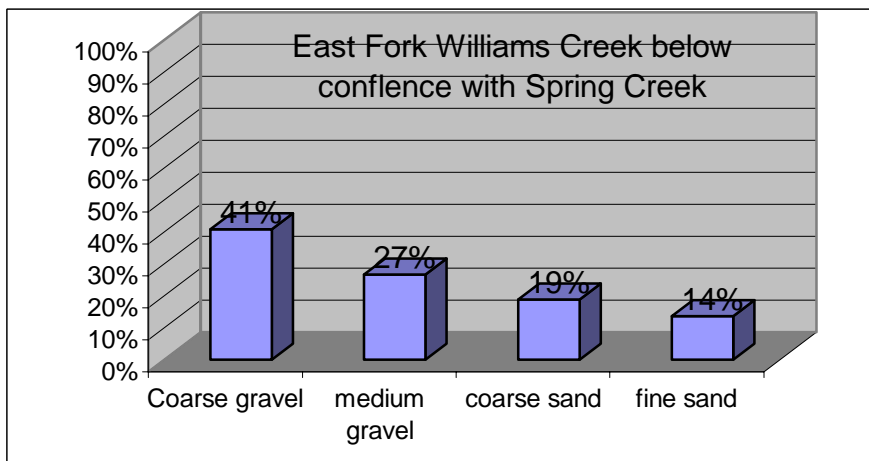
Fig 24. : East Fork Williams Creek above and below the confluence with Spring Creek

Spring Creek is identified as one of the tributaries that carries the highest content of sand in the East Fork subwatershed. Sampling was done at the confluence of Spring Creek to see if the impact on East Fork could be recognized by the gravel and sand content in the creek. Samples were taken above the confluence and below the confluence with the results shown on the graphs.

Results were mixed but did show that the coarse sand content increased to the lower side of the Spring Creek confluence with the fine sand content decreasing. This may be due to the fact that the input of Spring Creek is directly eroded off the granitic rocks and has not been physically broken down into its finer components. Pebble content increases in the downstream graph also supporting the coarsening of the gravels from Spring Creek. Other possibility for the coarsening is that the finer sand may be depositing in the low gradient fields above the confluence area as sand bars and flood deposits.

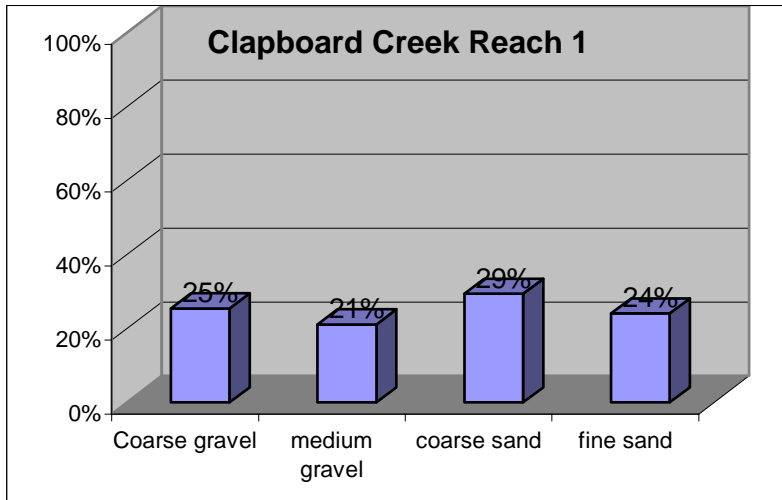
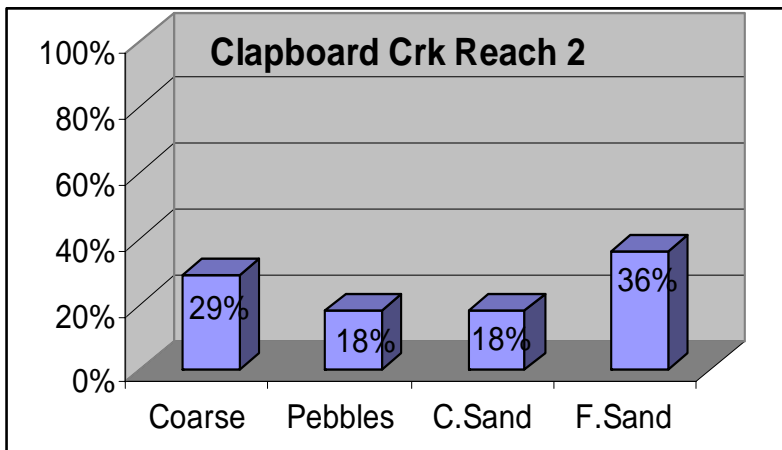
Fig 25. Clapboard Creek near the confluence with East Fork Williams Creek and in upper Reach 2

Clapboard Creek shows a marked increase in coarse and fine content of sand with the total sand content increased to 54% in the lower reaches and up to 54% in the upper reaches. Coarse-grained sand content is higher than fines in the lower reaches but fine sands increase considerably in reach 2 where sandy terraces are actively slumping and eroding into the creek. Much of this is the result of cattle in the riparian zones and dirt roads along the stream banks that are slumping.

Sand content in the gravels indicates nearness to the source gravels and although with fine sand this high it would be difficult to attest to good spawning habitat. Sand particles are angular or sub rounded, suggesting short duration in the stream gravels for rounding. Coarse gravel and medium gravel content are low.

Clapboard Creek contributes an enormous amount of sand to the East Fork Creek system due to the source area being entirely granitic with large sandy terrace deposits and deeply incised drainages. This area has two landowners with very different management practices, one with no cattle and abundant vegetation along creeks and another with cattle in riparian zone and little understory vegetation. Needless to say the latter has the most erosion and incision of the creek.

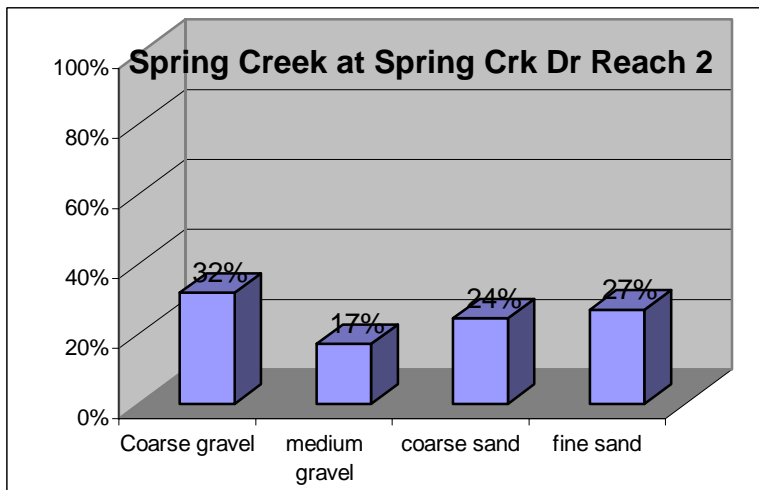
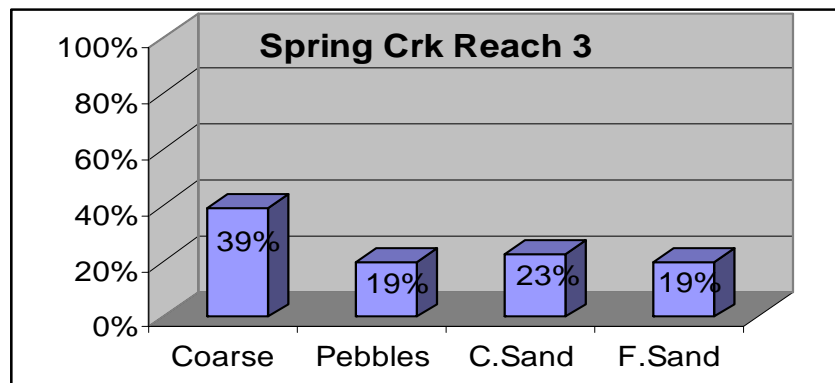
Fig 26. Spring Creek at Reach 1 and 2

Spring Creek shows high contents of sand in both the fine and coarse size class. The chart showing Spring Creek gravels in River Mile 1 or Reach 1 were collected in an area that contains a lot of sand deposition. Sand has been depositing here in the drainage where clusters of willow, alder, and other trees have been able to slow the water velocity and filter the sand. The high sand content here probably reflects the lower gradient and broad floodplains that receive deposits and have good soil accumulations.

Spring Creek Drive is located in River Mile 2 or Reach 2 and shows a balance of coarse, medium gravels along with a near equal amount of fine and coarse sands. This is very near the source of erosion of granitic rock in the Spring Creek drainage and is a good representation of the type of clastic material washing down off the granitic rocks. A large landslide has been eroding material near the headwaters of this drainage on BLM land from the 1997 winter

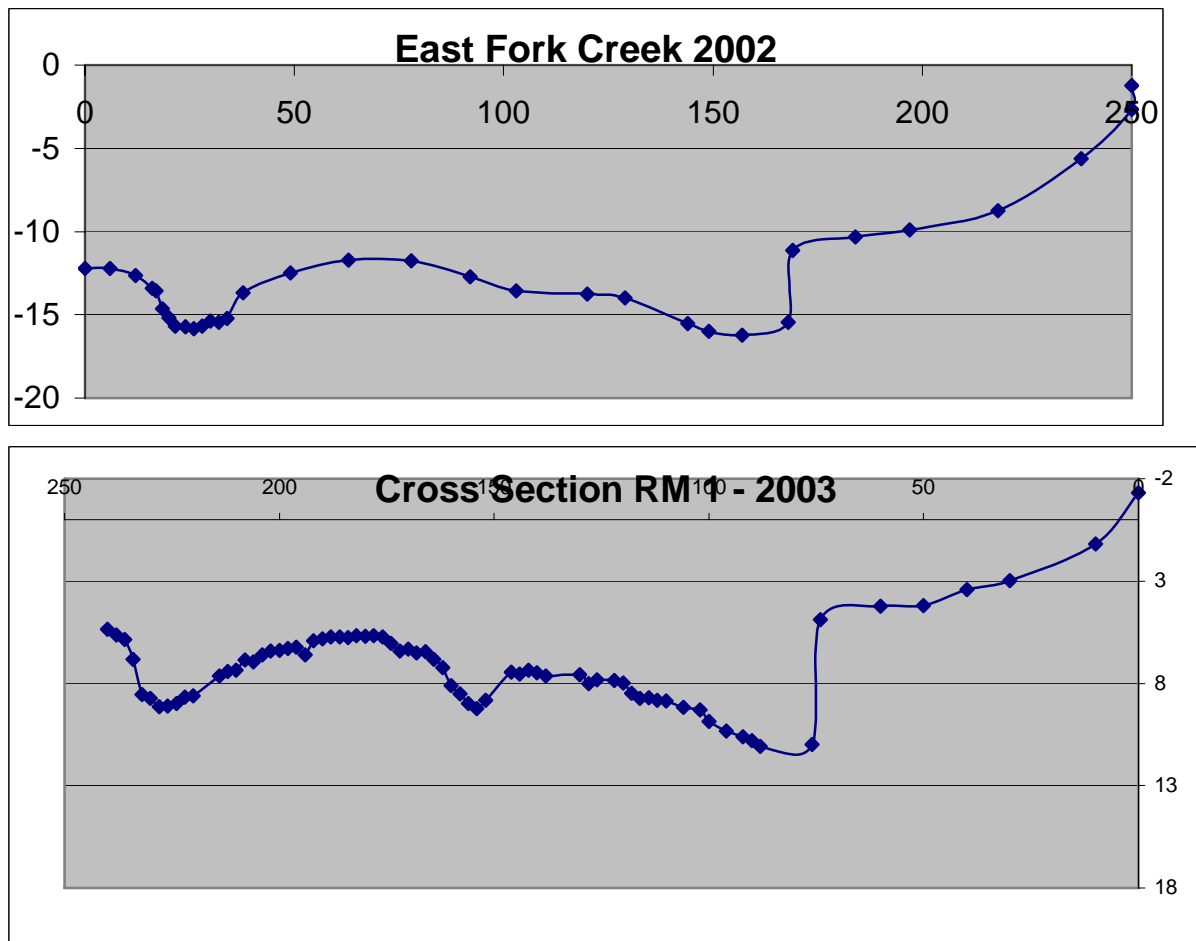
Fig 40. East Fork Creek Reach 1 - 2002

Comparisons of cross sections from successive years indicate erosion is active laterally and vertically. The right bank has been eroded close to 2.7 feet vertically and 6 feet laterally. Scour has been rapid where logs have been embedded producing pools. Deposition of large gravel continues here where the channel is restricted by the Brown's Road Bridge 200 feet downstream.

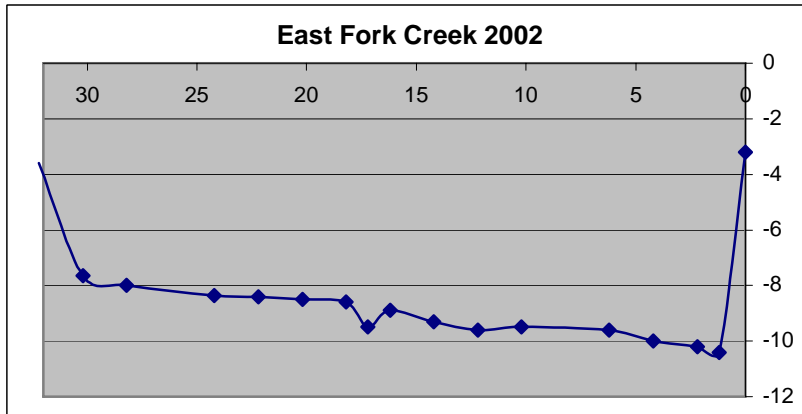
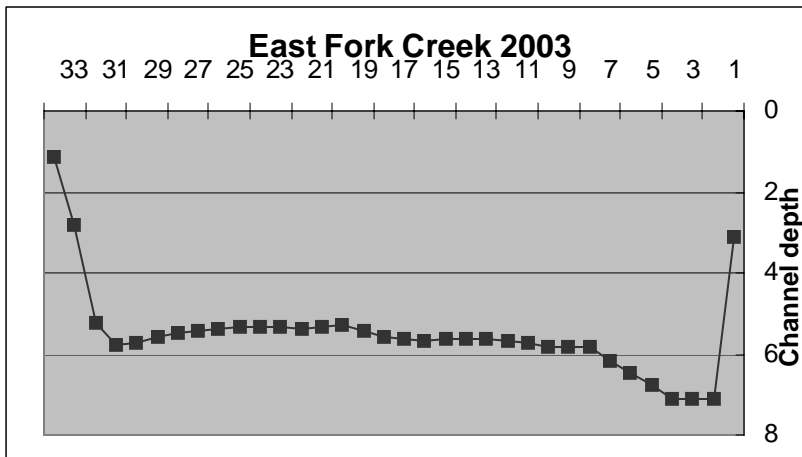
Fig 42: East Fork Williams Creek above Rock Creek, Reach 4

East Fork Creek experienced a debris dam 60 feet downstream of this point during the winter of 2003 which backed up the water and deposited gravel in this area. Accumulation of gravel built up the substrate with a broad riffle, several scour pools, and other channel features. Longitudinal profiles would be useful in this area.

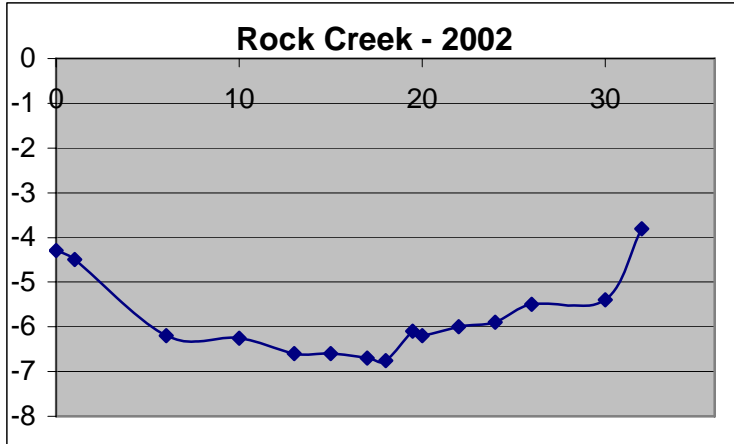
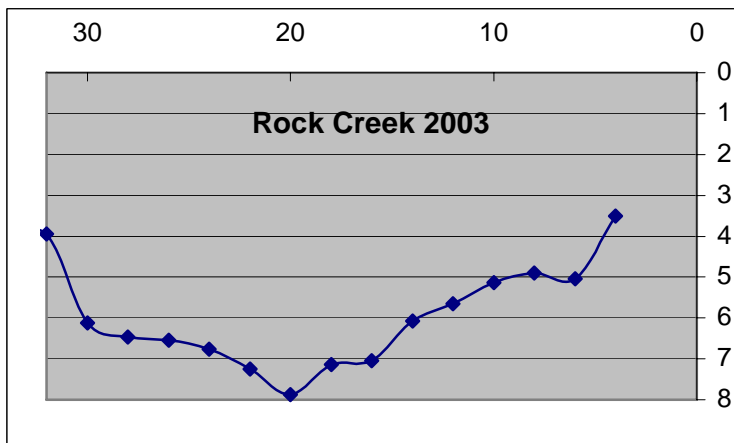
Fig 43. Rock Creek Reach One – 2002 - 2003

Rock Creek was subject to increased scour and erosion in this reach that increased the depth of the bed down 1 foot in the center in one year's time. Removal of large wood and rapid discharge will continue this process as water rapidly runs off the steep hillsides. Lateral erosion continues as bank height increases and undercutting promotes bank instability.

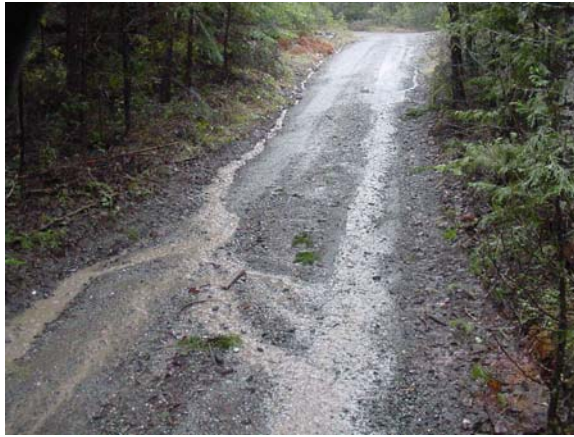
Fig. 44. Erosion down steep forest road carries fine material downslope

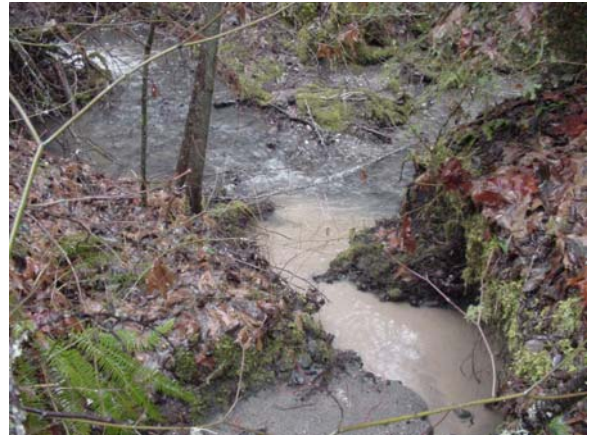
Fig 47 Erosion on side of road continues to down into Spring Creek mixing with clear water

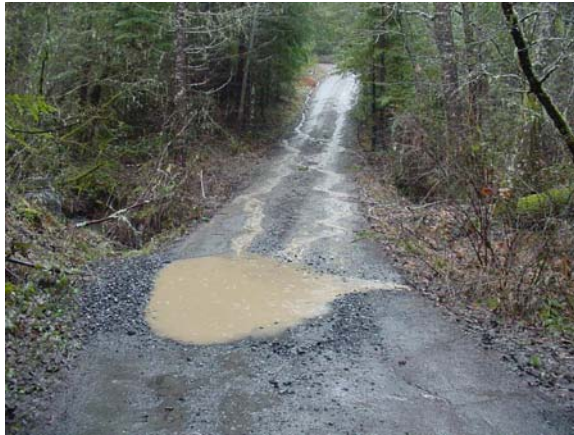
Fig. 45 Erosion on Spring Creek Driveway collecting at crossing of Spring Creek

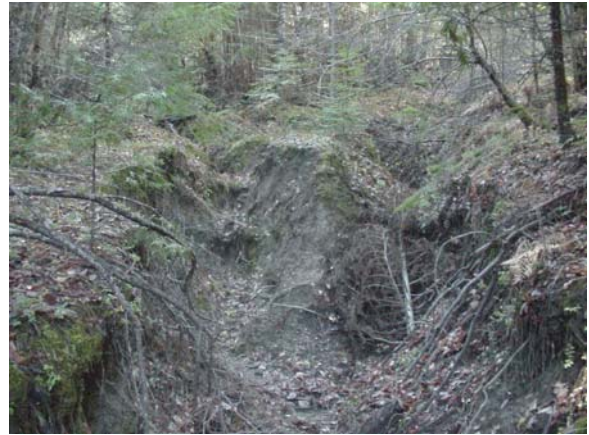
Fig 48. Gully erosion along Spring Creek Drive where erosion has cut 7 feet deep

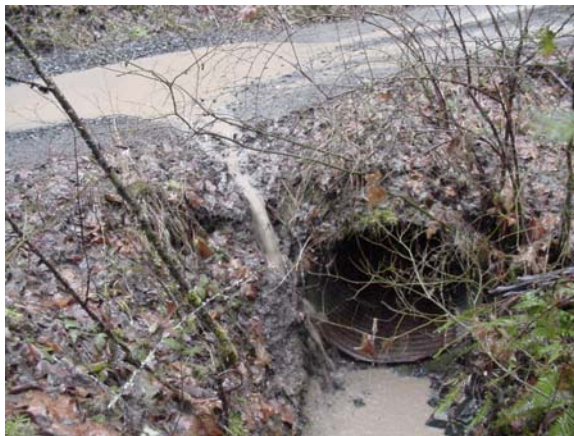
Fig 46. Sediment flowing directly into Spring Creek, tributary of East Fork Williams Creek

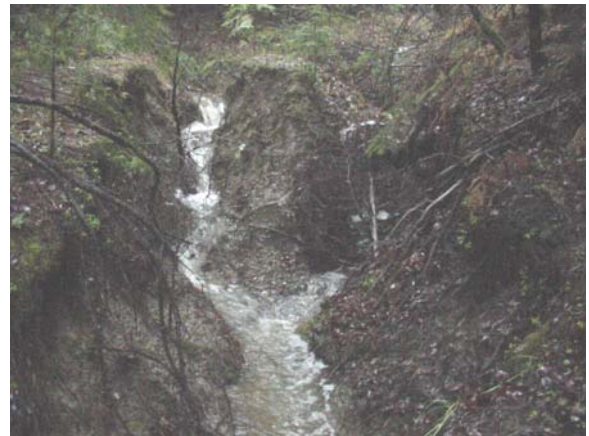
Fig 49. Runoff travels down road and enters gully during rainstorm continuing erosion

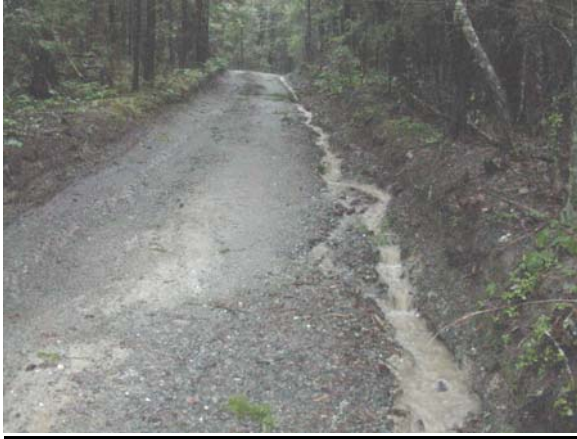
Fig 50. Erosion along side of road continues to cut ditches and removes gravel to Spring Creek

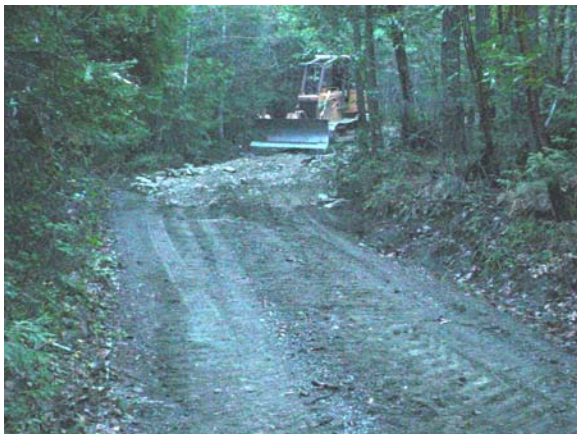
Fig 52. Dozer used to spread rock to outslope the road

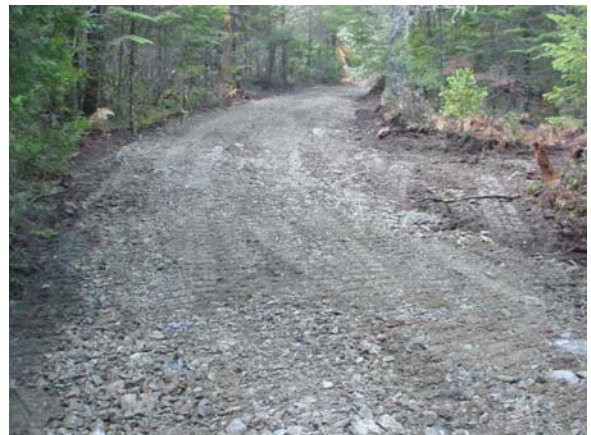
Fig 55. Completed section of road with outsloping and packed rock

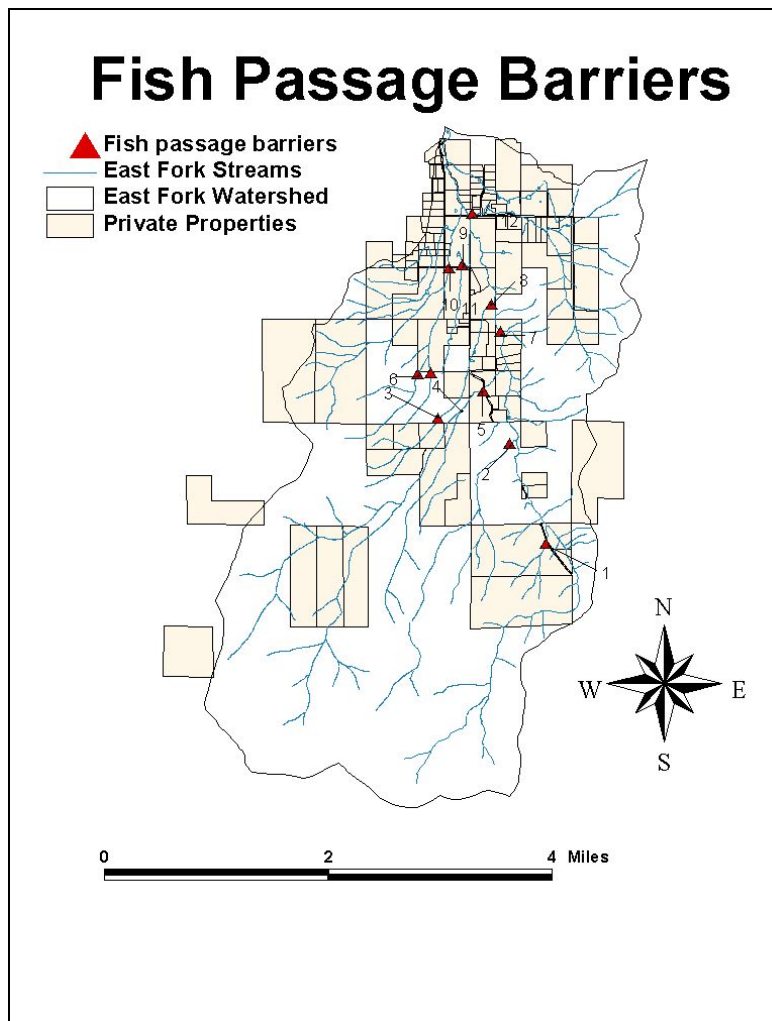
Fig 65 Fish Passage Barriers

- 1) Undersized culvert crossing East Fork Road on small tributary, Jones Creek**
 - a) Considered for Title II project with BLM to replace
 - b) Reduce 3 foot drop and improve fish passage
 - c) Targeted species- steelhead, cutthroat trout
- 2) Undersized culvert crossing East Fork Road on Clapboard Creek**
 - a) Consider for Title II project with BLM, County for replacement
 - b) Increase size and improve outflow conditions for fish passage
 - c) Targeted species- steelhead, cutthroat trout
- 3) Ditch crossing and small pushup dam on Spring Creek to transfer water across streambed**
 - a) Rock Creek Ditch carries water form Rock Creek across Spring Creek to lower ponds and irrigation fields
 - b) Push up dam on Spring Creek impacts fish passage and restoration
 - c) Target species- steelhead, cutthroat

- 12) **Panther Creek ditched and controlled**
 - a) Lower creek is captured by instream pond with control outflow
 - b) Pond has overflowed and broken dam structure
