Evaluation of Fish Passage Improvement Projects in the South Coast and Rogue River Basins 2009

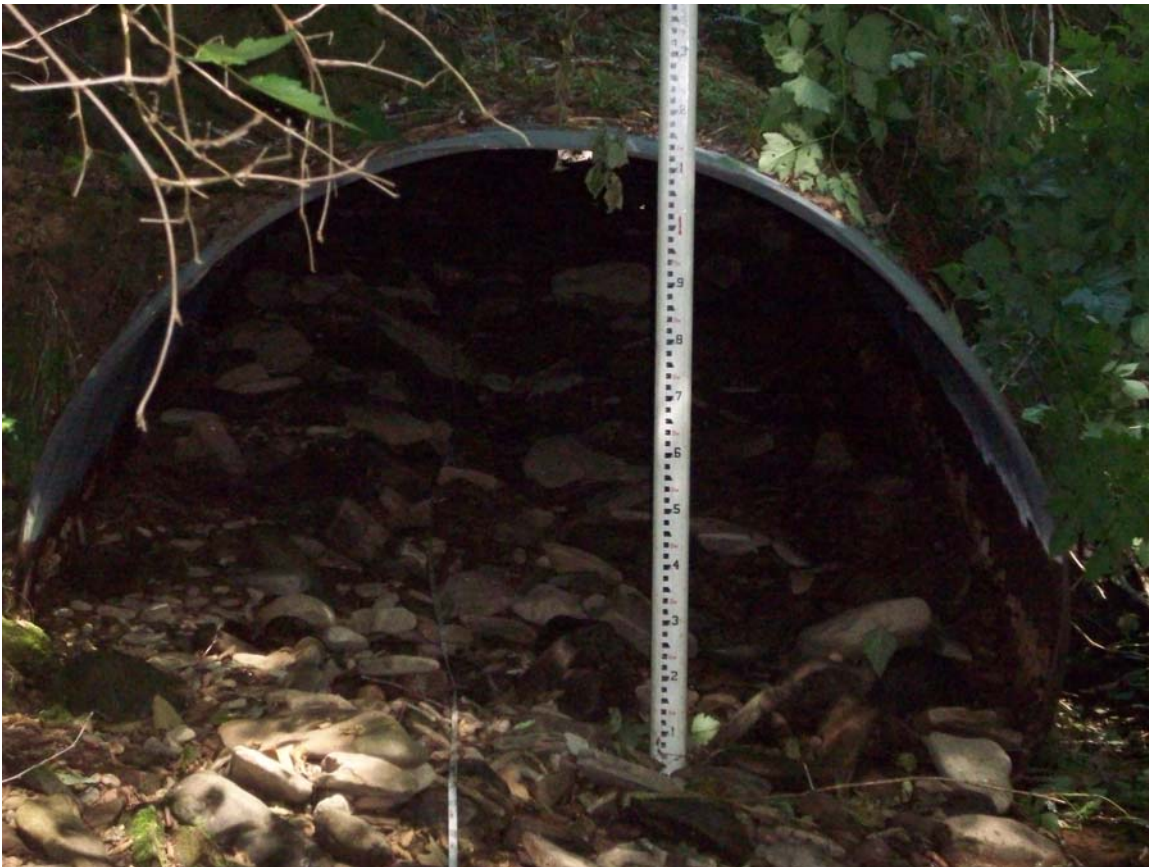
Similarly Site 21 (Photo 3) was predicted to be a juvenile barrier, yet it is clear that this culvert is stream simulated and probably not a barrier.

Photo 3. Site 21, stream simulated design predicted to be a 100% juvenile barrier because of velocity.

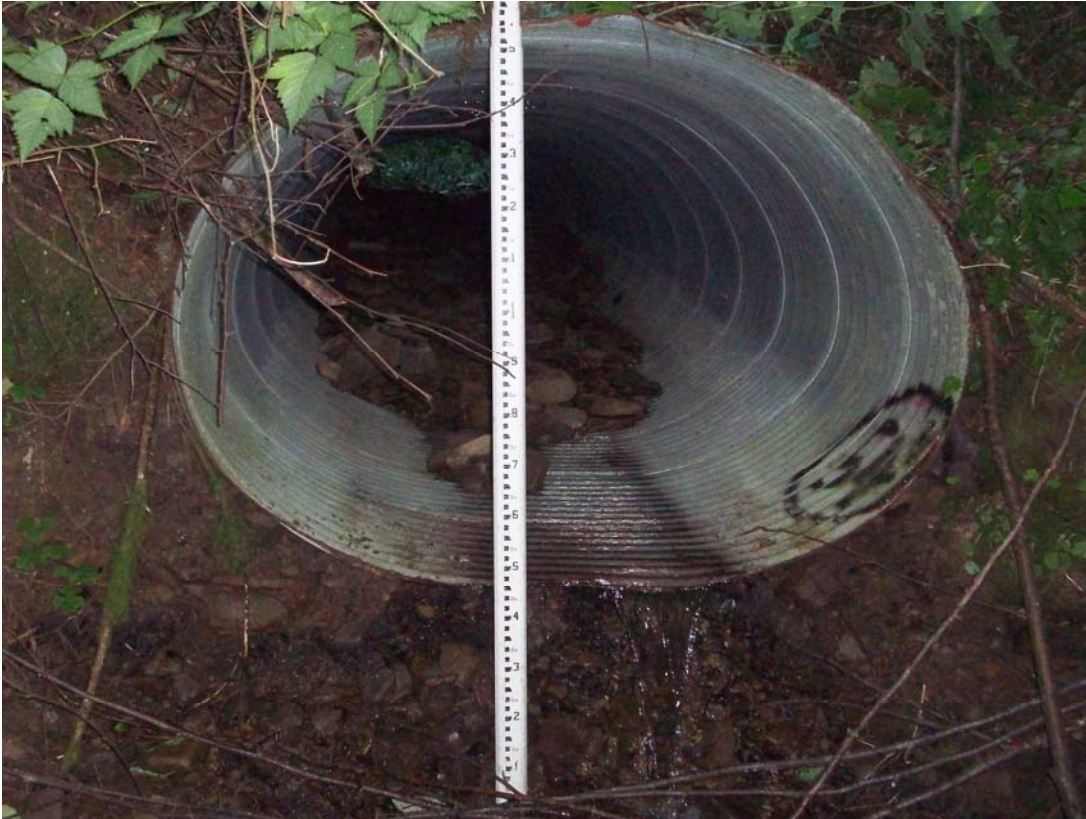
| *Site 73 had a significant outlet drop ([Photo 4](#)) and is clearly a barrier to fish passage.*

Photo 4. Site 73, a clear barrier due to the outlet jump.
