Klamath Falls earthquakes, September 20, 1993—including the strongest quake ever measured in Oregon

by Thomas J. Wiley¹, David R. Sherrod², David K. Keefer³, Anthony Qamar⁴, Robert L. Schuster⁵, James W. Dewey⁵, Matthew A. Mabey⁶, Gerald L. Black⁶, and Ray E. Wells³

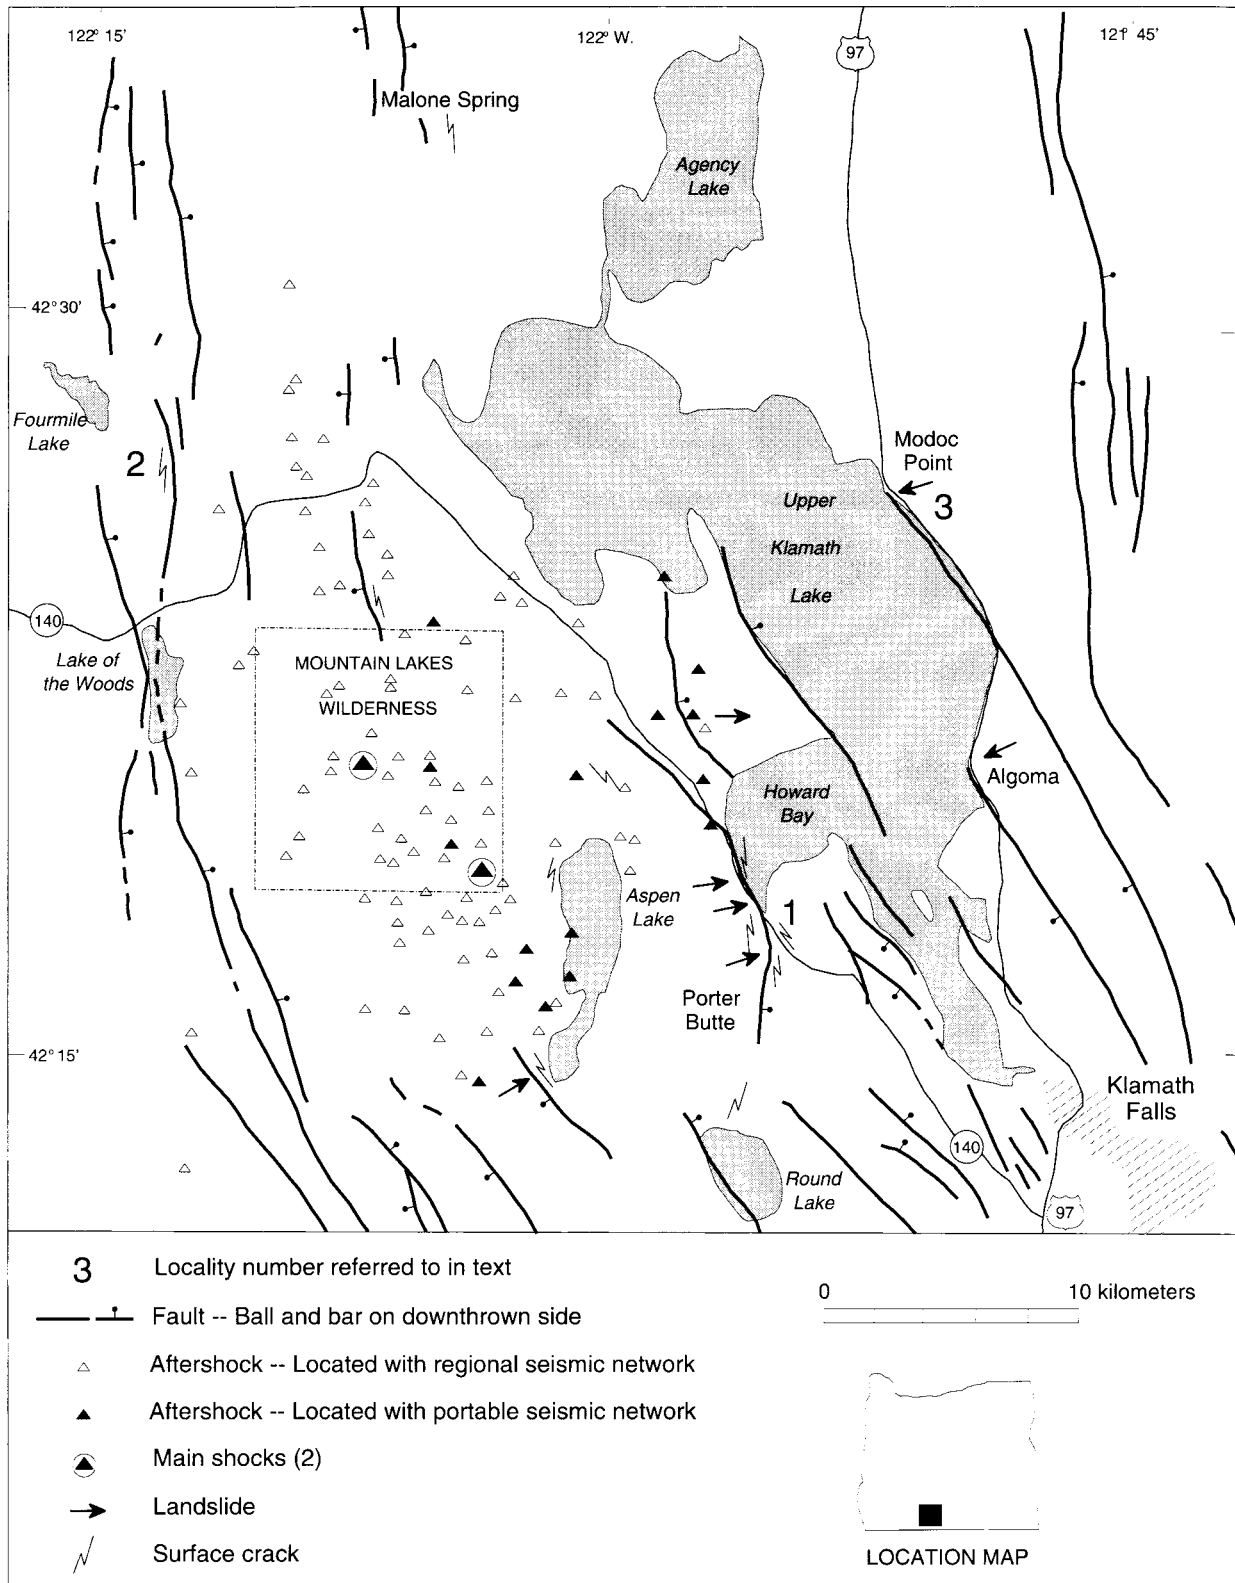
Figure 2. Map showing location of the two main shocks, aftershocks, surface deformation, mapped faults, and localities discussed in text.

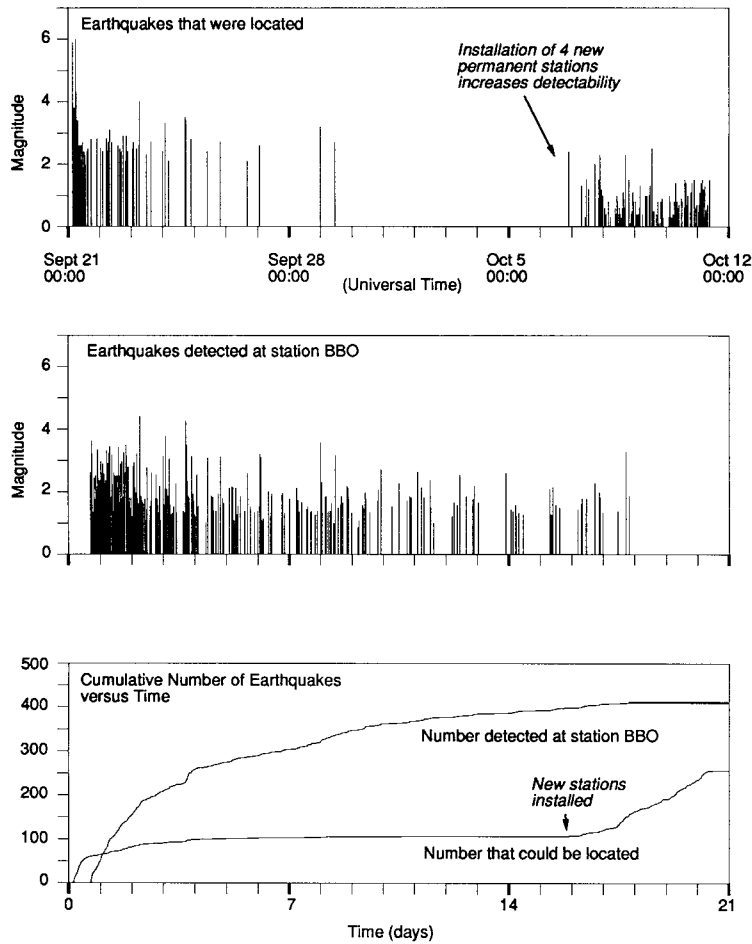
Figure 3. Plots showing earthquake magnitude versus time during first three weeks of earthquake activity. (a) Earthquakes located by University of Washington (UW) seismic network. (b) Earthquakes detected by closest permanent seismograph at station BBO (see Figure 11). (c) Total number of located and detected events. With the addition of the new stations now being recorded at UW, 780 earthquakes had been located by October 22.

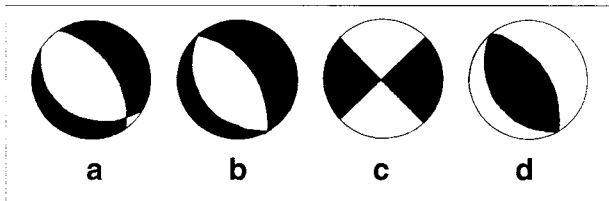
Analysis of the shock waves was used to determine the orientation of the fault plane and the direction of slip in what is known as a fault-plane solution. One fault-plane solution for the magnitude 6.0 main shock at 10:45 p.m. is shown on Figure 4 and is interpreted to represent a northwest- to north-northwest-striking (N. 38° W.), east-dipping (56°) normal fault with a very small component of left-lateral motion.

Figure 4. (a) Fault-plane solution for magnitude (M_c) 6.0 main shock at 10:45 p.m. on September 20, 1993 (lower hemisphere stereographic plot). The two planes defined by the boundaries between black (compression) and white (dilation) zones indicate fault orientations that could have produced this earthquake. The N. 38° W. plane dipping 56° NE. parallels many of the known faults in area. (b) Idealized normal-fault solution. (c) Idealized strike-slip-fault solution. (d) Idealized thrust-fault solution.

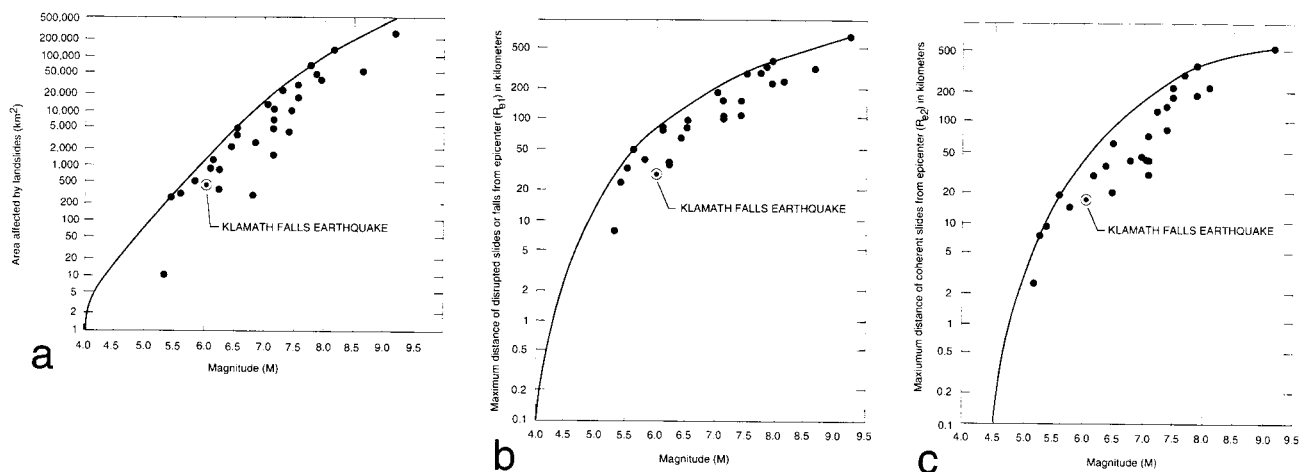
The types and areal limits of landslides (Figure 10) caused by the Klamath Falls earthquakes are typical for earthquakes of this magnitude. The area throughout which landslides occurred (Figure 10a), the maximum epicentral distances for rock slides and rock falls (Figure 10b), and the maximum epicentral distances for rotational slumps (Figure 10c) are comparable to similar data from other historical earthquakes. In addition, rock falls, rock slides, and slumps of fill material are among the most common types of landslides in other historical earthquakes of comparable magnitude (Keefer, 1984).

Figure 10. Plots comparing landslides caused by Klamath Falls earthquakes with landslides caused by other historical earthquakes (solid dots). Data on historical earthquakes and solid line denoting upper limit are from Keefer (1984). (a) Area affected by landslides. (b) Maximum epicentral distance of rock falls and rock slides (disrupted slides and falls). (c) Maximum epicentral distance of slumps (coherent slides).
