Complex mass-movement terrains in the western Cascade Range, Oregon

FREDERICK J. SWANSON

DOUGLAS N. SWANSTON

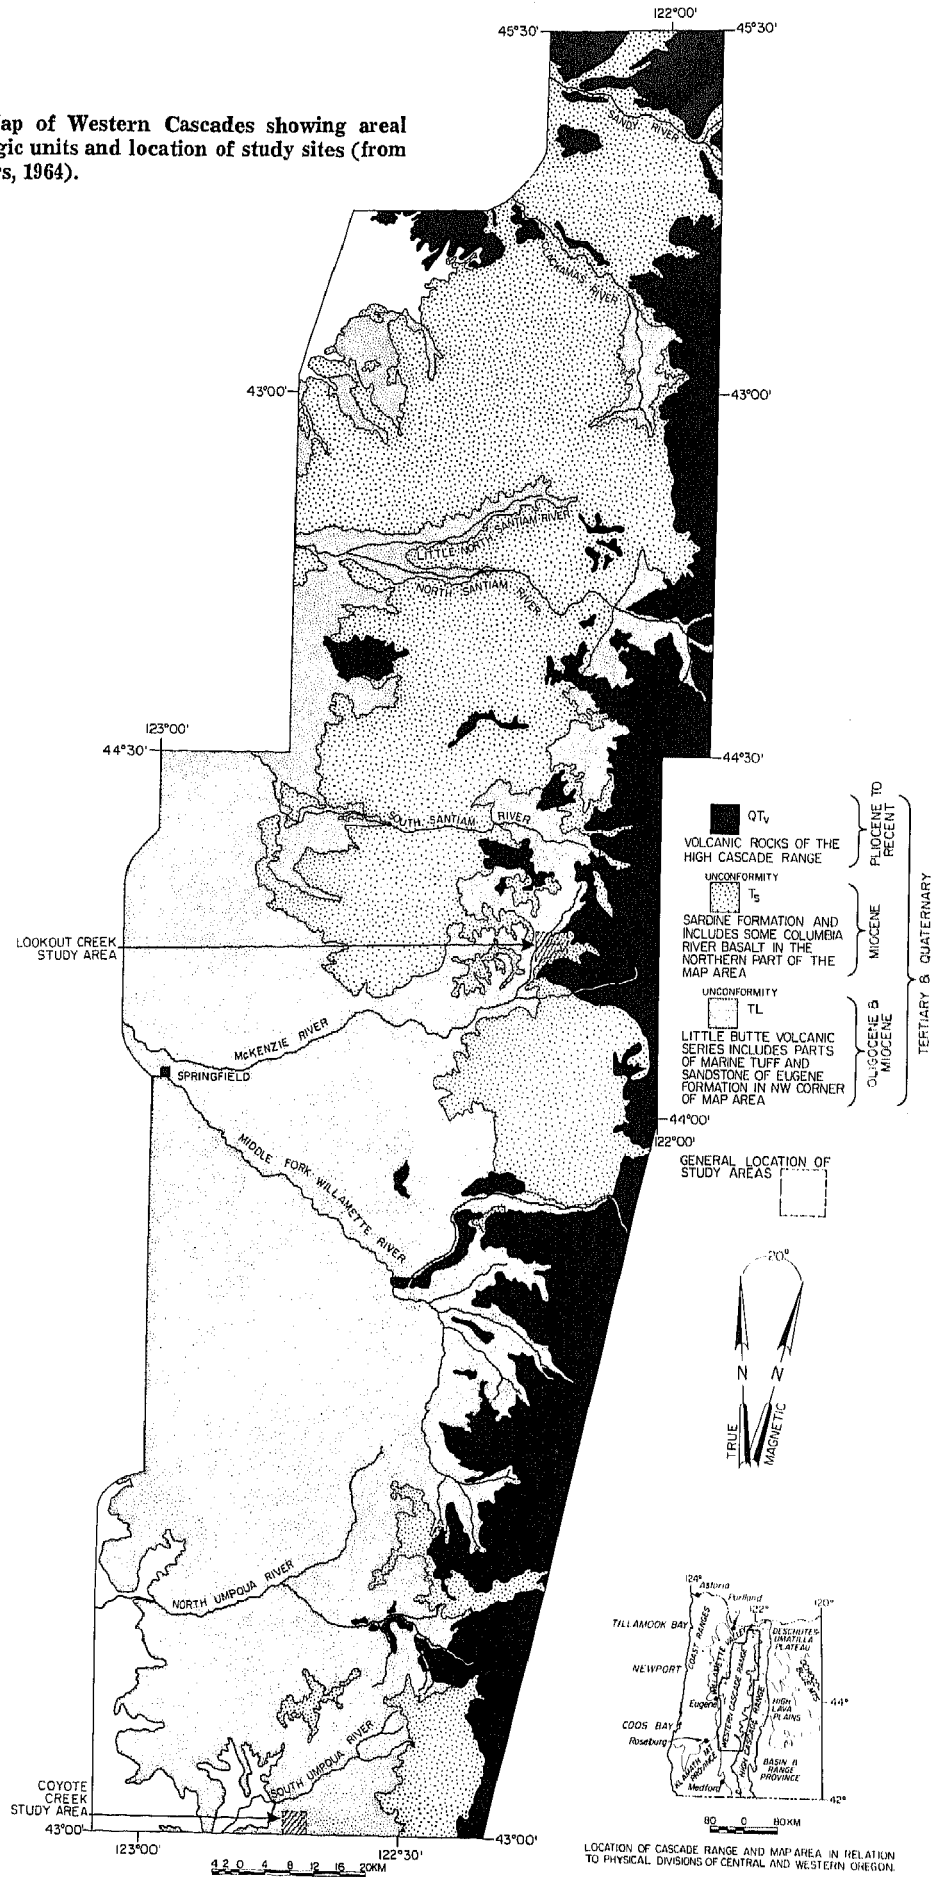
Figure 1. Map of Western Cascades showing areal extent of geologic units and location of study sites (from Peck and others, 1964).

The Coyote Creek mass-movement site lies in the South Umpqua Experimental Forest, which is located in the South Umpqua Falls region, as defined by Kays (1970), about 64 km southeast of Roseburg, Oregon (Fig. 1). About a fourth of the region is underlain by deeply weathered, clay-rich rhyodacitic volcanoclastic rocks and subordinate lava flows of the Little Butte Volcanic Series (Kays, 1970). Relatively small parts of the region on the eastern and western edges are capped by andesitic flows of the overlying Sardine formation.

The Lookout Creek earthflow site (sec. 30, T. 15 S., R. 6 E.) is a complex mass-movement terrain in the H. J. Andrews Experimental Forest approximately 90 km east of Eugene, Oregon (Fig. 1). Much of the earthflow has developed in a

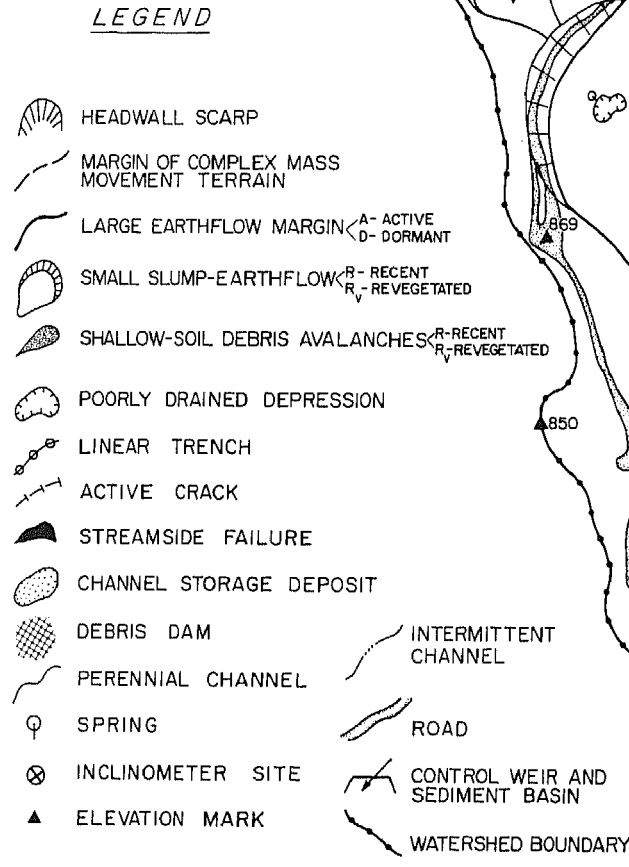
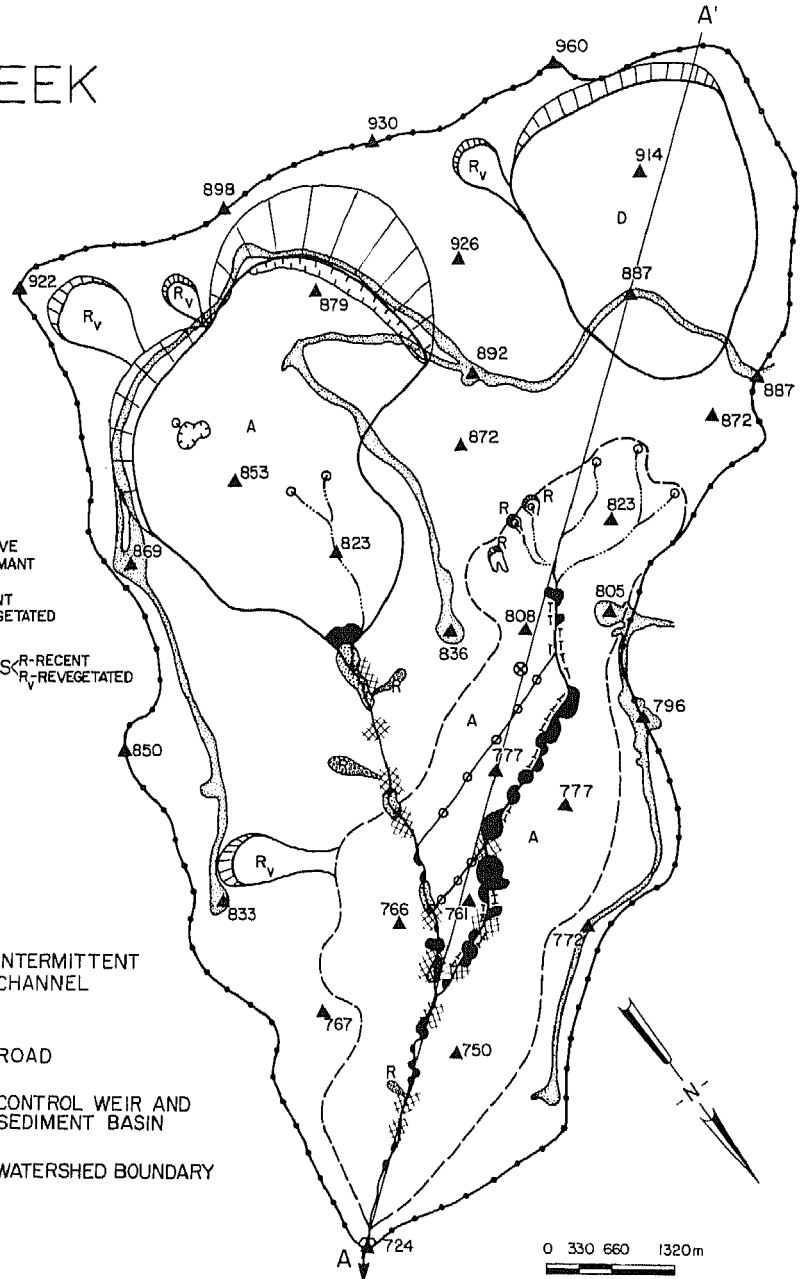
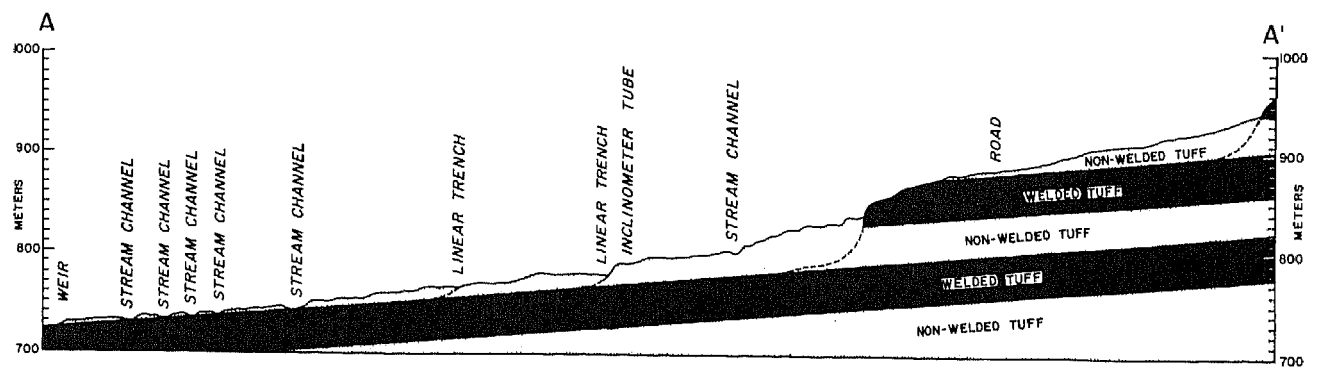
COYOTE CREEK

Figure 2. Map of Coyote Creek watershed 3 showing location of earthflows, complex mass-movement terrain, and associated channel features.

Inclinometer tube measurements in the soil and deeply weathered volcanoclastic rocks in the lower half of the watershed (Fig. 2) indicate movement along the plane of maximum deformation in a N50°E direction toward the mouth of the valley. Surface movement is approximately 10.5 mm/yr and movement at the base of the active movement zone at a depth of approximately 6.0 m is 9.1 mm/yr. This movement exhibits strong seasonal variation with most movement taking place during the fall and winter rainy period when maximum soil-water levels occur (Fig. 3). The similarity of the movement rates at the surface and the base of the movement zone suggests a fairly uniform rate of deformation of approximately 10 mm/yr above a lower boundary layer corresponding to the saprolite contact or the top of an intervening layer of relatively resistant welded tuff or flow rock.

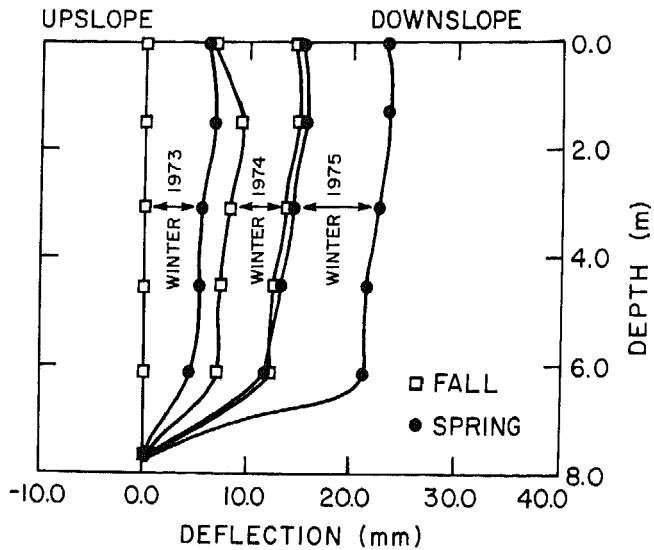
Figure 3. Apparent seasonal deformation along $N70^{\circ}E$ direction recorded in inclinometer tube installed in complex mass-movement terrain at Coyote Creek. Movement is directly plotted from field data and has not been projected into the plane of maximum deformation ($N50^{\circ}E$). Note minor upslope movement of tube during summer of 1974 owing to settlement in hole.

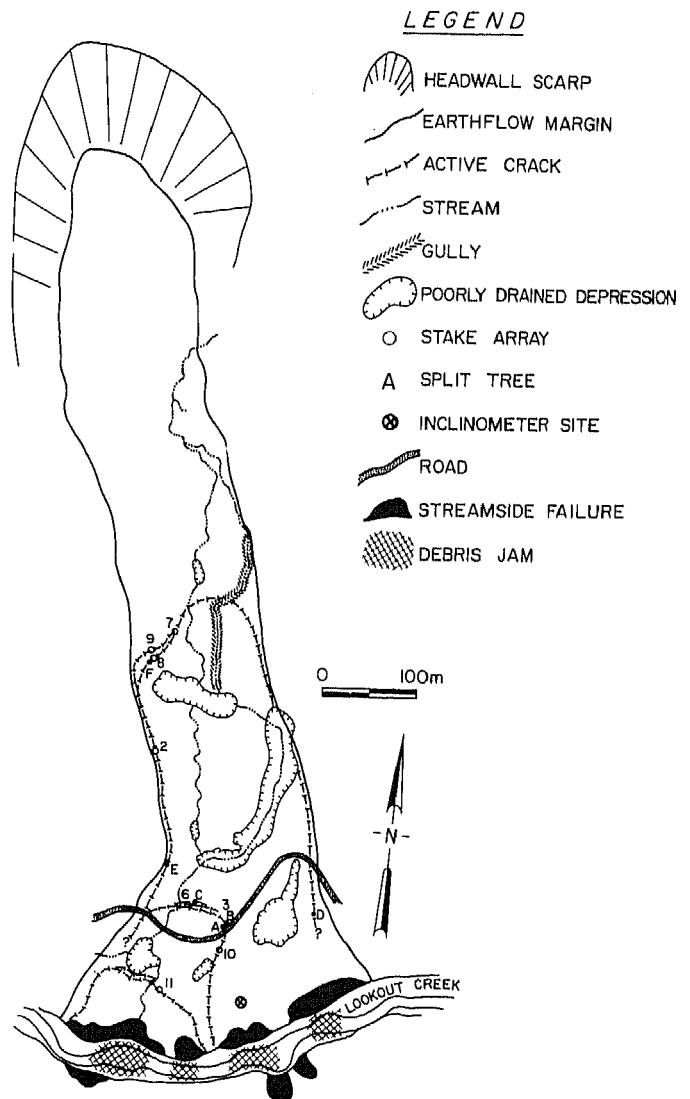
Figure 4. Map of Lookout Creek earthflow. Mapped by G. Lienkaemper using compass and range-finder. See also Tables 2 and 3.

The earthflow covers an area of approximately 20 ha on a south-facing valley wall. The flow extends from a rocky headwall at an elevation of 1,010 m downslope 900 m into Lookout Creek at a 790-m elevation (Fig. 4).

Drainage patterns on the earthflow are very irregular owing to frequent disruption by earth movement (Fig. 4). In several instances, streams have been channeled along tensional and shear cracks. Discontinued gullies, unusual features in the western Cascades, have developed along restricted stream reaches. Surface-water movement has been altered by the

Arrays of 4 to 9 stakes were established on several areas of the earthflow where shear and tensional movement appear to be very active (locations shown in Fig. 4). The stake arrays

Note: Differential movement in centimetres. Precision of measurement is approximately ±2 mm. Locations of stake arrays shown in Figure 4.

Note: Location of trees noted in Figure 4.

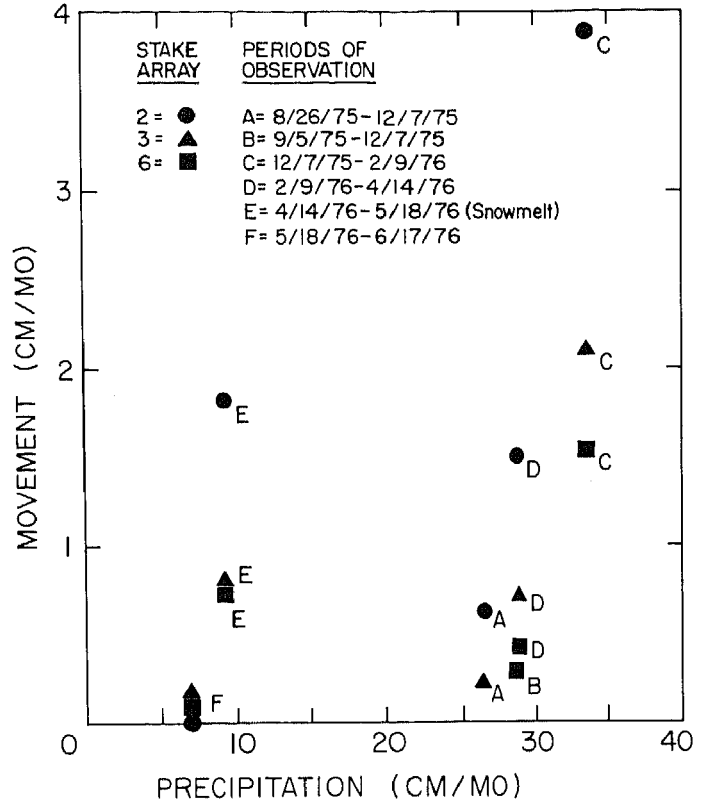
Figure 5. Rate of precipitation versus relative earthflow movement rate at several sites on the Lookout Creek earthflow for wet season of water year 1976.

The influence of moisture on earthflow movement is seen more clearly in readings taken every 1 to 4 mo between August 1975 and June 1976. A plot of movement rate (centimetres per month) versus precipitation rate (centimetres per month) for the periods of observation clearly shows accelerated mass movement during periods of high-moisture availability (Fig. 5). Maximum rates of differential earthflow movement were recorded during the December 7, 1975, to February 9, 1976, period of highest precipitation. Early in the wet season, movement rates were low even for precipitation of 27 cm/mo because of very low antecedent moisture conditions. During spring snowmelt, late in the wet season, movement rate was high relative to precipitation because of the presence of residual water from earlier in the wet season, plus incoming water from snowmelt. In the month following May 18, differential movement at the three stake arrays was negligible.

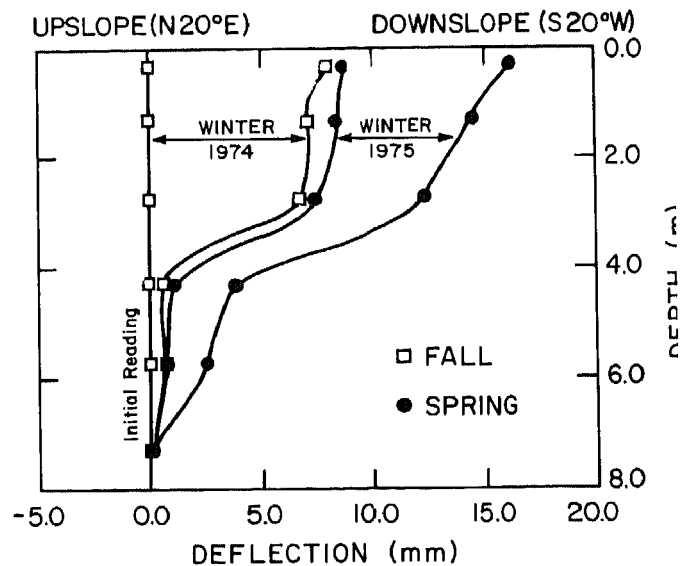
Figure 6. Apparent seasonal deformation along S20°W direction recorded in inclinometer tube installed in Lookout Creek earthflow. Movement is directly plotted from field data and has not been adjusted into the plane of maximum deformation. Note minor upslope movement of tube during summer of 1975 owing to settlement of tube.

An inclinometer tube installed near the toe of the earthflow has been used to record deformation within an individual block of the earthflow adjacent to Lookout Creek (Fig. 6). The tube (located in Fig. 4) reveals downslope movement of 8.25 mm/yr at the surface along a plane of maximum deformation oriented approximately S82°E. Near the base of the movement zone at a depth of 4.3 m, deformation is occurring at an average rate of 2.3 mm/yr to approximately S60°E. Creep deformation is occurring throughout the profile with

probable discrete failure at about 4 m. This may be related to incipient streamside slumping and probably accounts for the difference in orientation of the plane of maximum movement activity, with the fastest movement occurring during the months of high precipitation.

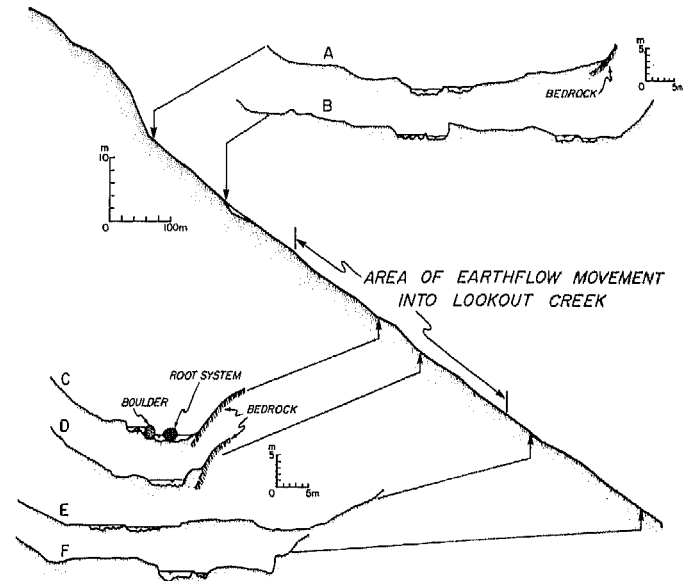
Figure 7. Long profile and cross profiles (A-F) Lookout Creek valley floor in the vicinity of the earthflow. Long profile based on field measurements of channel gradient over 30-m channel sections.

The long profile of Lookout Creek is remarkably straight through the area of earthflow impact and for more than 200 m both upstream and downstream (Fig. 7). Impact of the earthflow on this long profile is not clear. If there were no earthflow impact, the channel might have a more typical concave long profile. Earthflow movement may have caused local increases in stream-bed elevation as a result of high levels of sediment and large organic debris inputs to the stream in the area of direct impact and immediately down-
