Evaluation of Fish Passage Improvement Projects in the South Coast and Rogue River Basins 2009

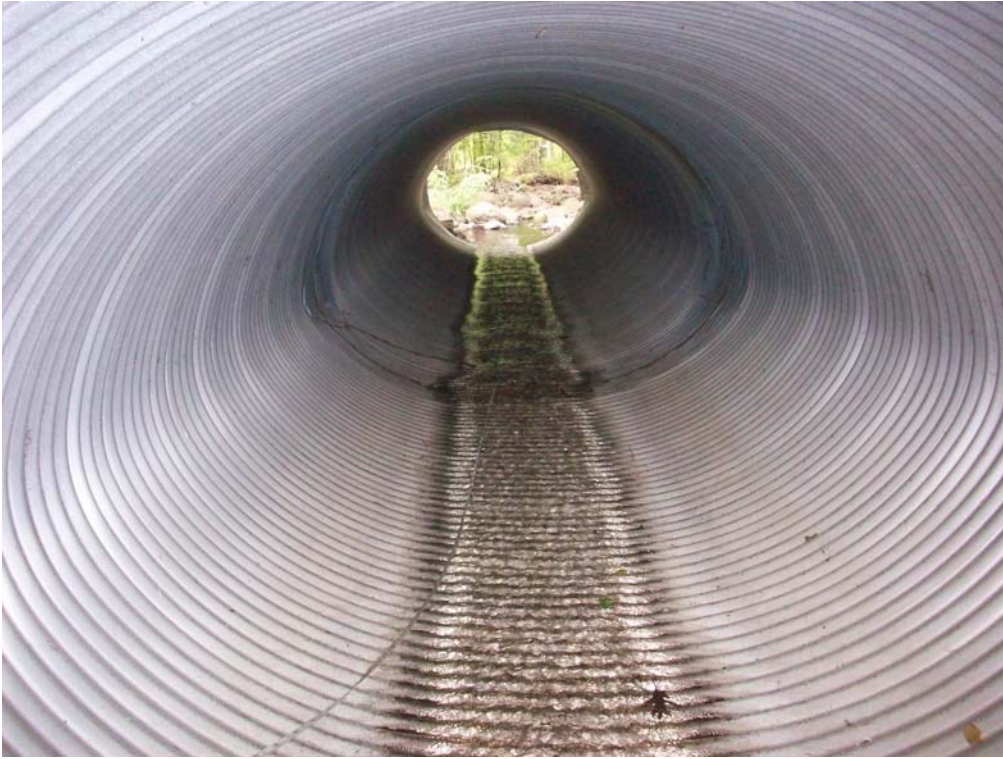
| Site 75 (~~Photo 5~~~~Photo 5~~), a recently installed culvert was so clear and free in terms of a lack of velocity reduction factors, it would seem very likely to be a juvenile barrier.

Photo 5. Site 75 predicted to be a 100% velocity barrier to juveniles; notice no objects present to retard velocity.
